Field investigations on the application of ACQ treated wood and use of metal fasteners and connectors in residential construction

**Dr. John N.R. Ruddick
Mychem Wood Protection Consultants Ltd.,
1365 Ottawa Ave.,
West Vancouver,
BC V7T 2H6**

December 2006

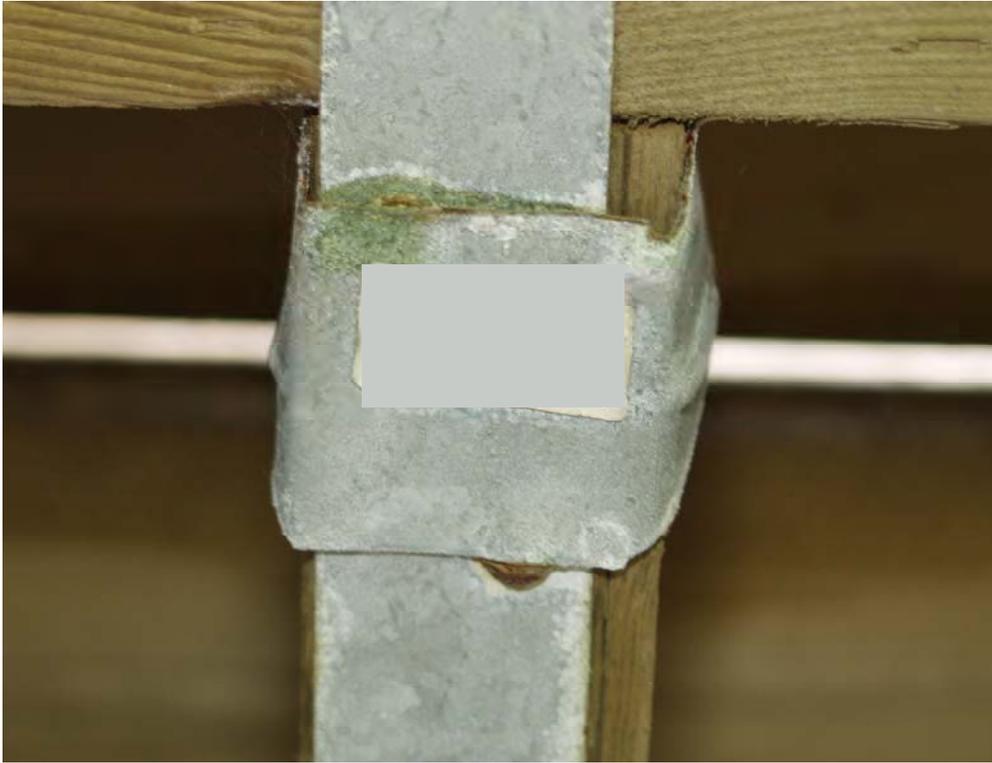
Inspection of the deck supporting structure quickly revealed two observations. The first was that a mixture of different quality of fasteners and connectors had been used. At the six decks inspected, most of the fasteners hammered directly into the ACQ treated wood appeared to be non-galvanized and were heavily red rusted. The fasteners used with hangers and straps appeared to be a mixture of un-galvanized and possibly some galvanized. Without removal of the fasteners it was not possible to confirm their type. Discussions with the technical manager indicated when the structure was being built, there was confusion about the type of fastener needed and that some common nails may have been used. The hangers were galvanized and they appeared from the labeling to meet the G185 standard. They commonly showed red rust on the edges. The technical manager informed the author that a hanger had been removed during routine maintenance and it had shown clear red rust formation on the inner surface. Inspection of the hangers on several decks showed red rust on the edges, some white rust and clear green copper deposits (Figures 1 to 9).

Figure 3 Hanger with red rust and copper deposits

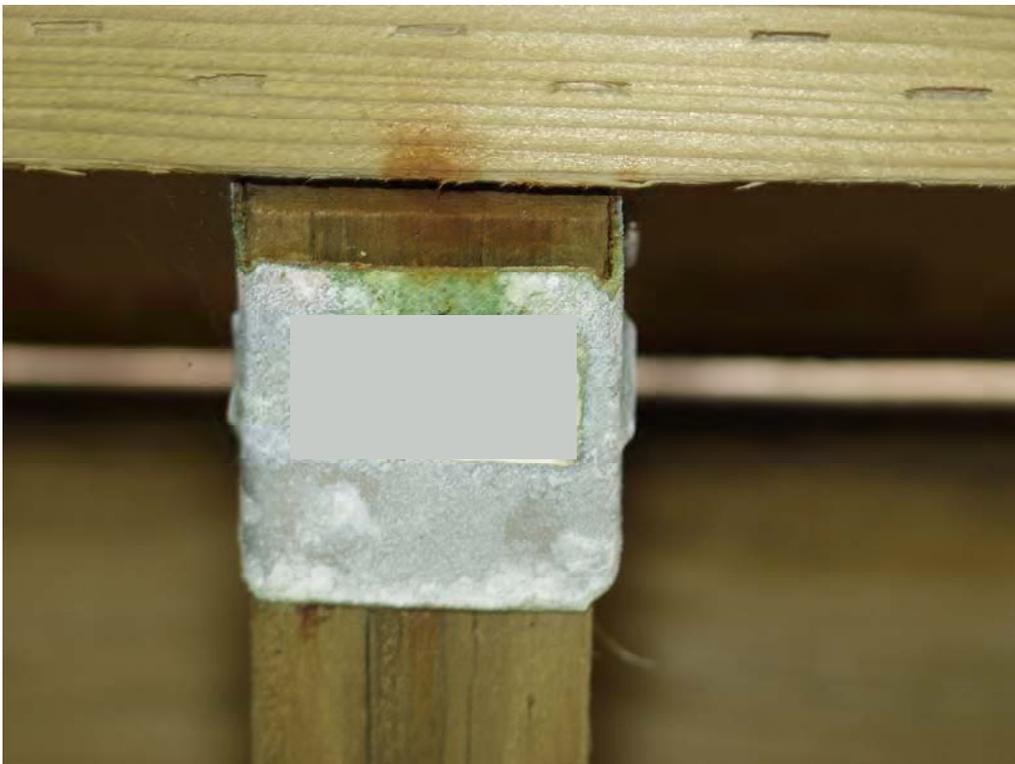
Figure 4 Hanger with red rust and copper deposits

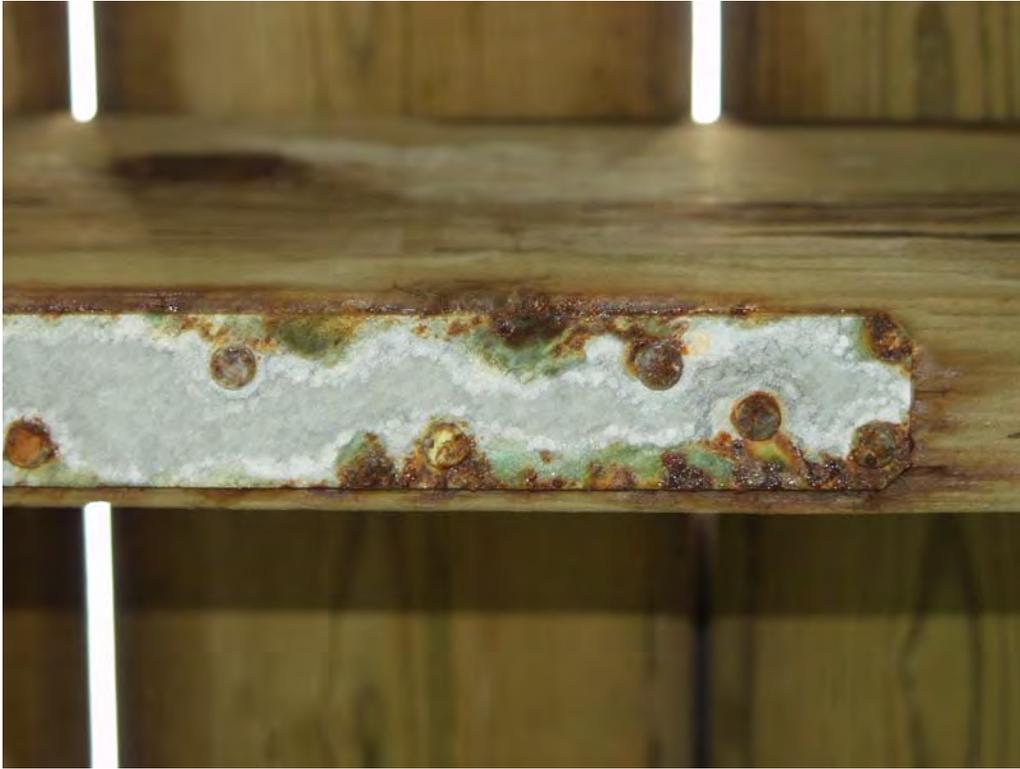
The second observation was that electroplated galvanized strapping had been used and showed severe red rust formation. This confirmed the unsuitability of electroplated galvanized material in contact with ACQ treated wood.

Figure 5 Electroplated strapping showing red rust

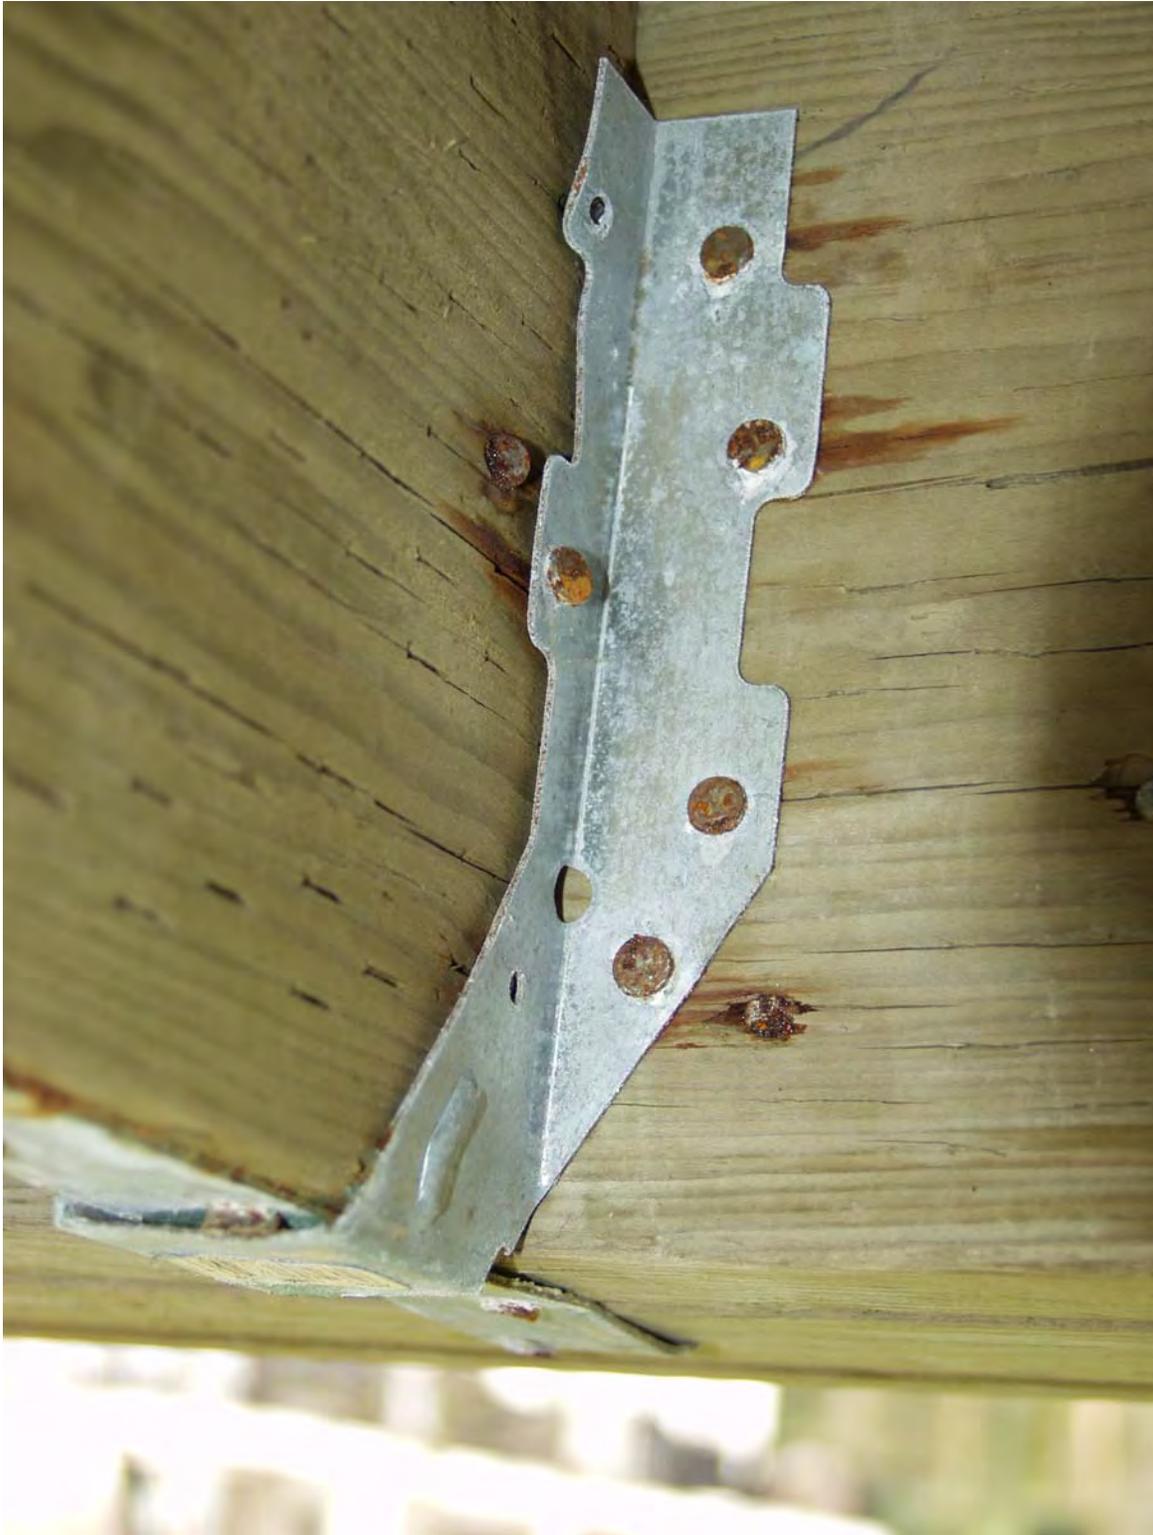
Figure 6 Red rust on common fasteners

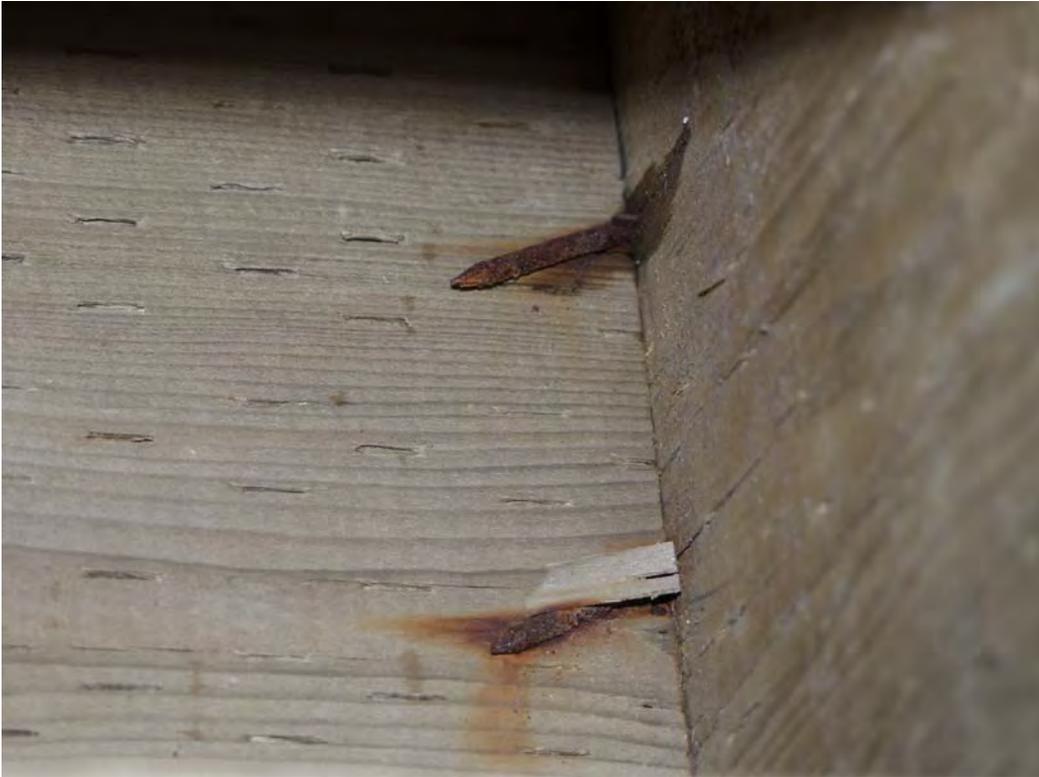
Figure 7 Corrosion of mild steel un-galvanized nails

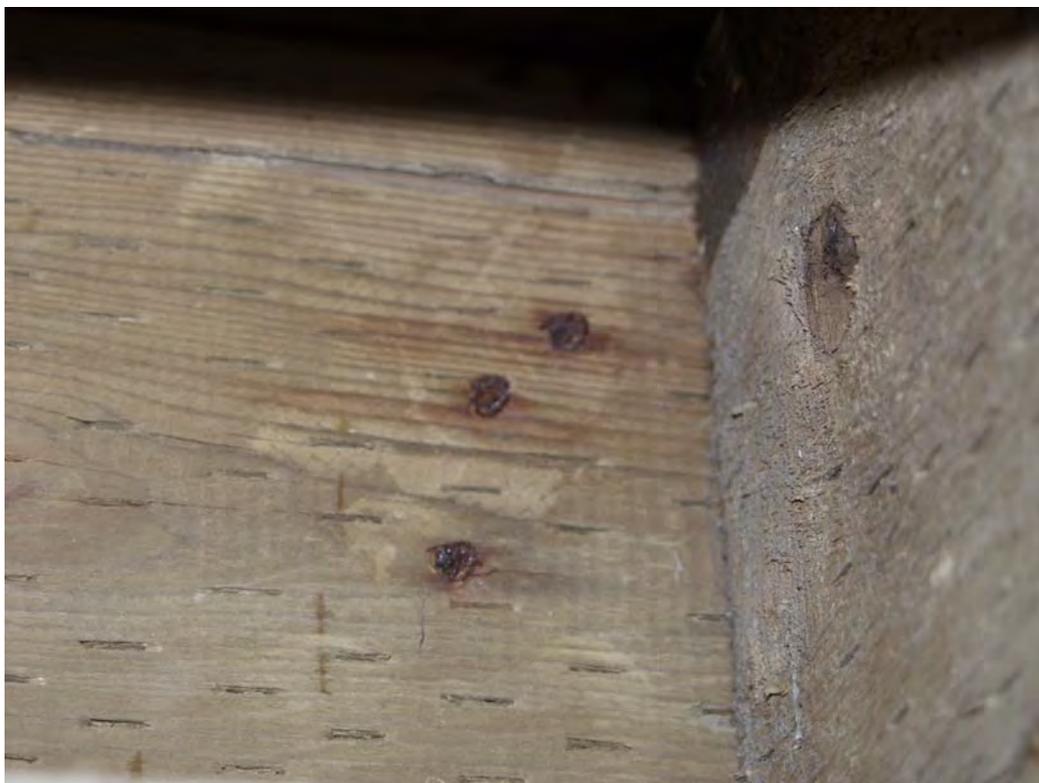
Figure 8 Corrosion of mild steel un-galvanized nails

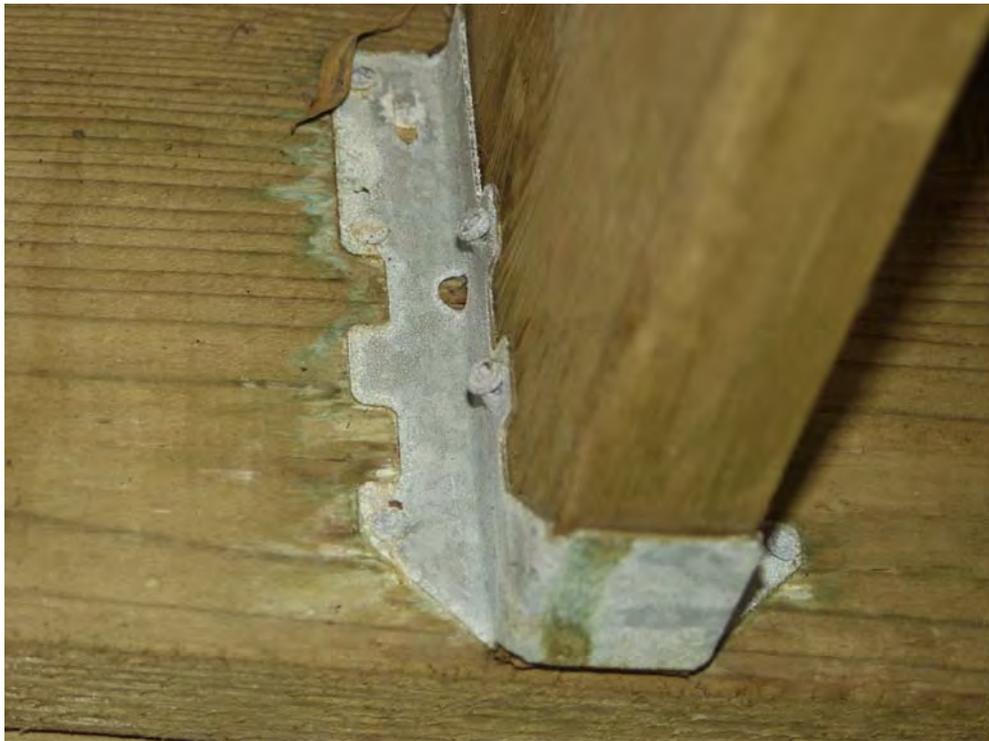
Figure 10 Copper deposits and red rust on lower edge of hanger

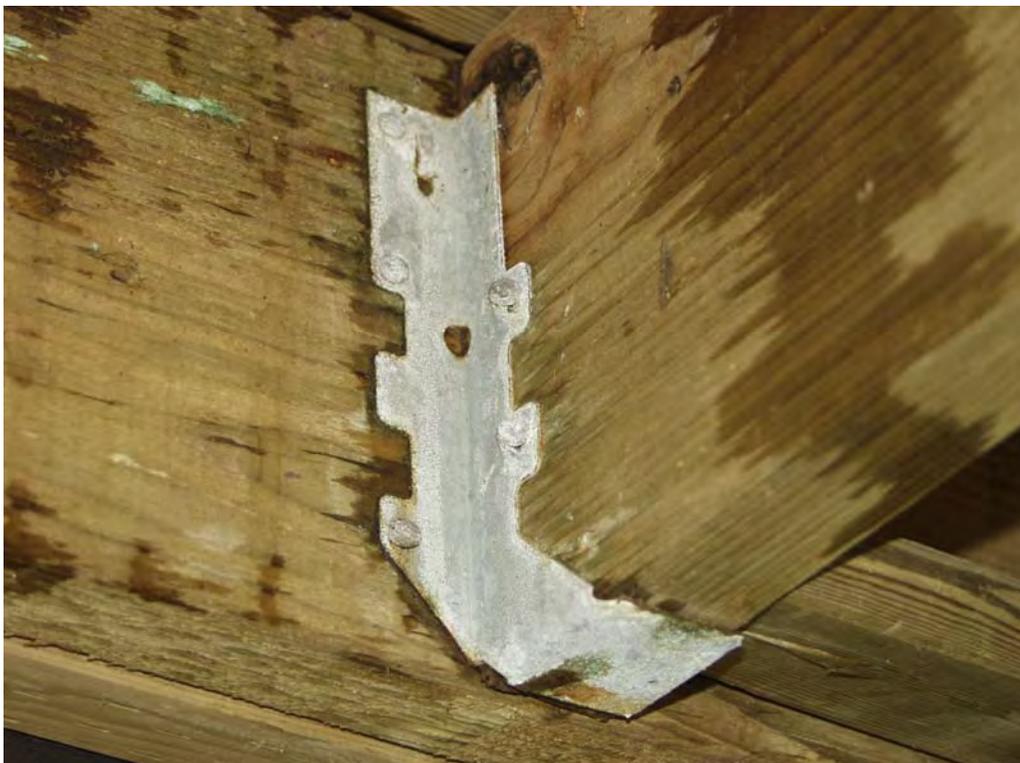
Figure 11 Copper deposits and red rust on edges of hanger and nails

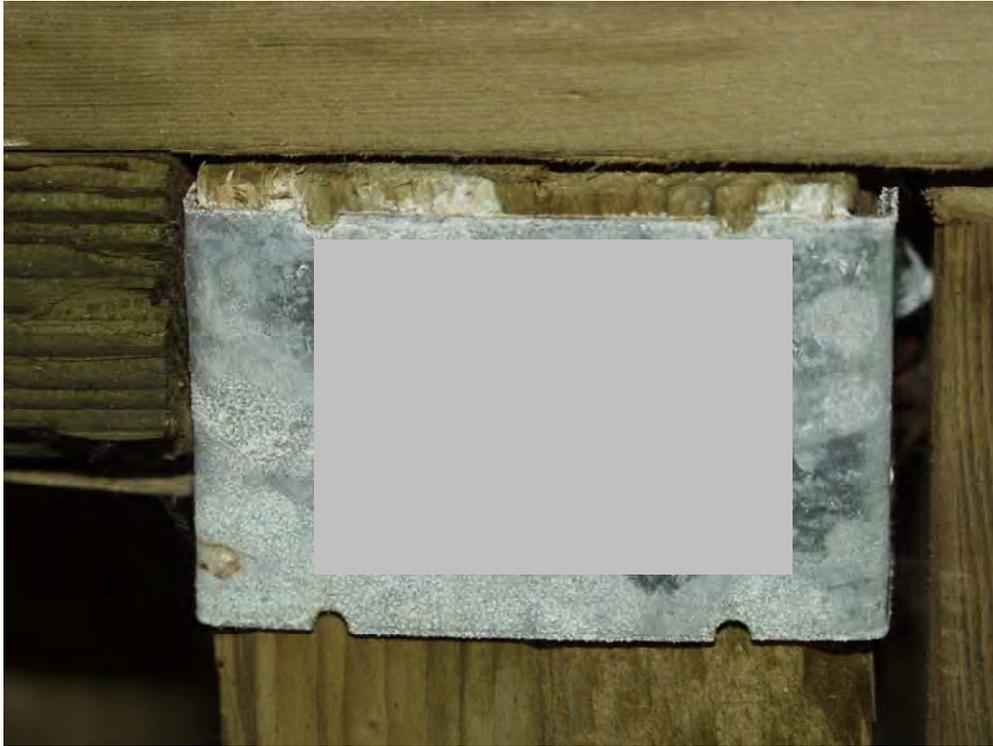
Figure 12 White rust on proprietary hanger, the specifications of which meets the G185 requirement

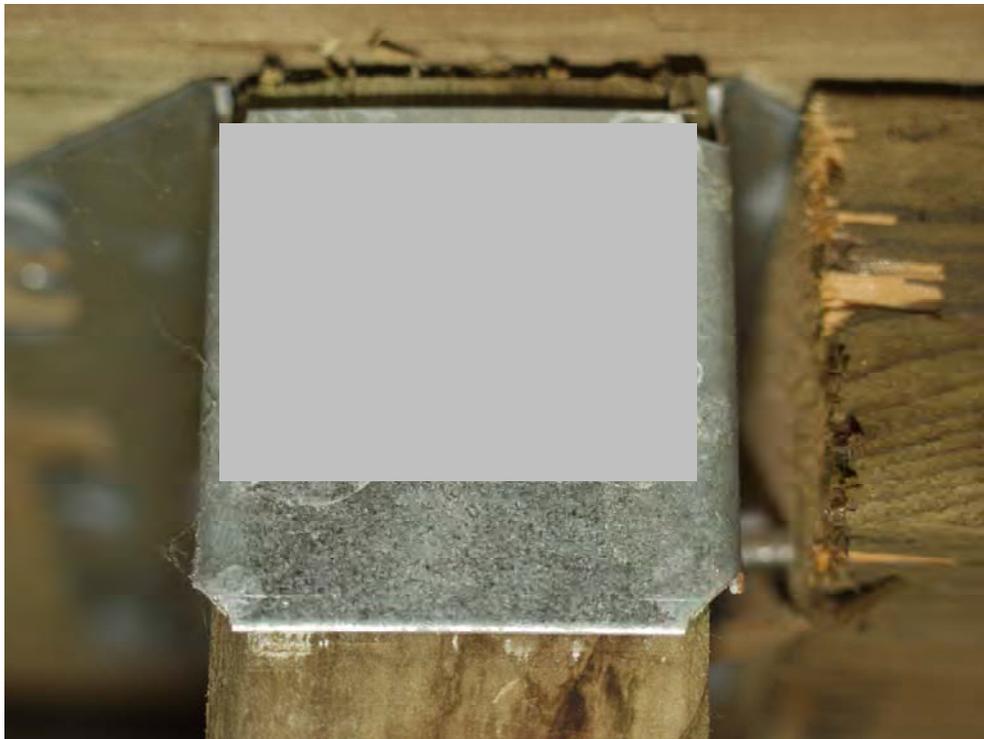
Figure 13 No corrosion on proprietary hanger, the specifications of which meets the G185 requirement on rear drip deck

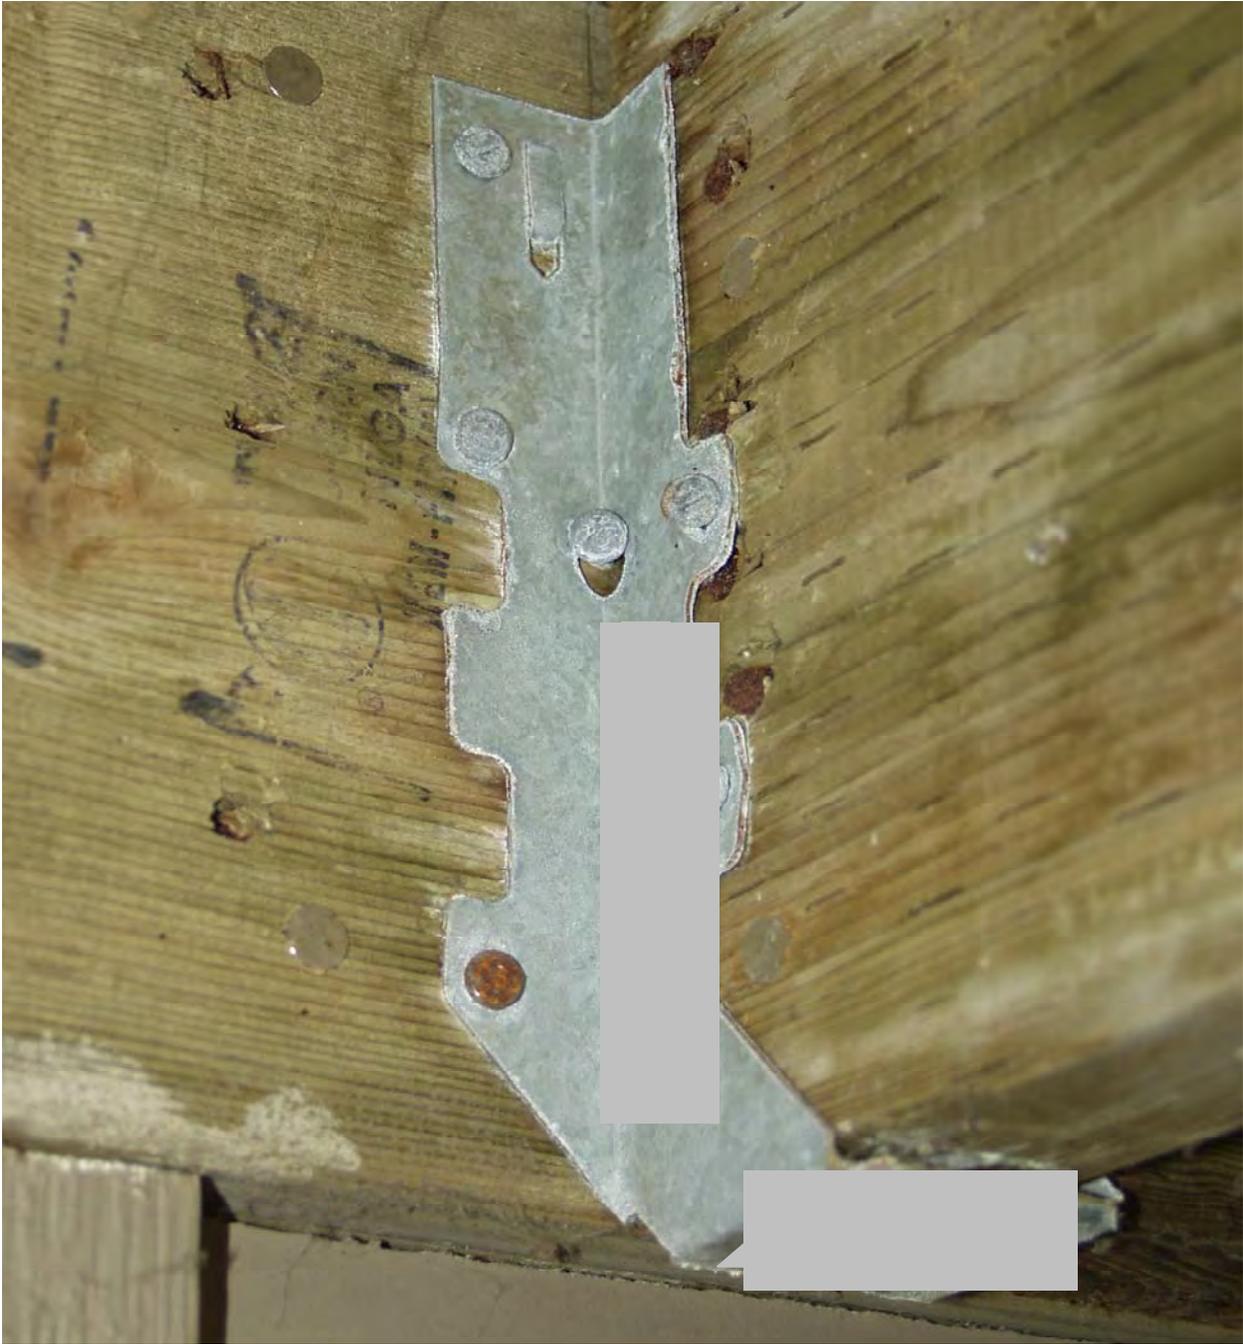
Figure 14 Small amount of red rust on edge of proprietary hanger, (the specifications of which meets the G185 requirement) and lower galvanized nail head. Common nails on right have red rust.

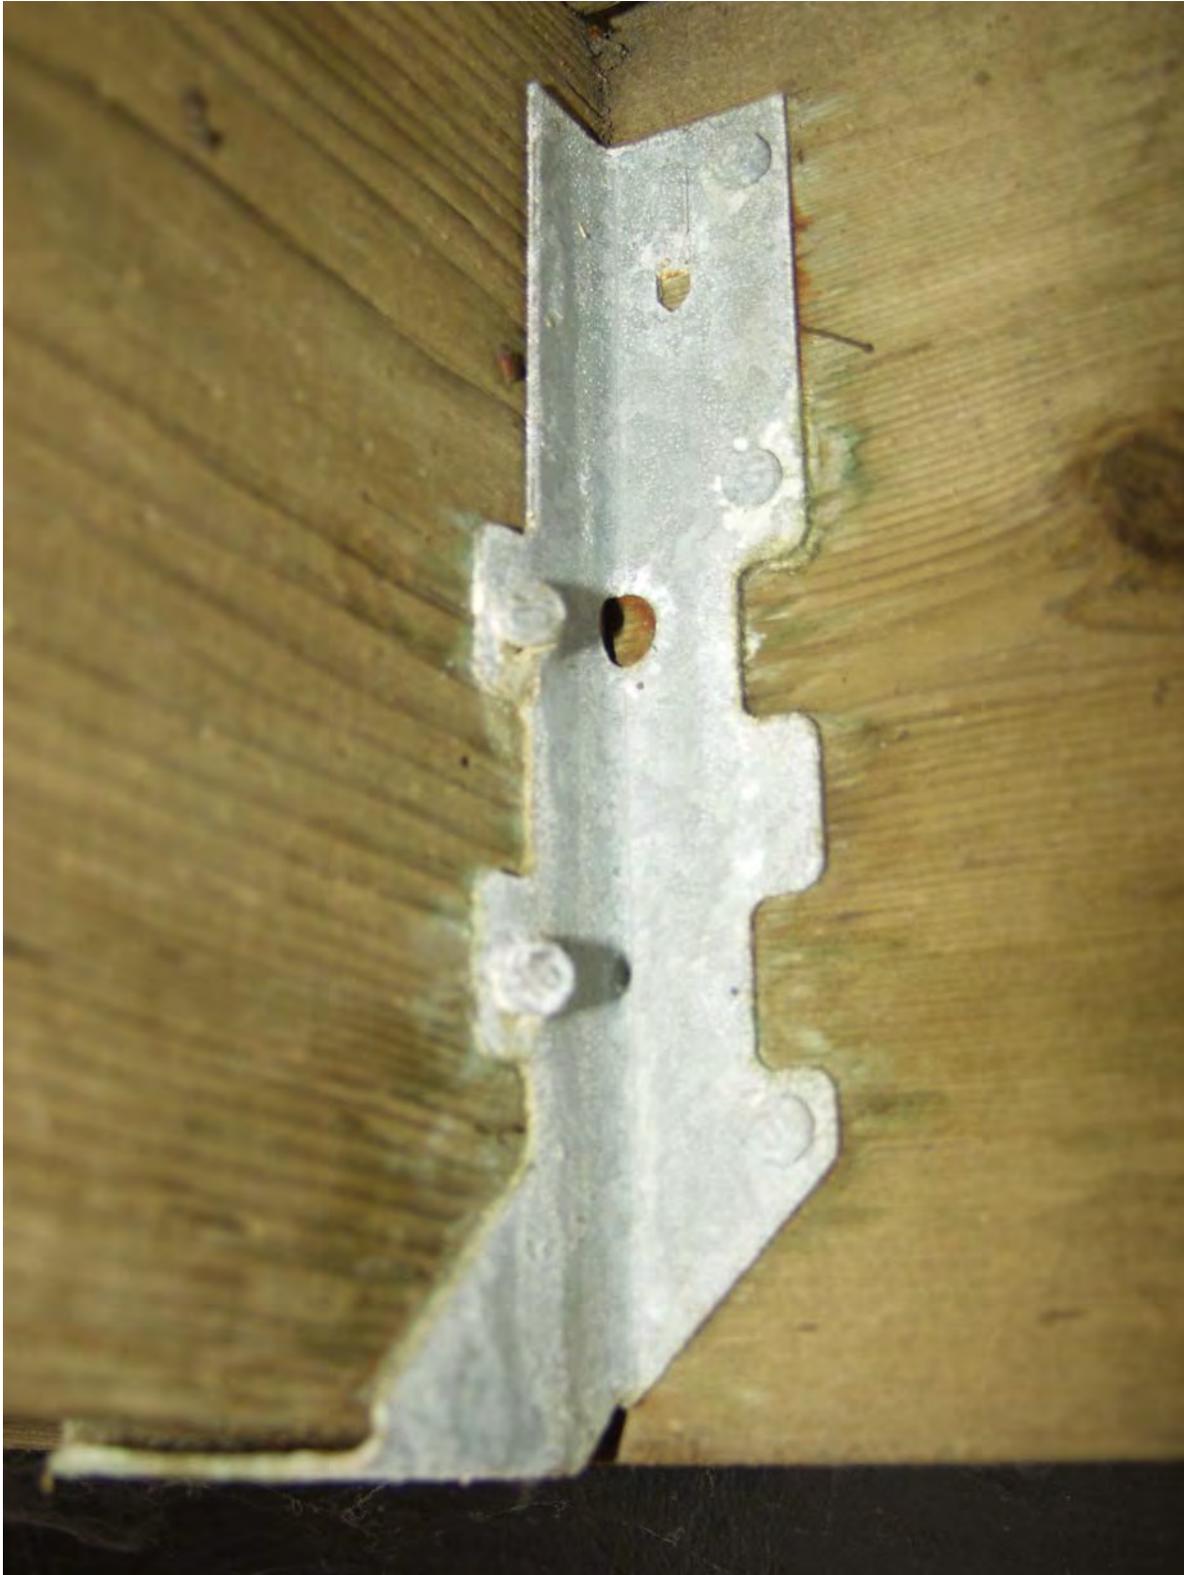
Figure 15 White rust on proprietary hanger, (the specifications of which meets the G185 requirement) and nails

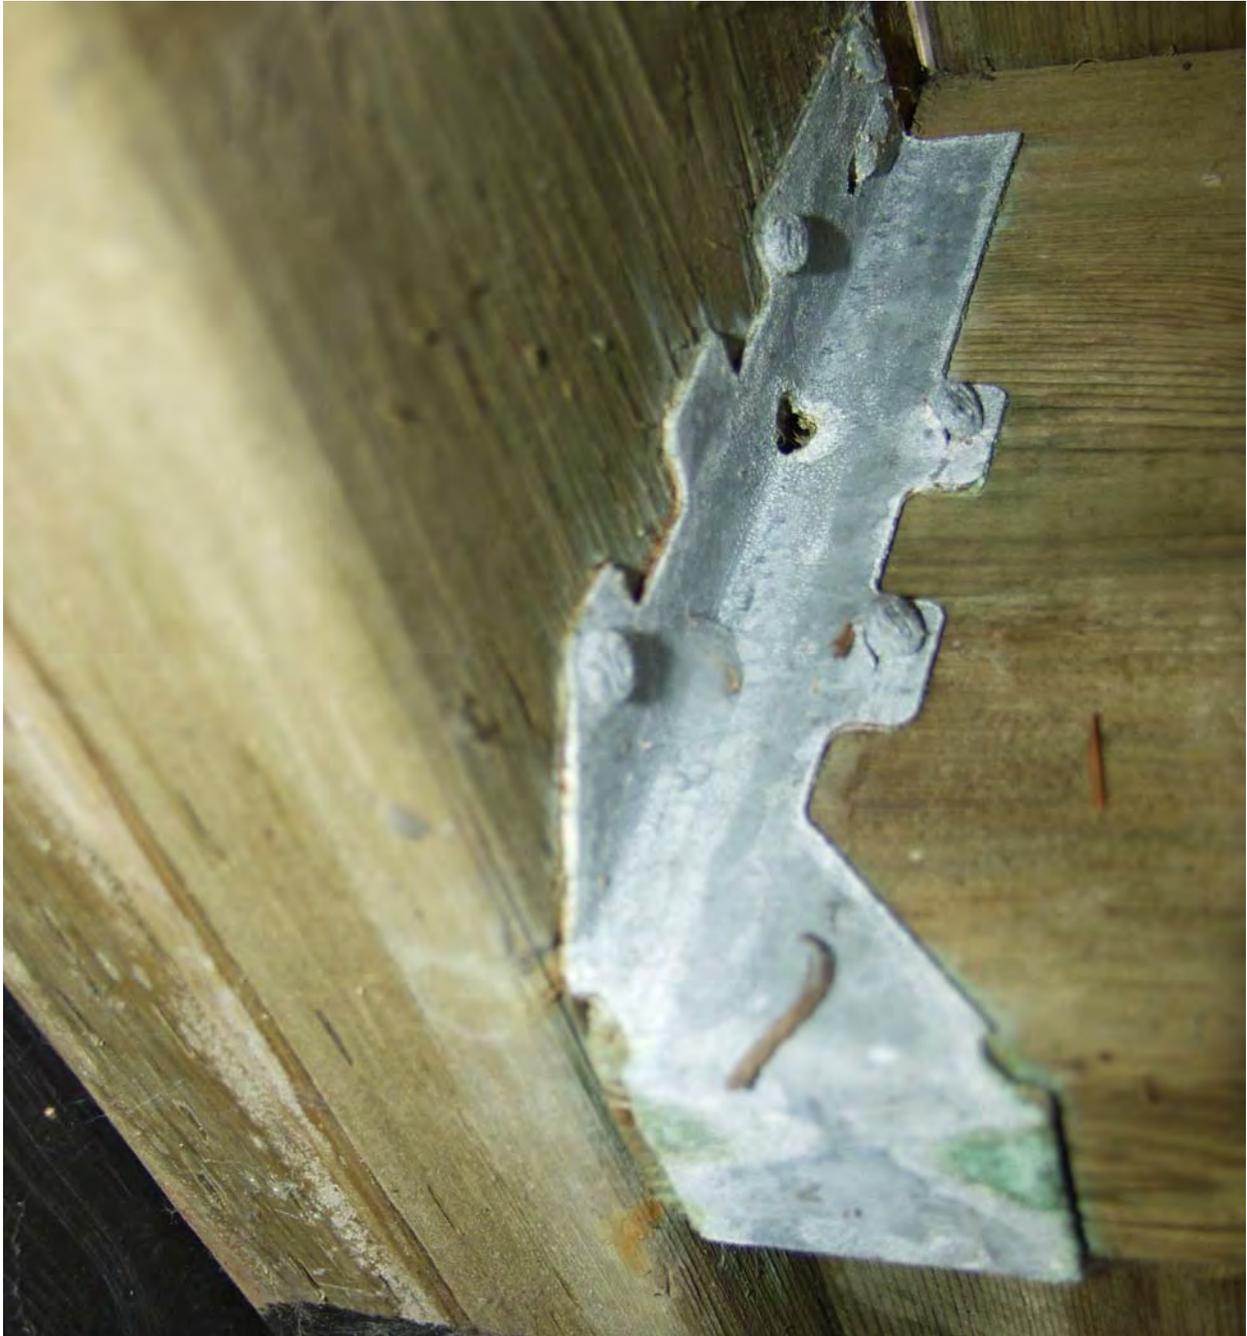
Figure 16 White rust on proprietary hanger, (the specifications of which meets the G185 requirement) and nails. Green copper deposit visible on lower hanger surface.

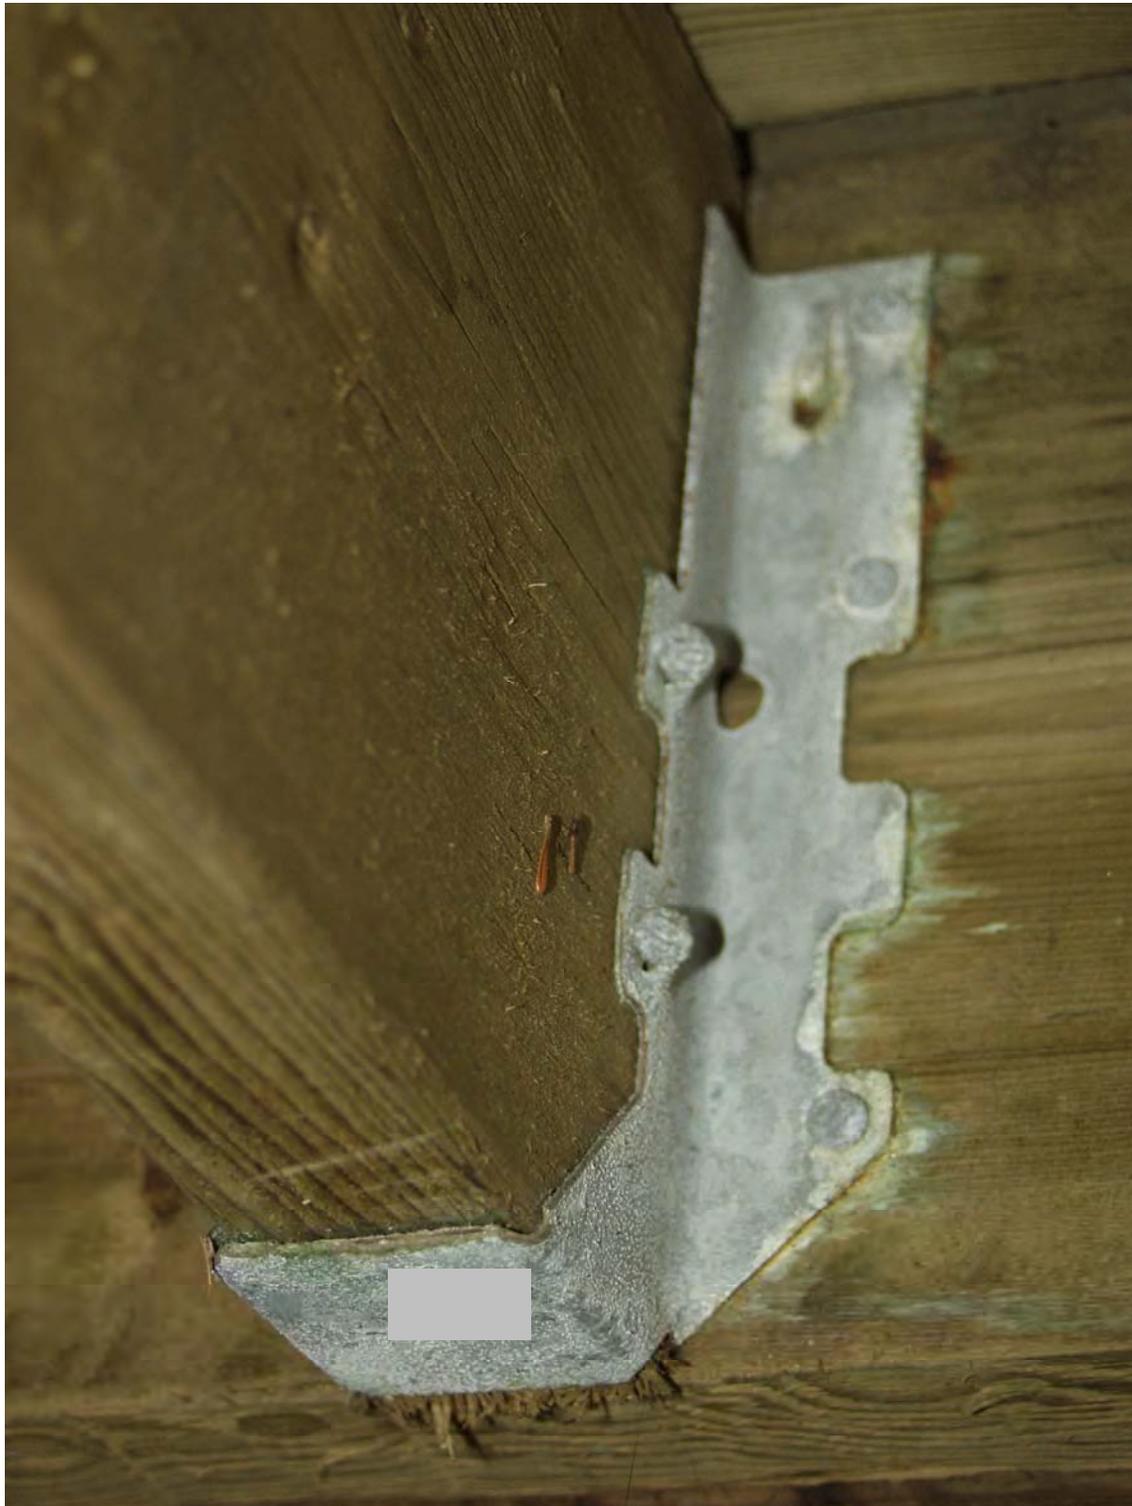
Figure 17 Small amount of red rust on the edge of proprietary hanger, (the specifications of which meets the G185 requirement)

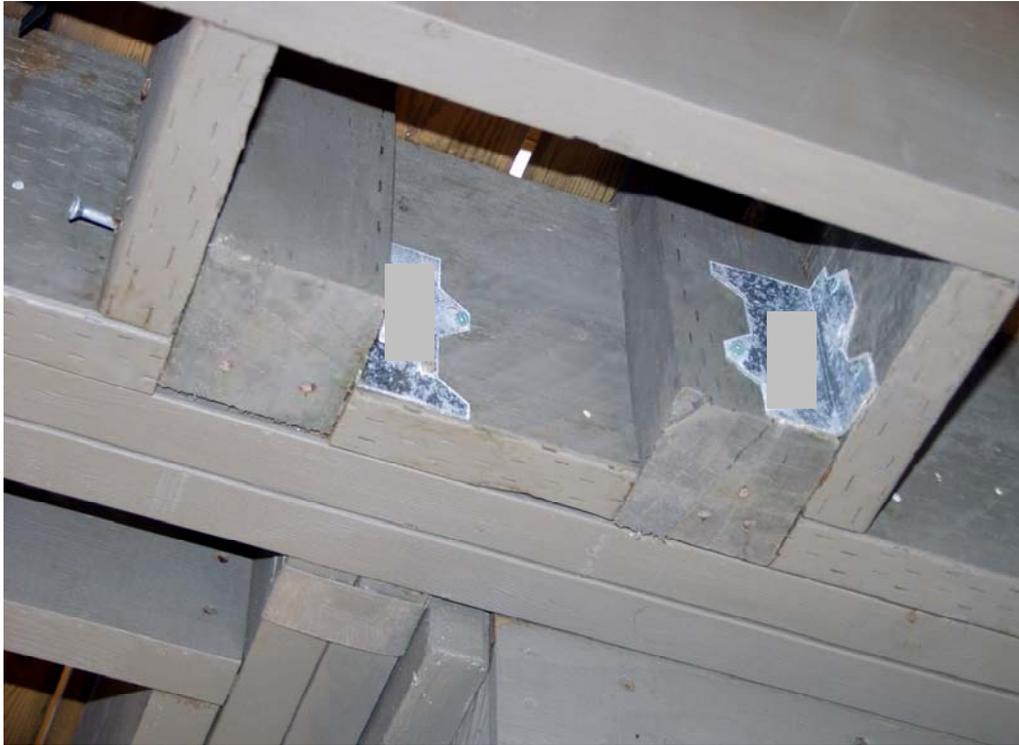
Figure 18 General view of the underside of the deck showing the painted wood and the modified structure. Connectors are galvanized but appear generic electroplated and would not therefore conform to G 185. They are fastened with screws. Nails into the incised block to which the connector is attached show some red rust.

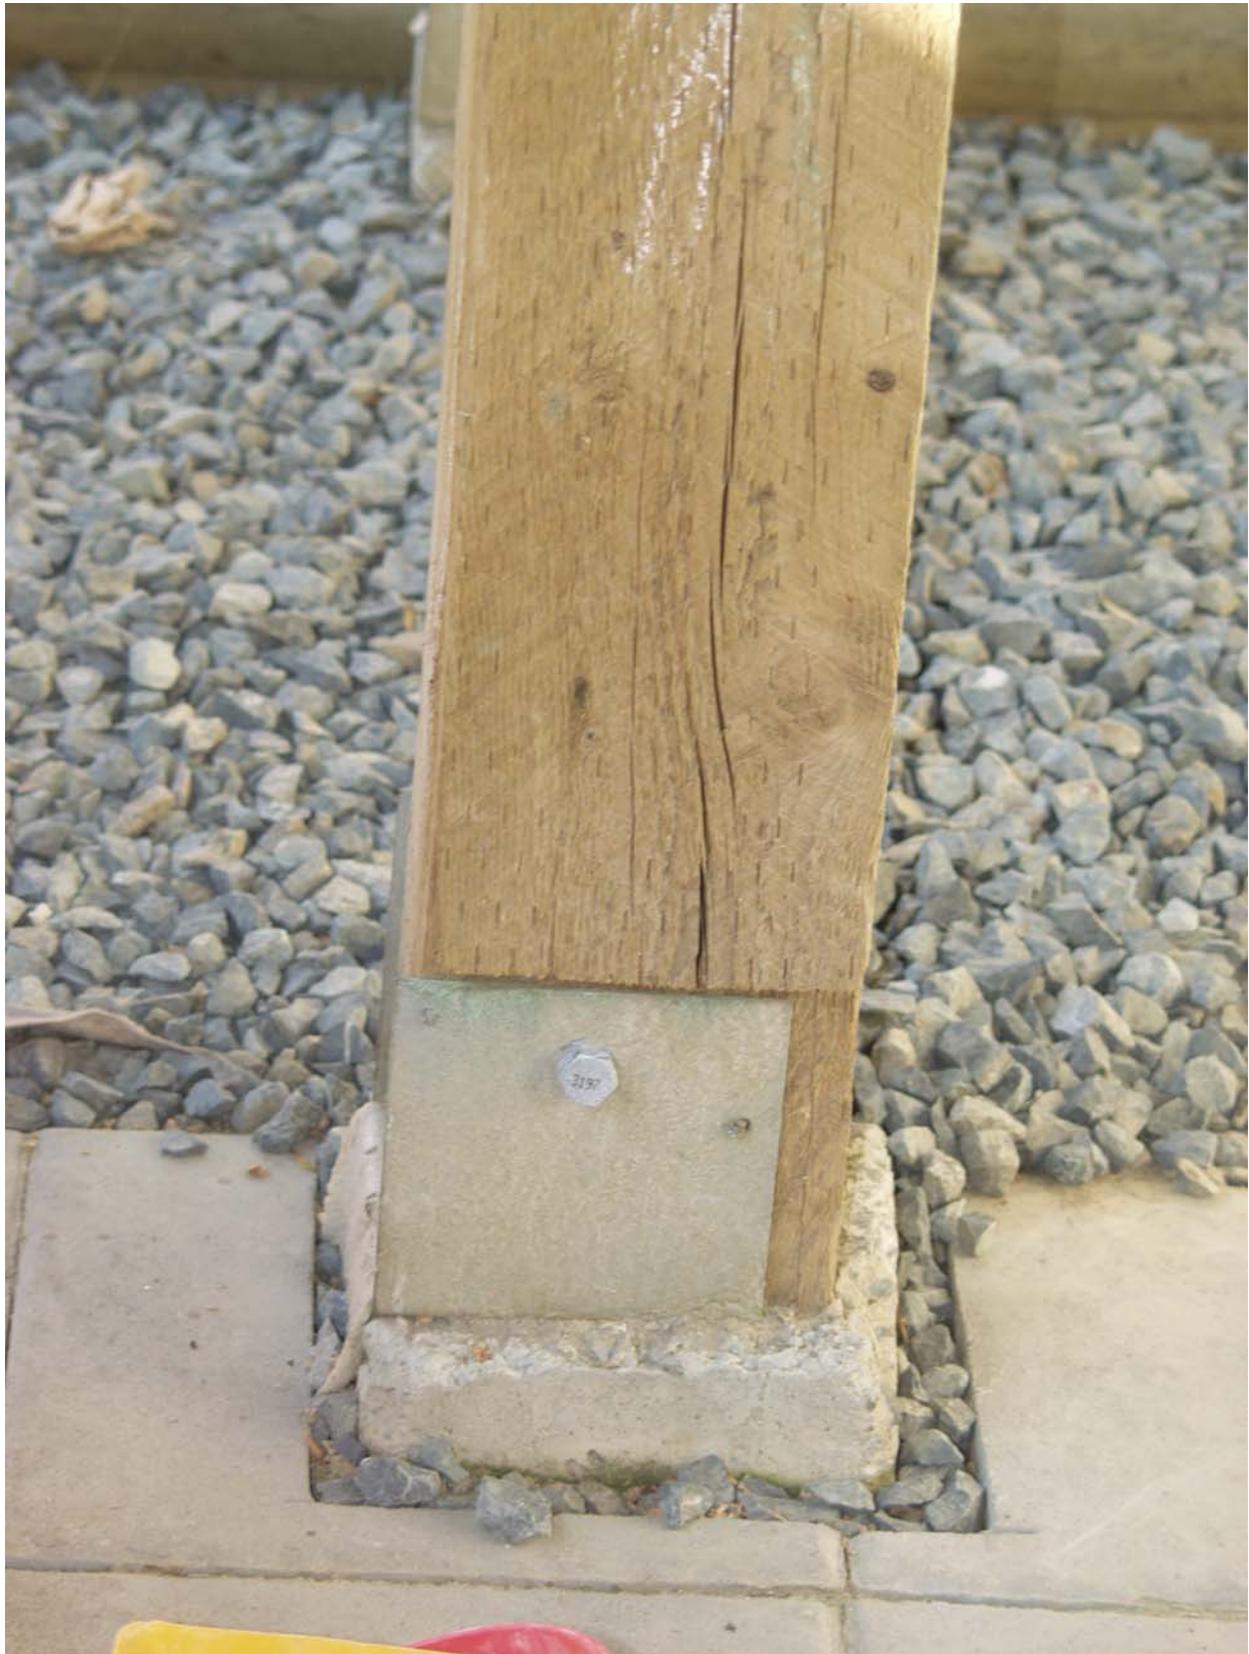
Figure 19 Post support showing absence of corrosion

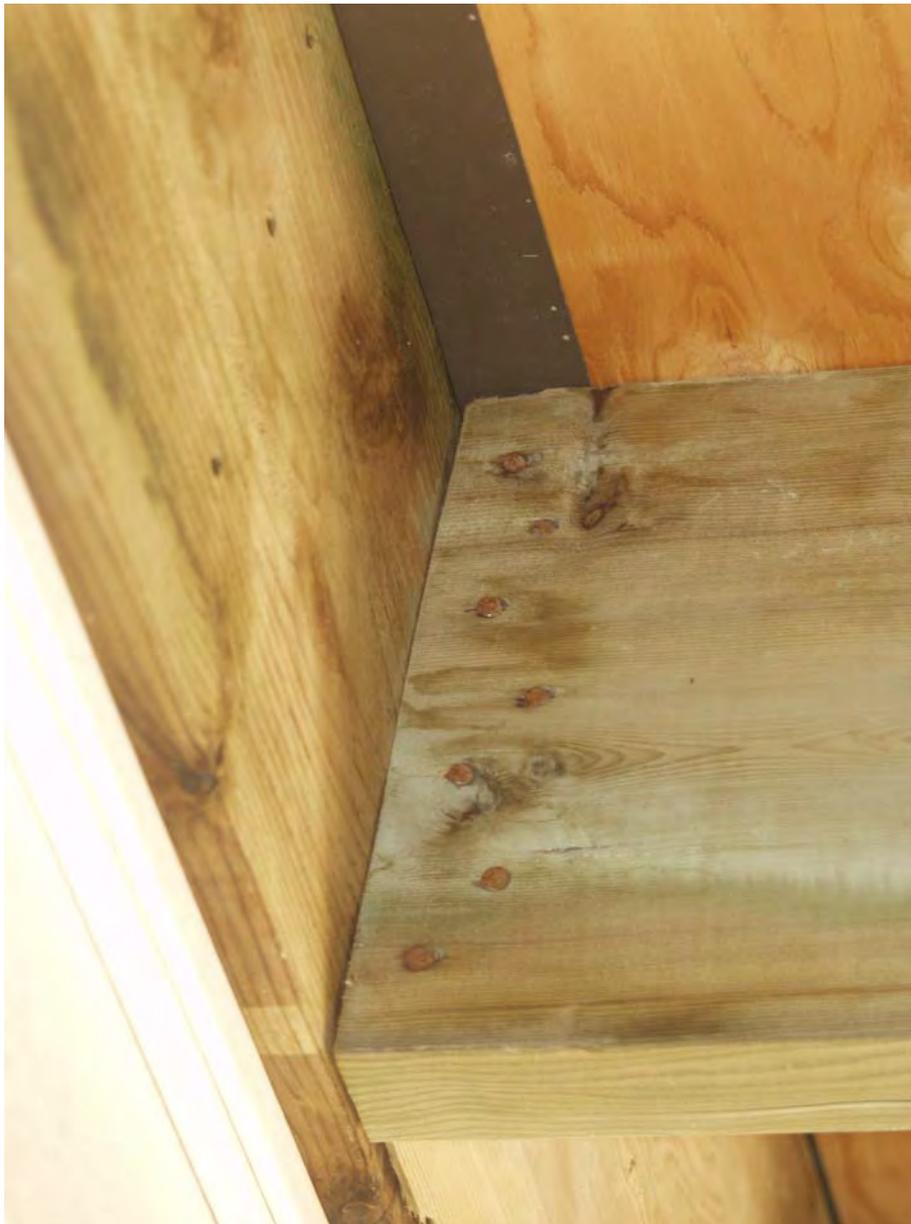
Figure 20. Red rust on nails fastening deck joist to rim joist. Blocking is used in this design so no hangers are required

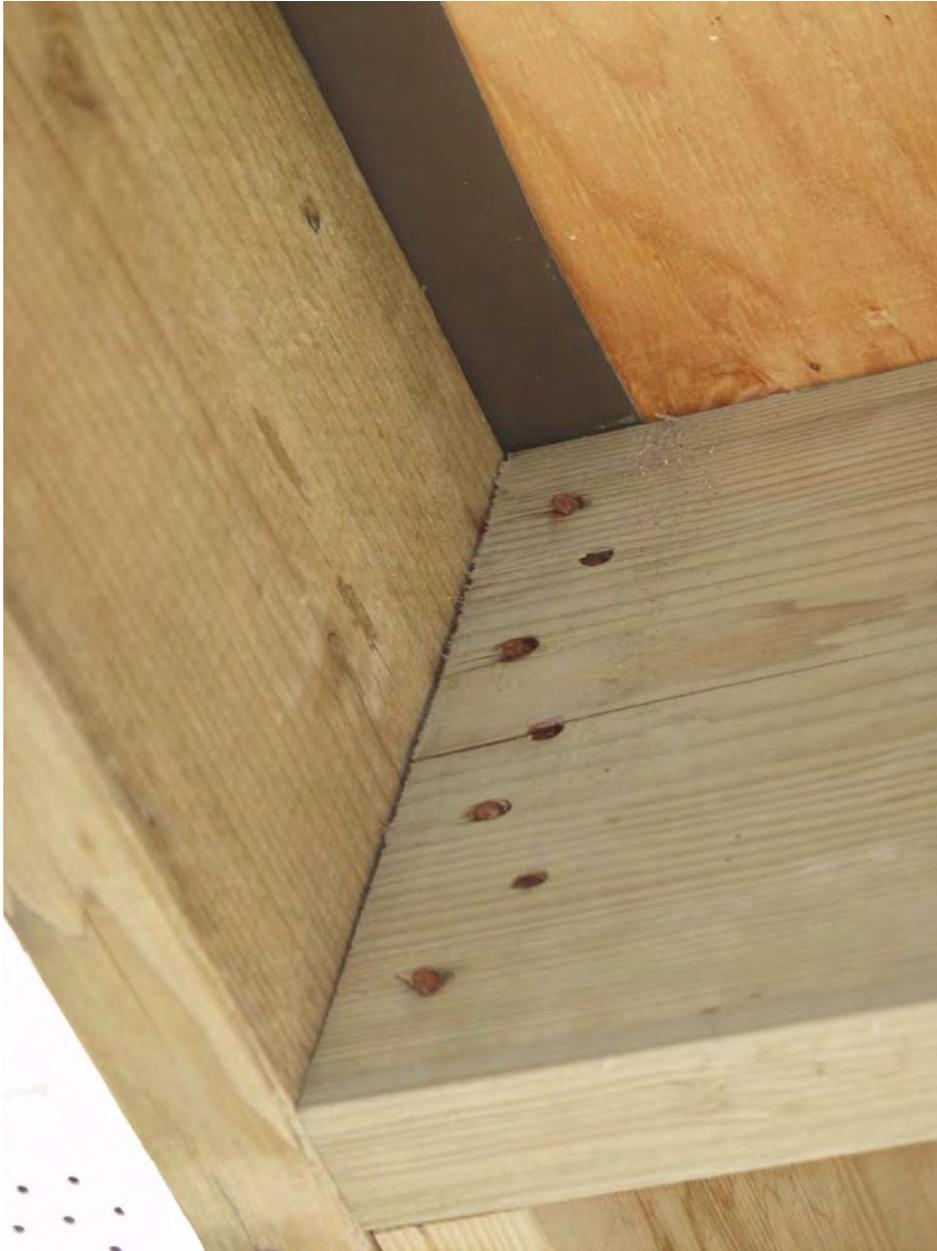
Figure 21. Red rust on common mild steel nails fastening deck joist to rim joist.

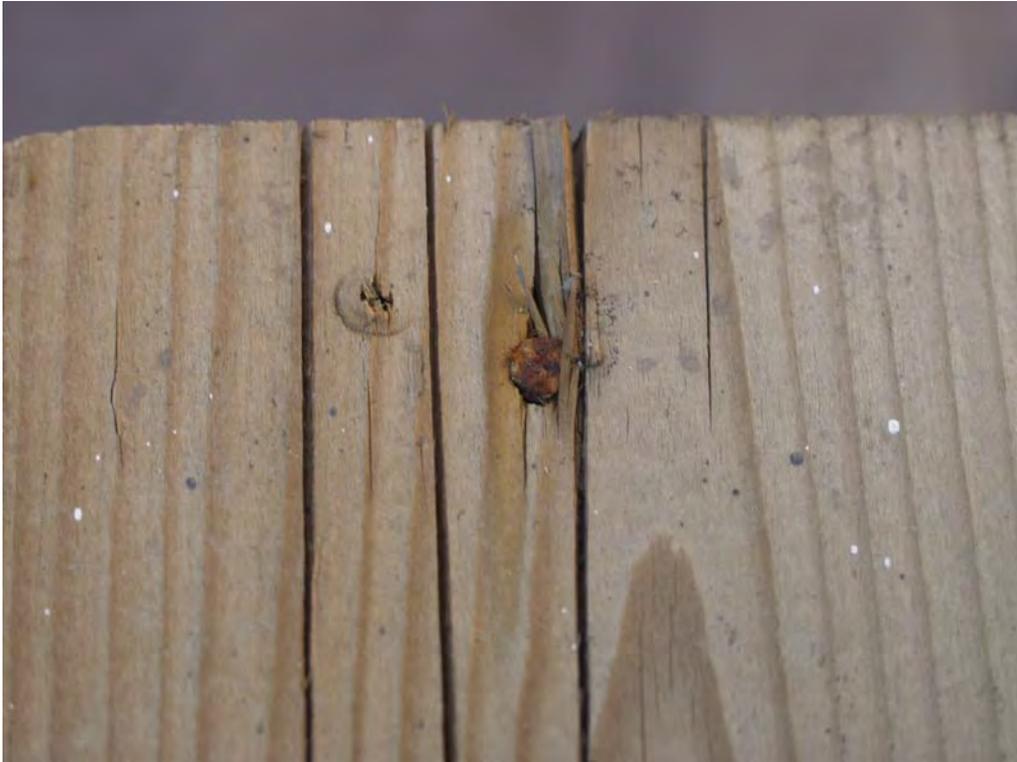
Figure 22. Red rust on common mild steel nails fastening stairs.

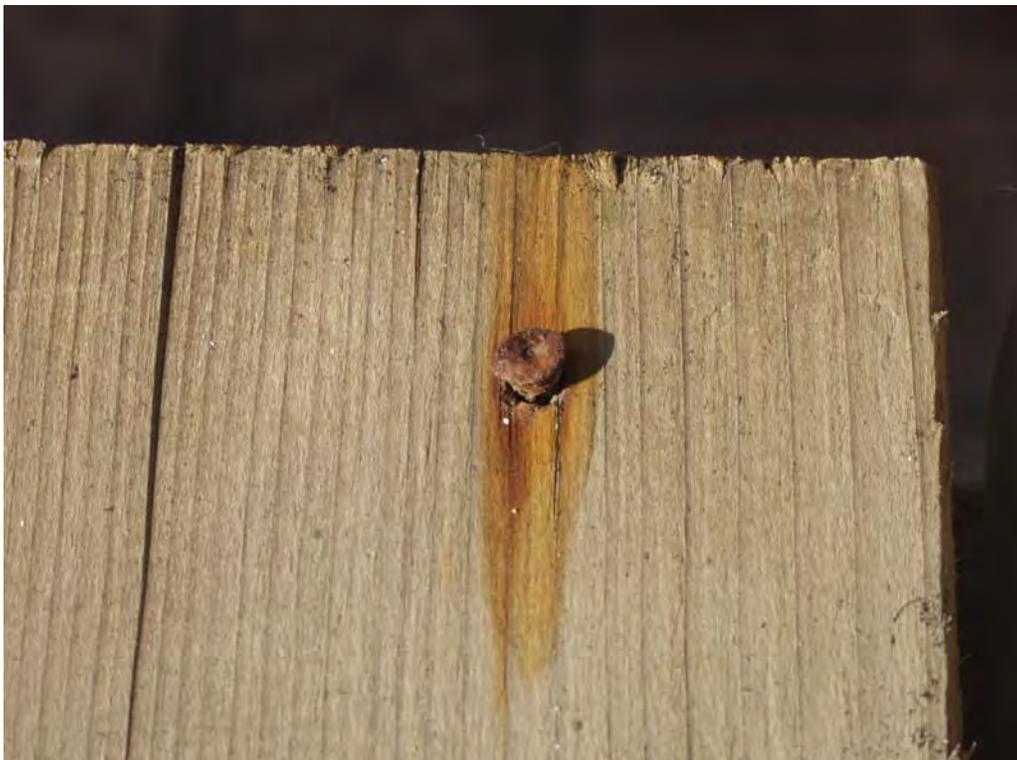
Figure 23. Red rust on un-galvanized screw.
