Field investigations on the application of ACQ treated wood and use of metal fasteners and connectors in residential construction

**Dr. John N.R. Ruddick
Mychem Wood Protection Consultants Ltd.,
1365 Ottawa Ave.,
West Vancouver,
BC V7T 2H6**

December 2006

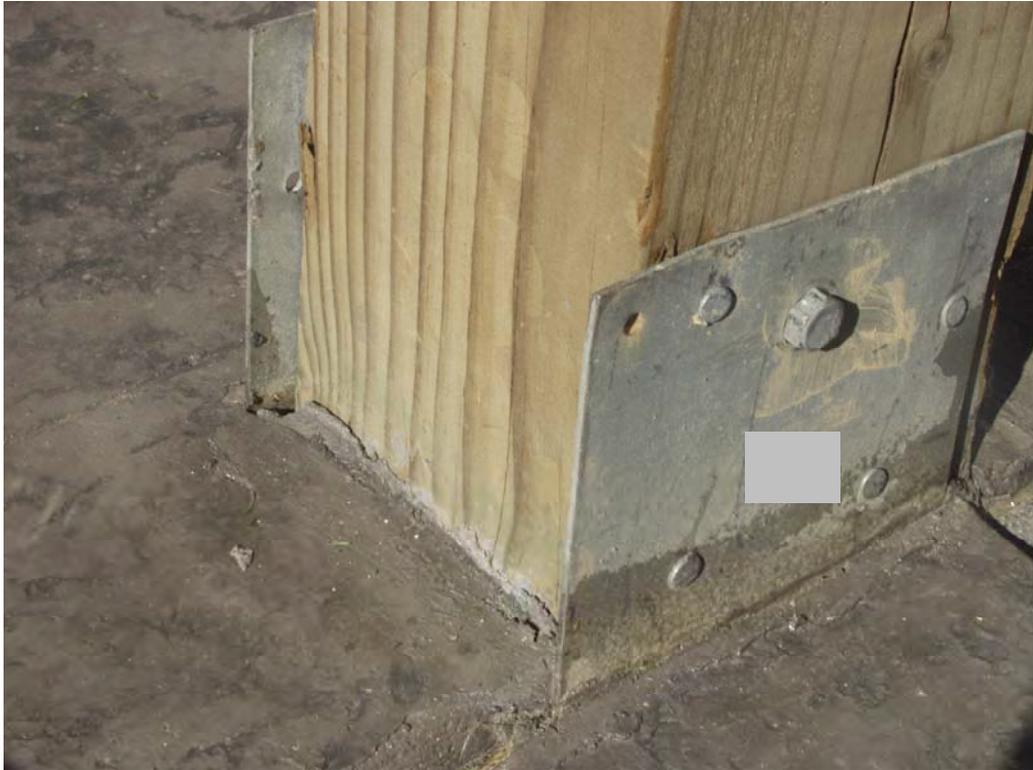
Figure 24. Shoes for posts showed no corrosion.

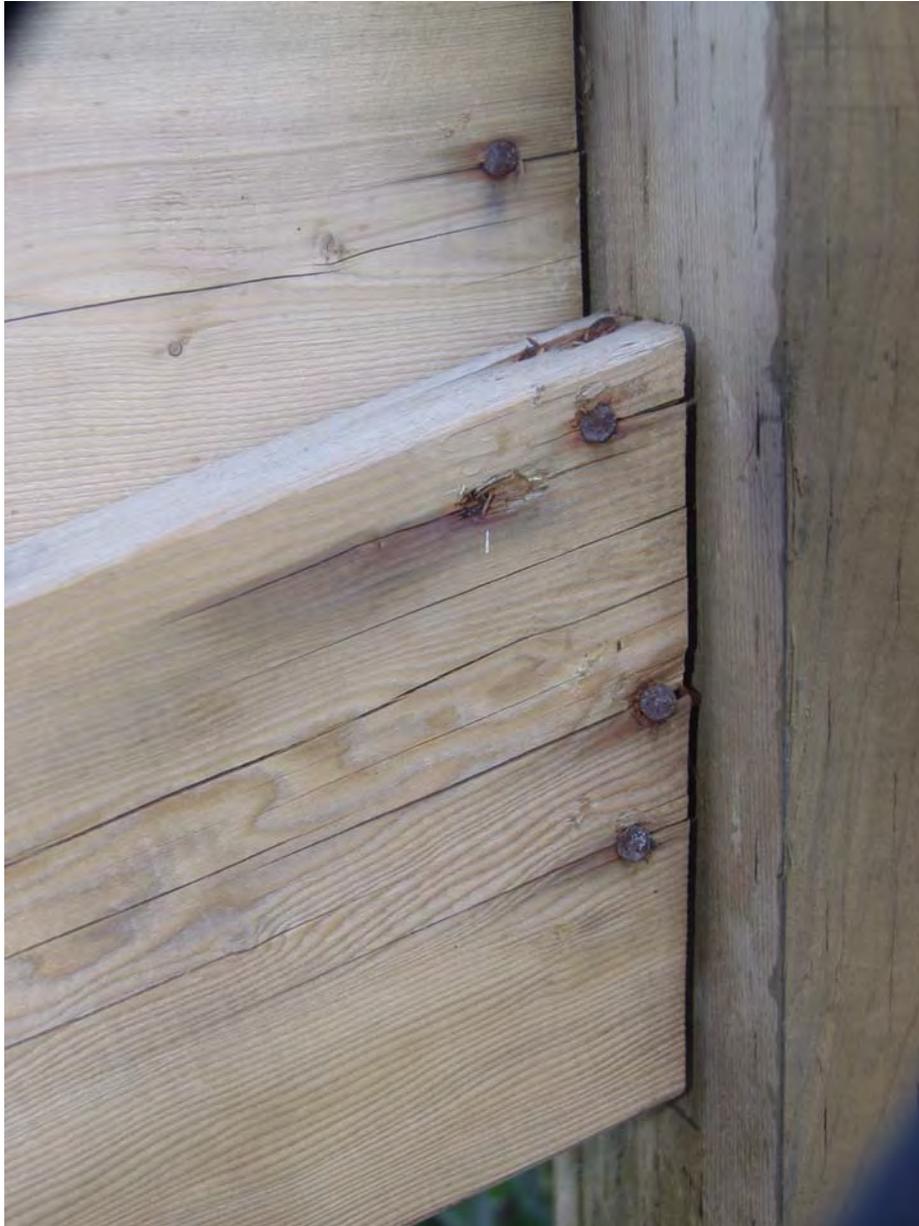
Figure 25. Red rust on un-galvanized nails.

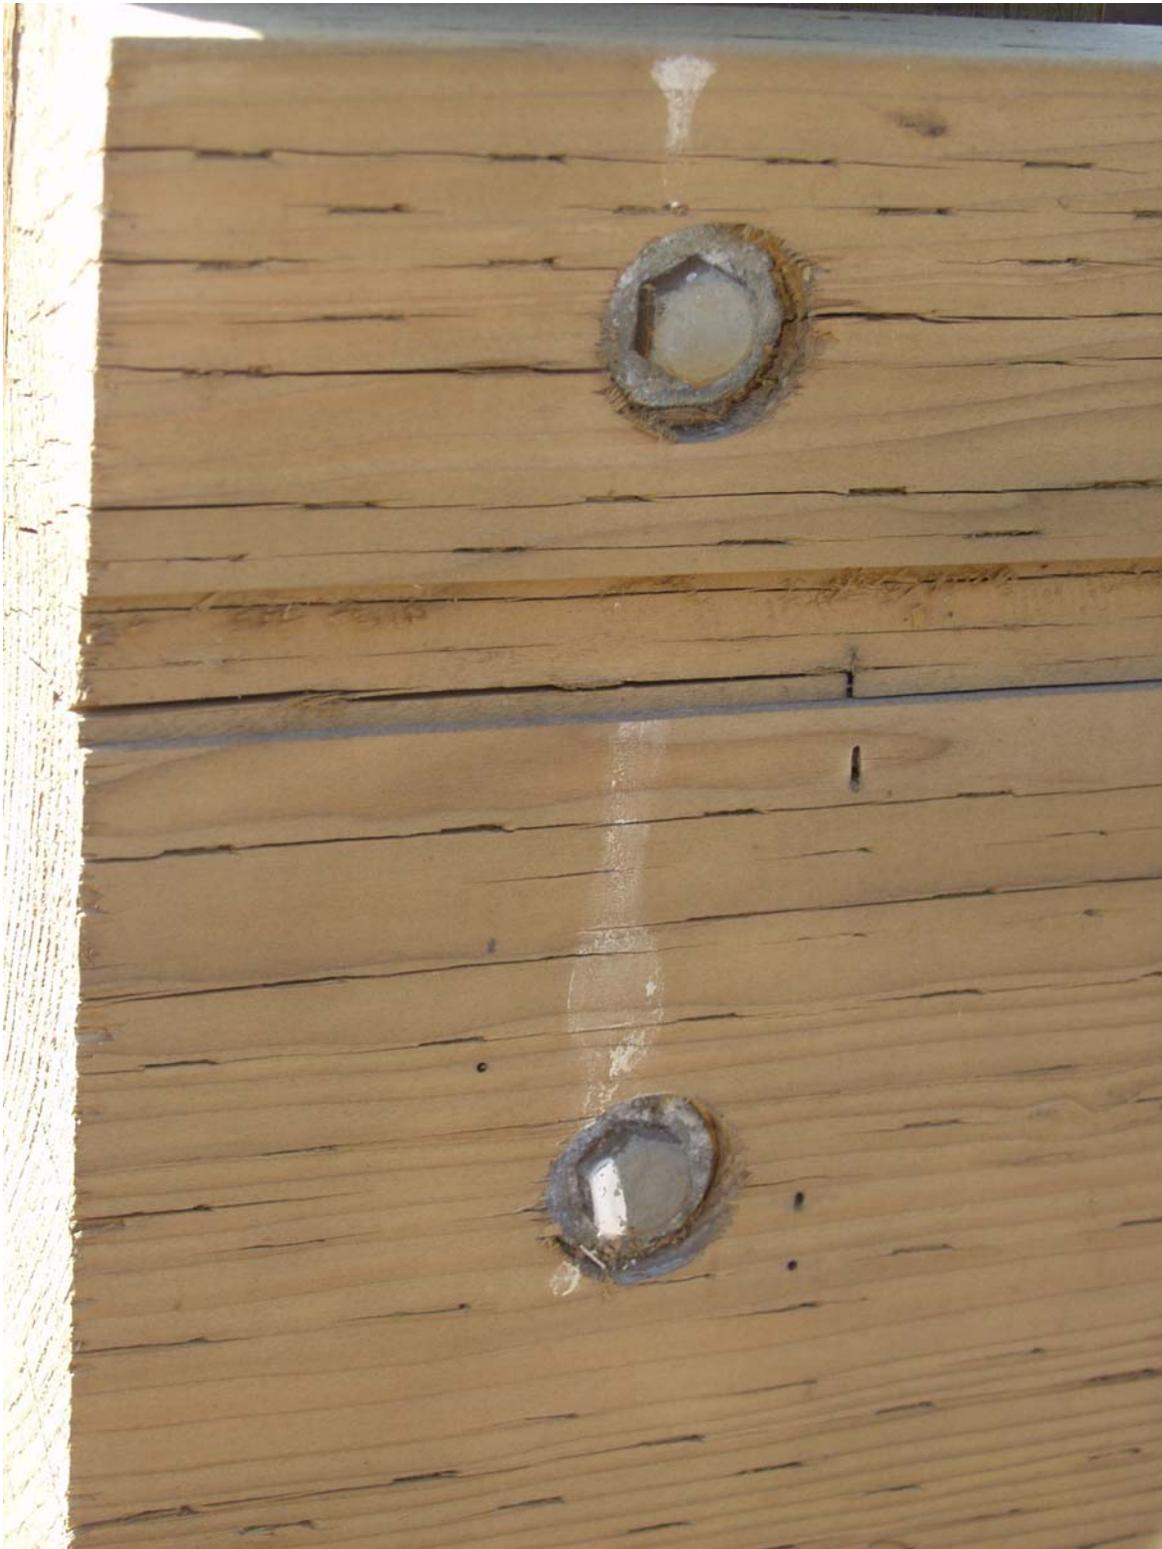
In front of the properties, an incised ACQ treated timber had been used as a road island barrier. The bolts used on the barrier were slightly corroded, but the level of galvanizing could not be determined. The barrier was not part of the construction project.

Figure 26. Corrosion on bolts on barrier fencing made from ACQ treated wood

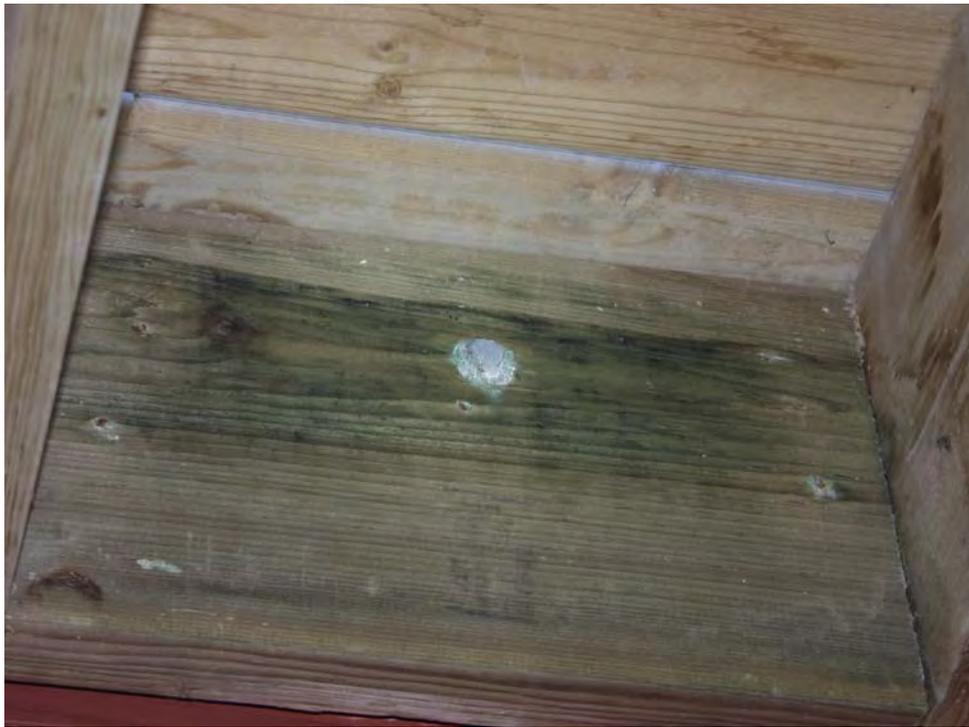
Figure 27. White rust on galvanized bolt

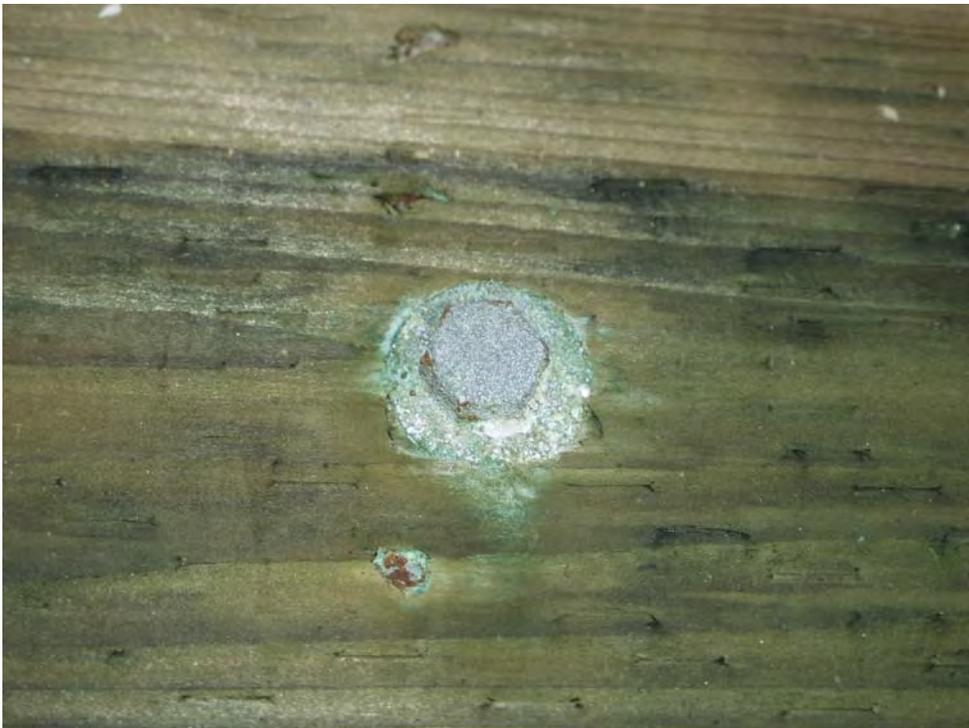
Figure 28. White rust on galvanized bolt and washer contacting incised ACQ treated wood

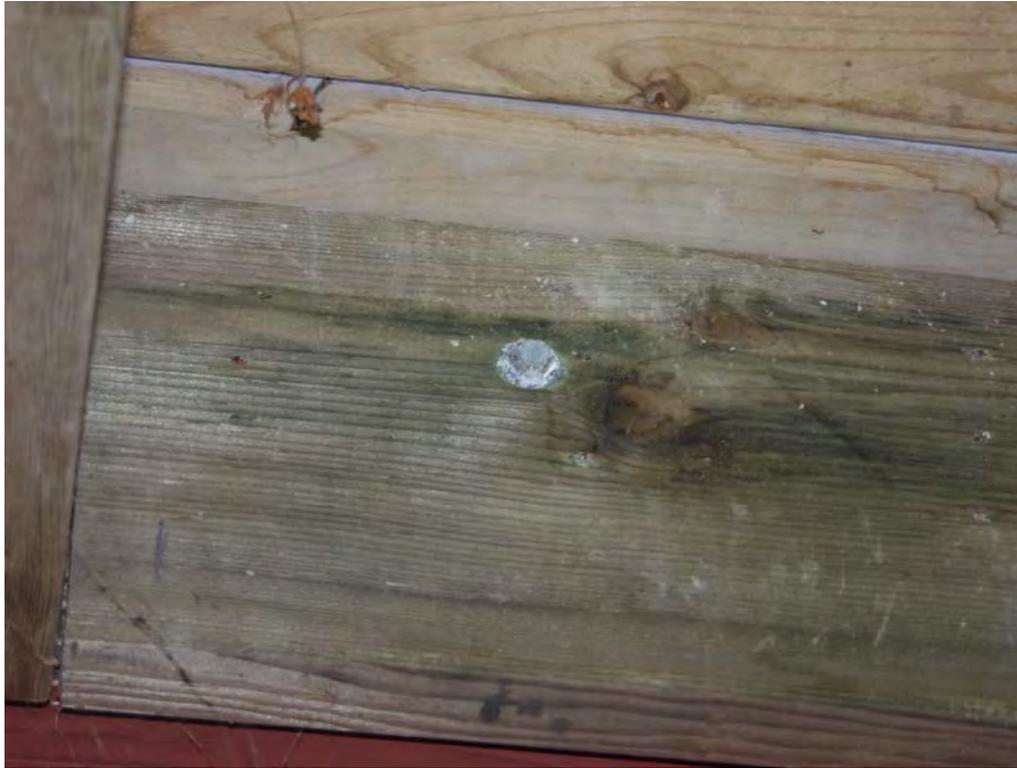
Figure 29. White rust on galvanized bolt

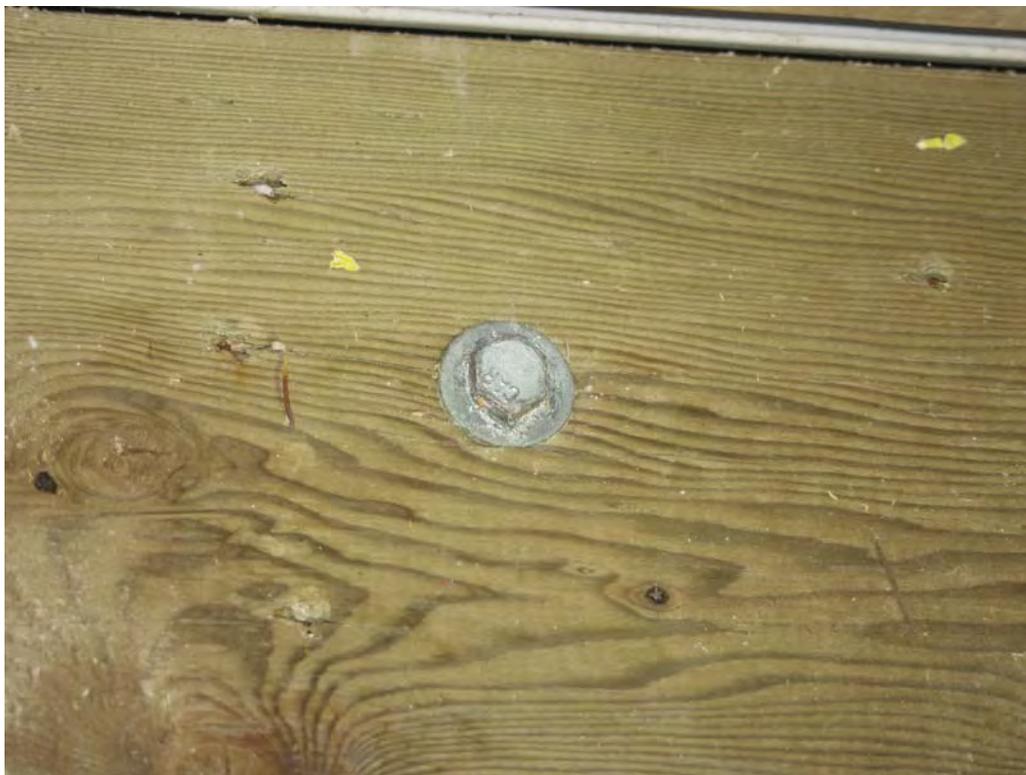
Figure 30. Bolt, washer and nails all free from corrosion

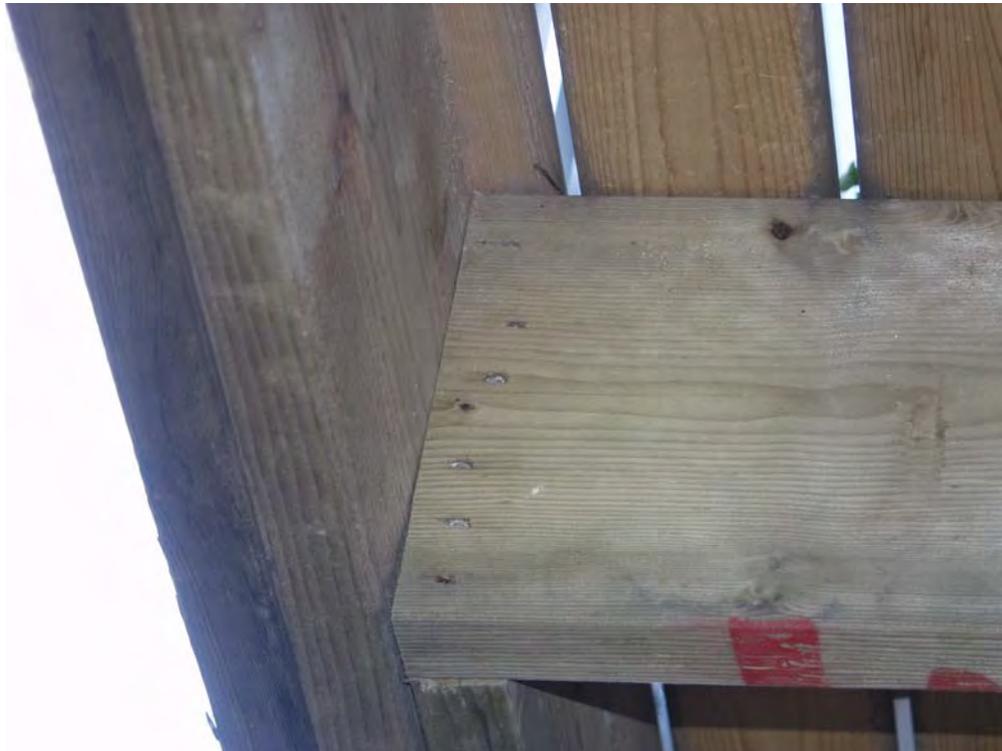
Figure 31. Red rust on common mild steel nails

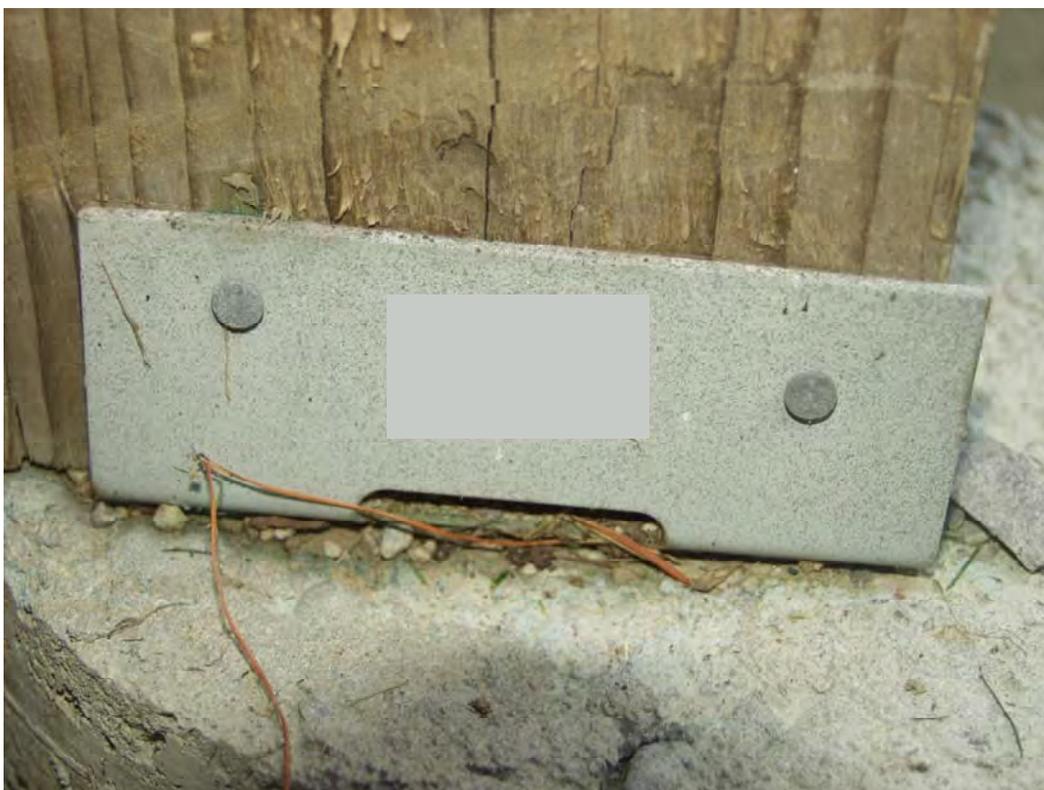
Figure 32. Galvanized connector and nails for post base showing no corrosion

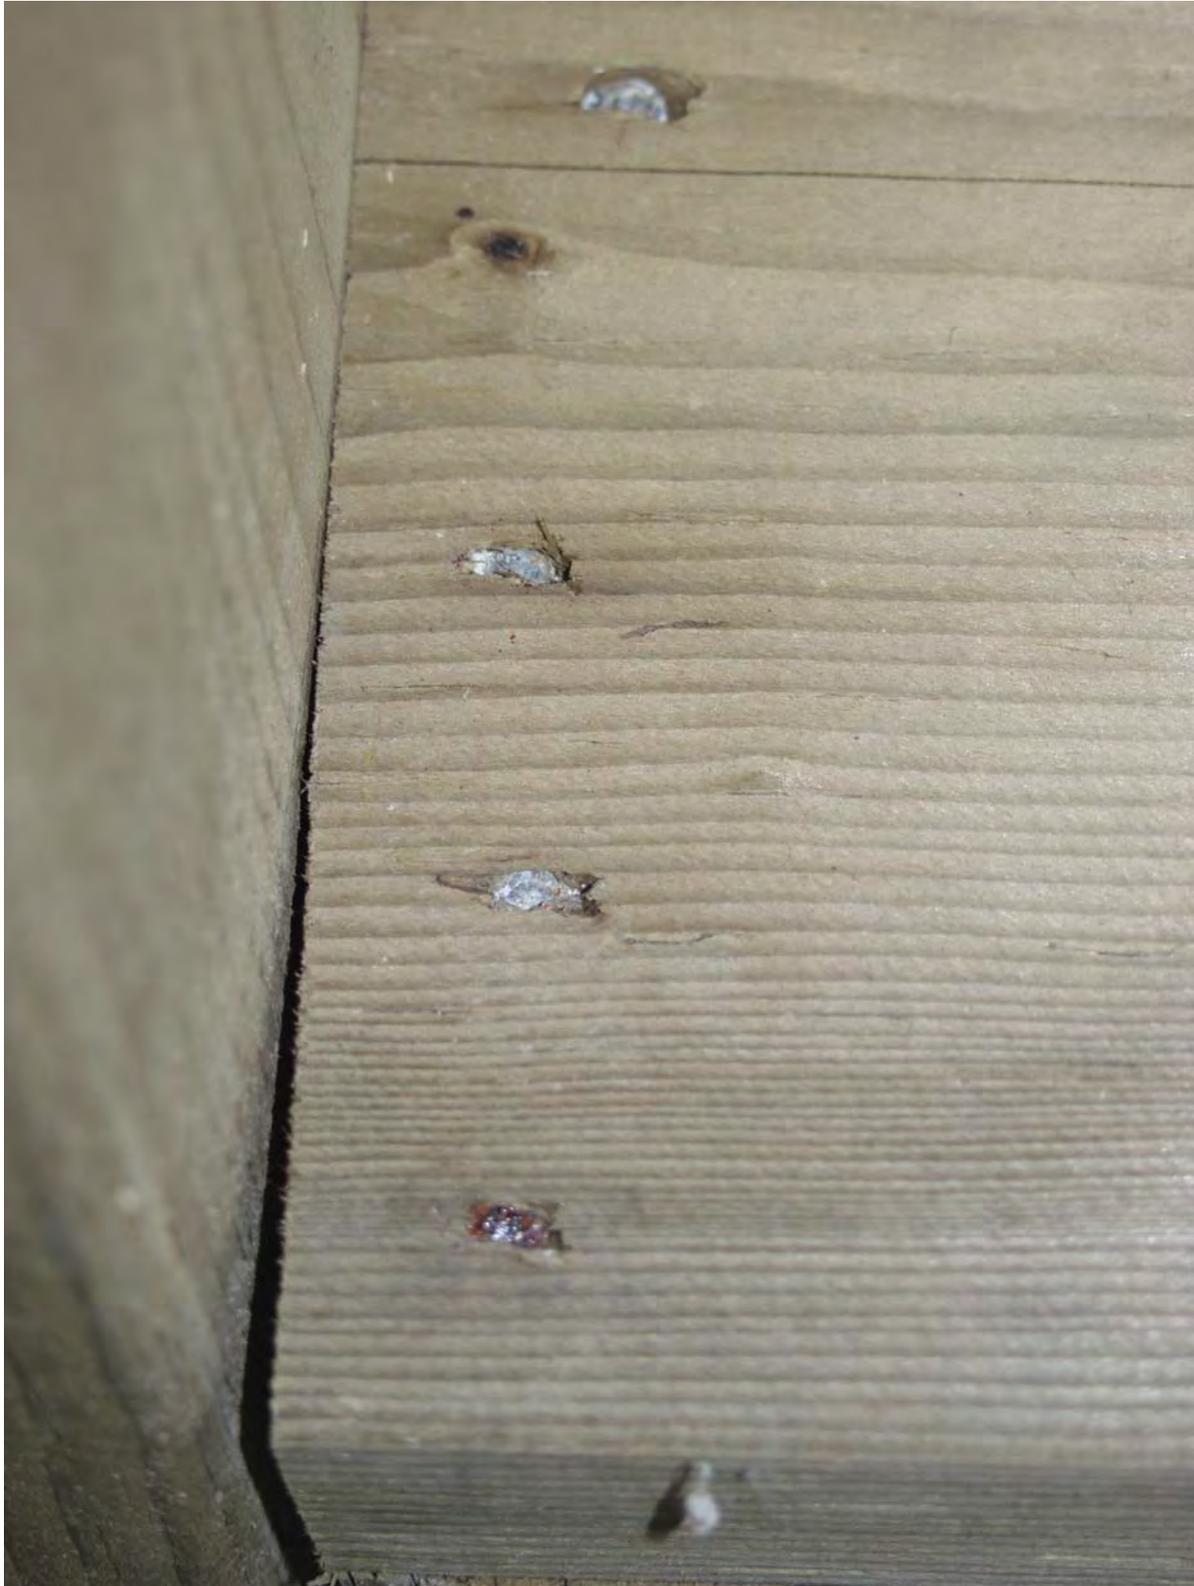
Figure 33. Galvanized nails in unincised ACQ deck joist show no corrosion except for small amount of red rust on the head of the lowest one. Probable cause is damage during nailing.

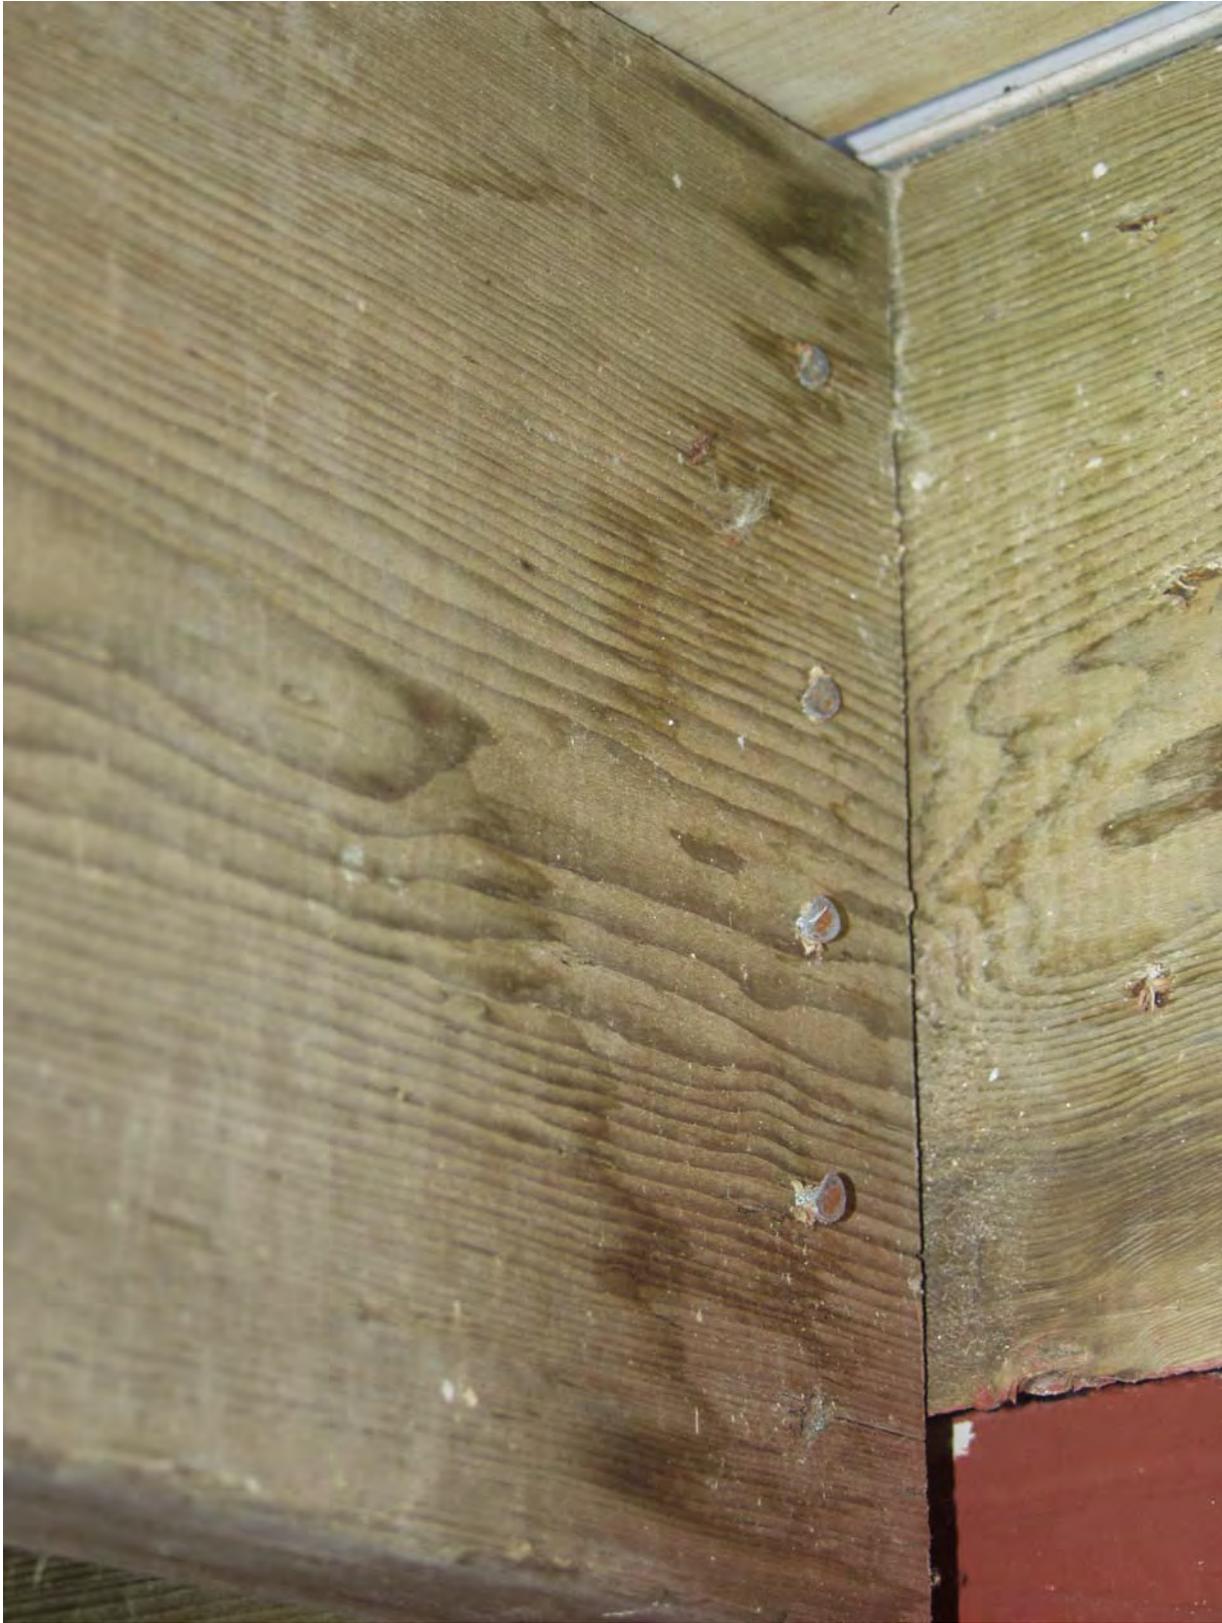
Figure 34. Galvanized nails in unincised ACQ deck joist show corrosion (red rust) on the heads most probably due to loss of zinc coating during nailing.

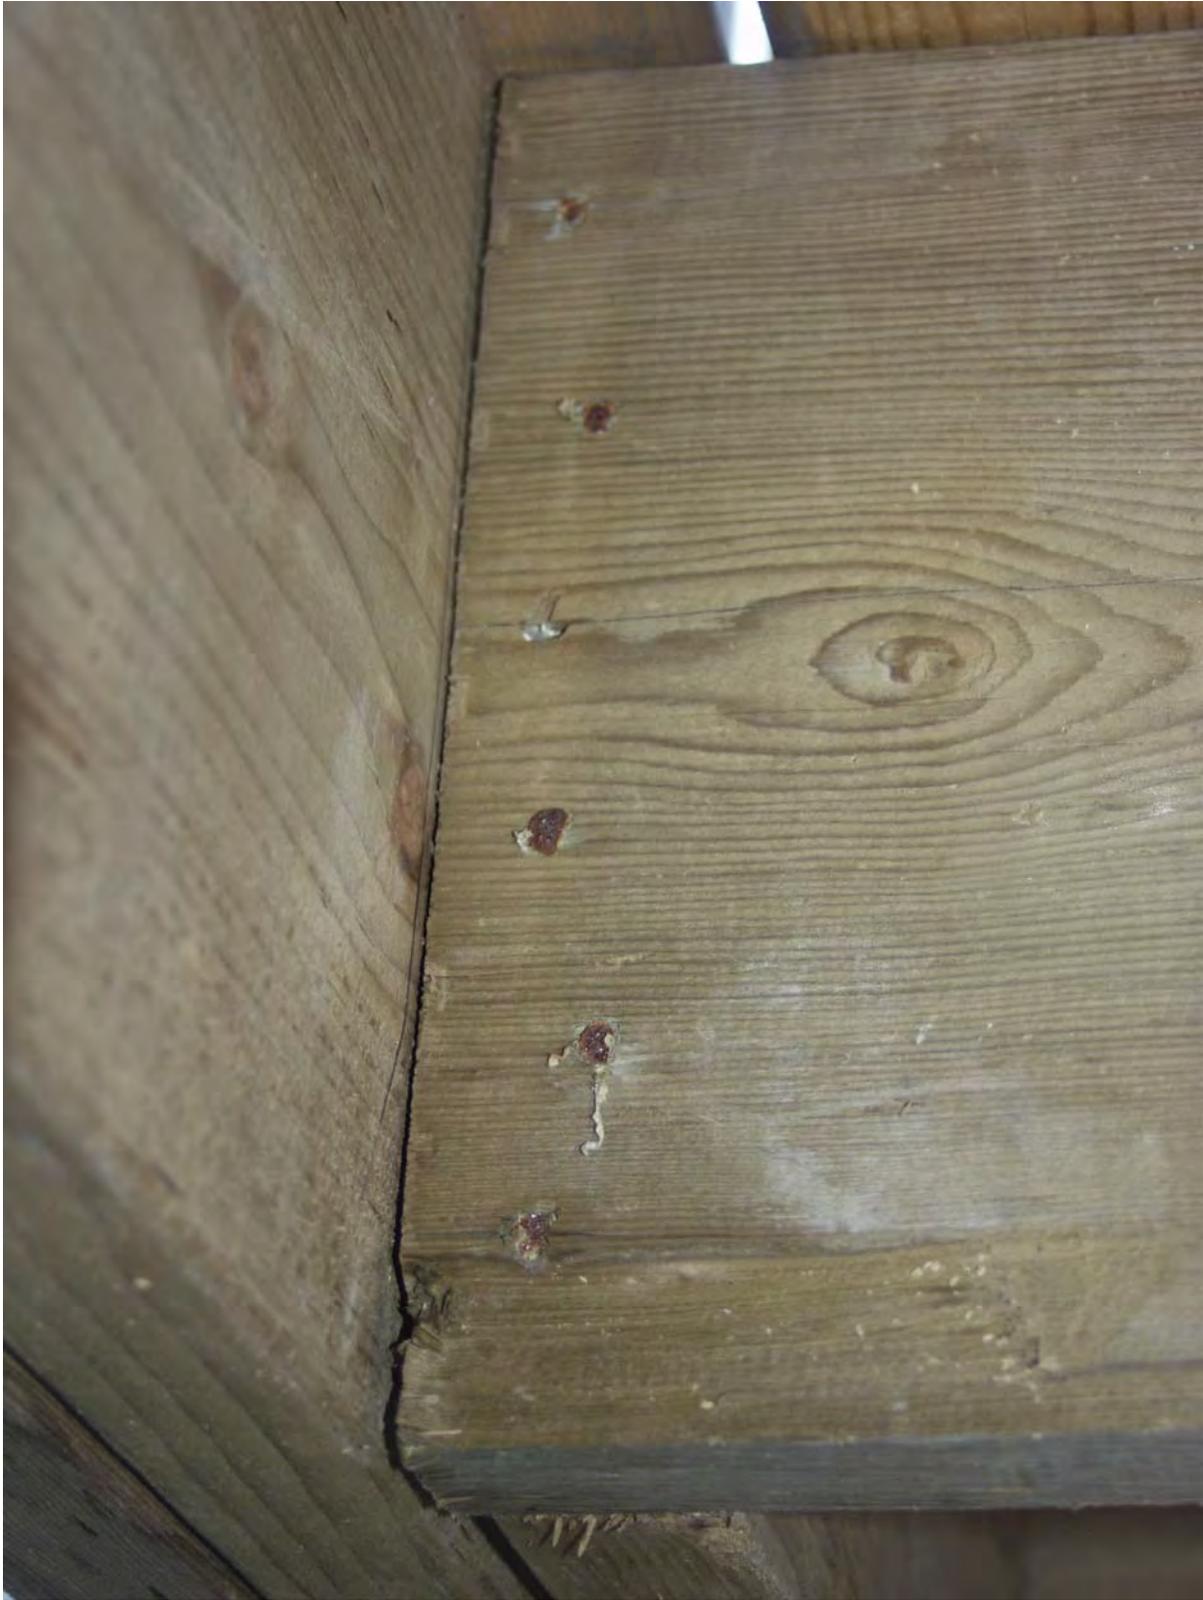
Figure 35. Galvanized and possible common nails in unincised ACQ deck joist show corrosion (red rust) on the heads. Note lack of water marking on lumber.

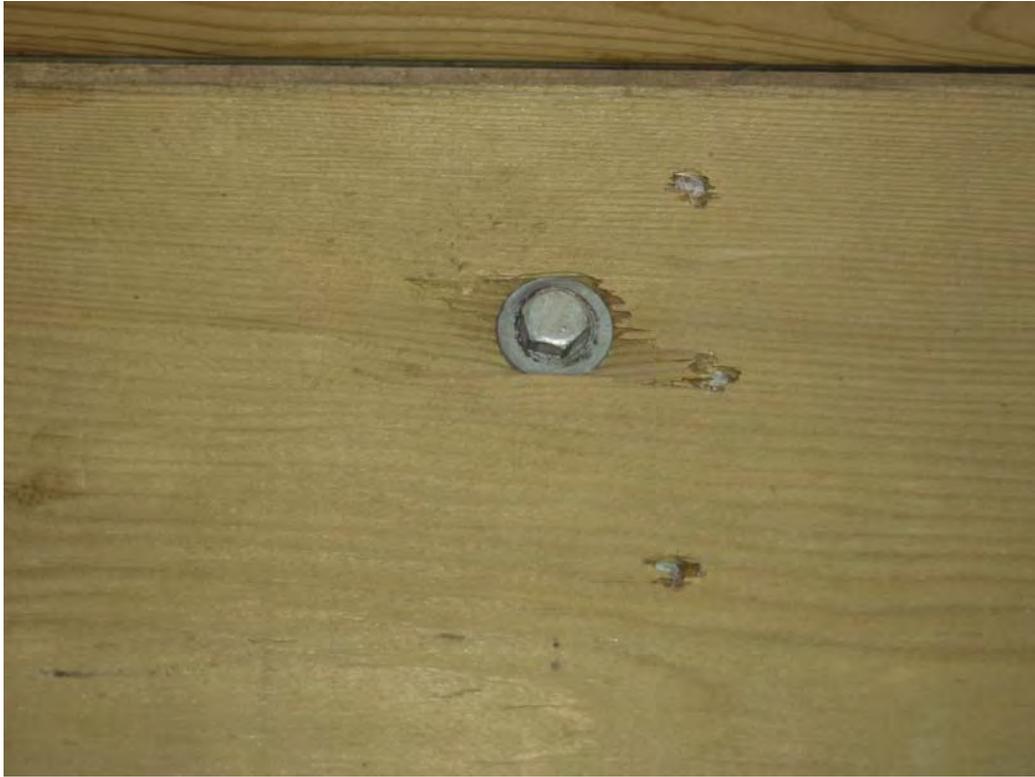
Figure 36. Galvanized bolt, washer and nails in unincised ACQ deck joist show no corrosion

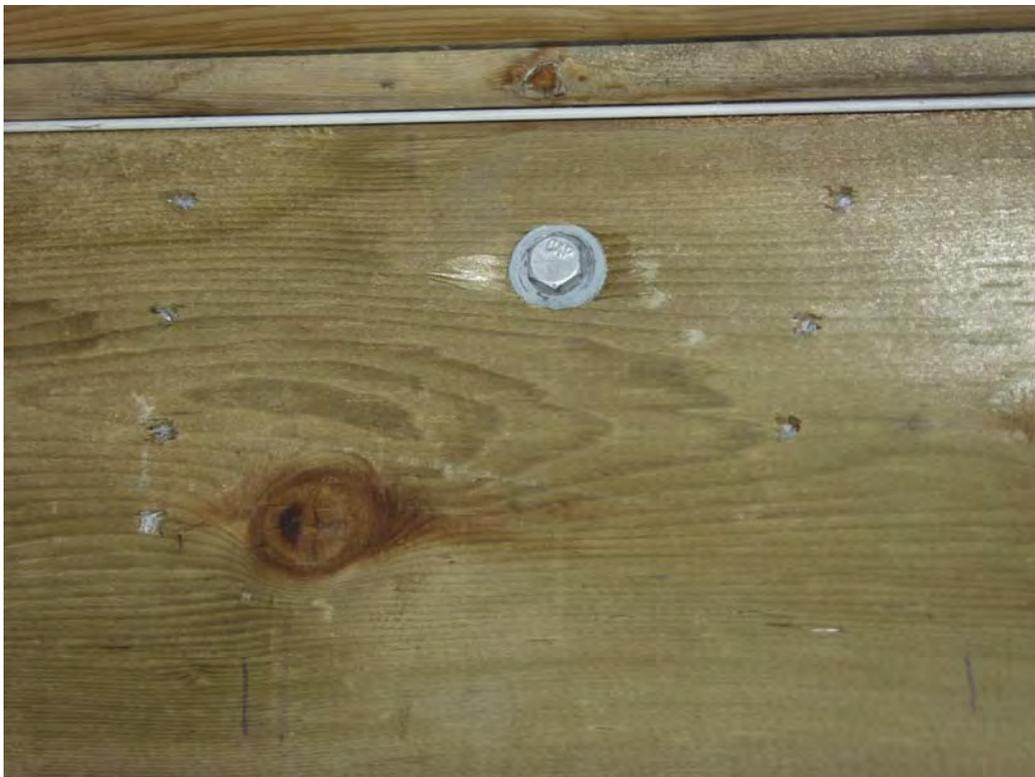
Figure 37. Galvanized bolt, washer and nails in unincised ACQ deck joist show no corrosion

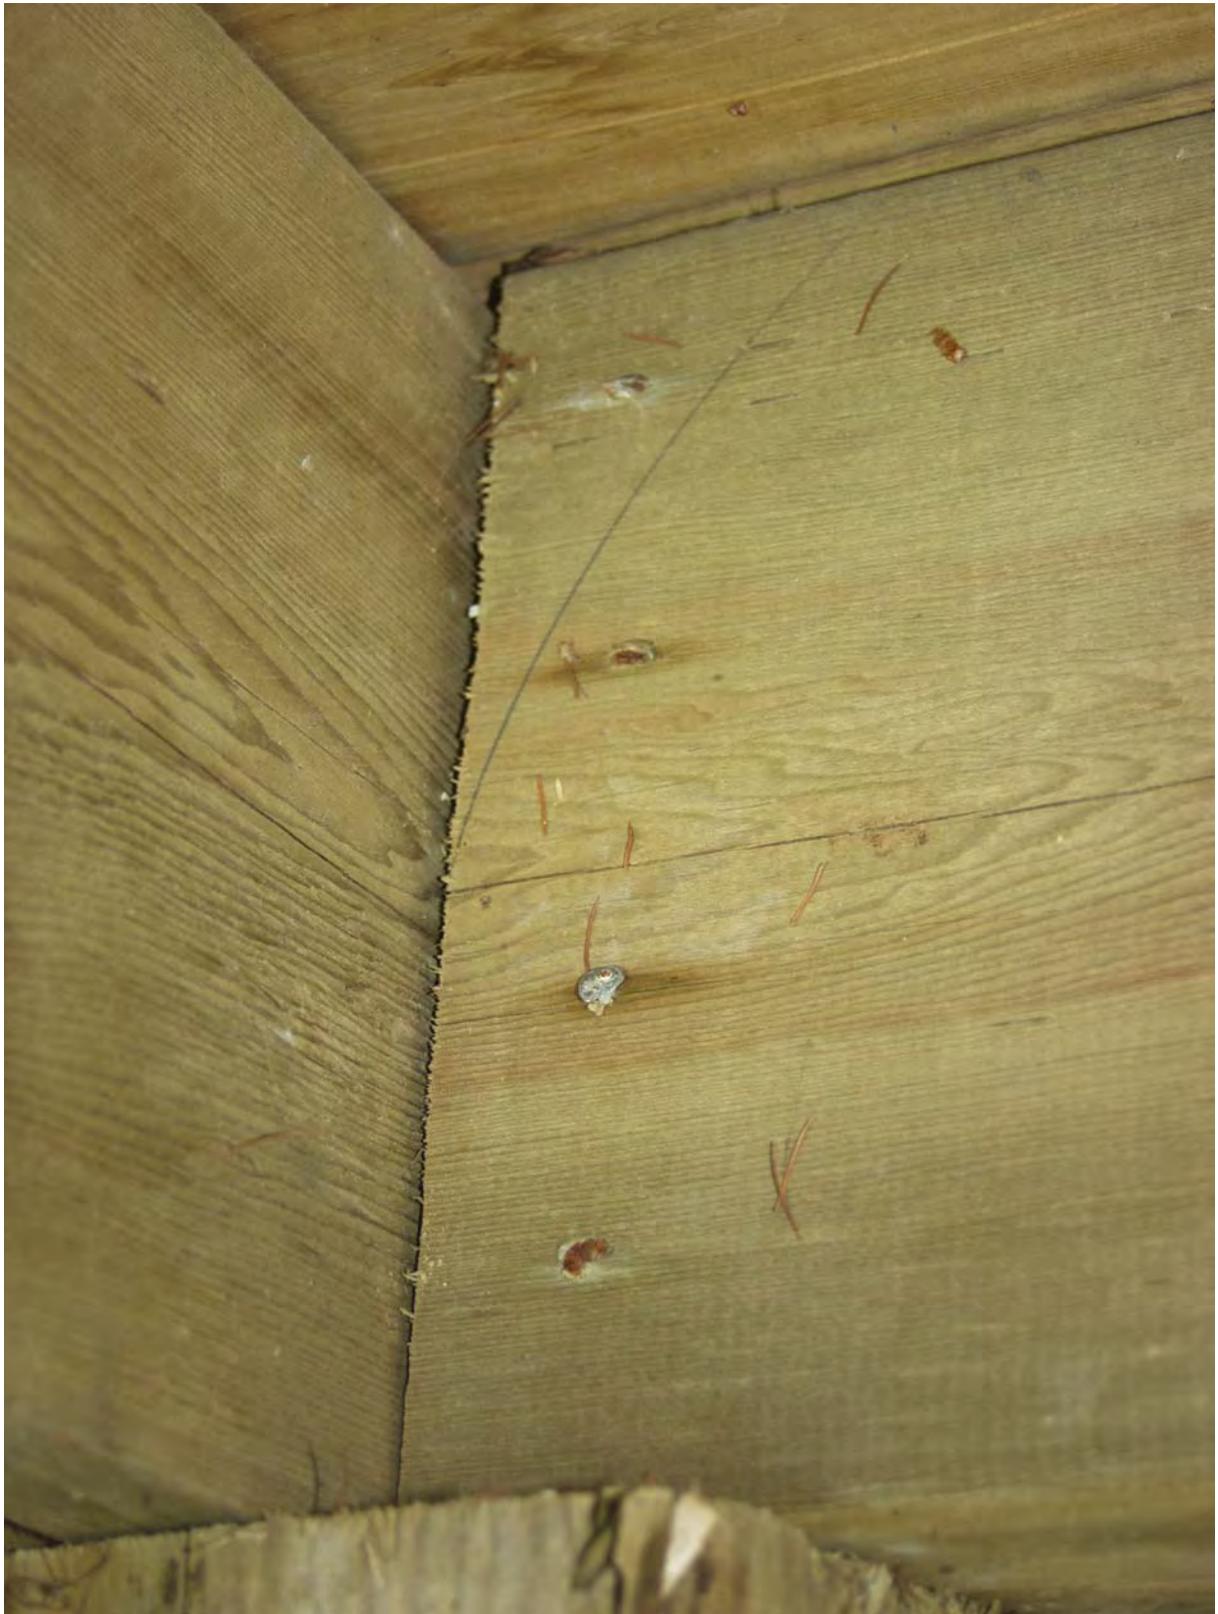
Figure 39. Galvanized fasteners showing red rust on their heads due to loss of zinc during nailing

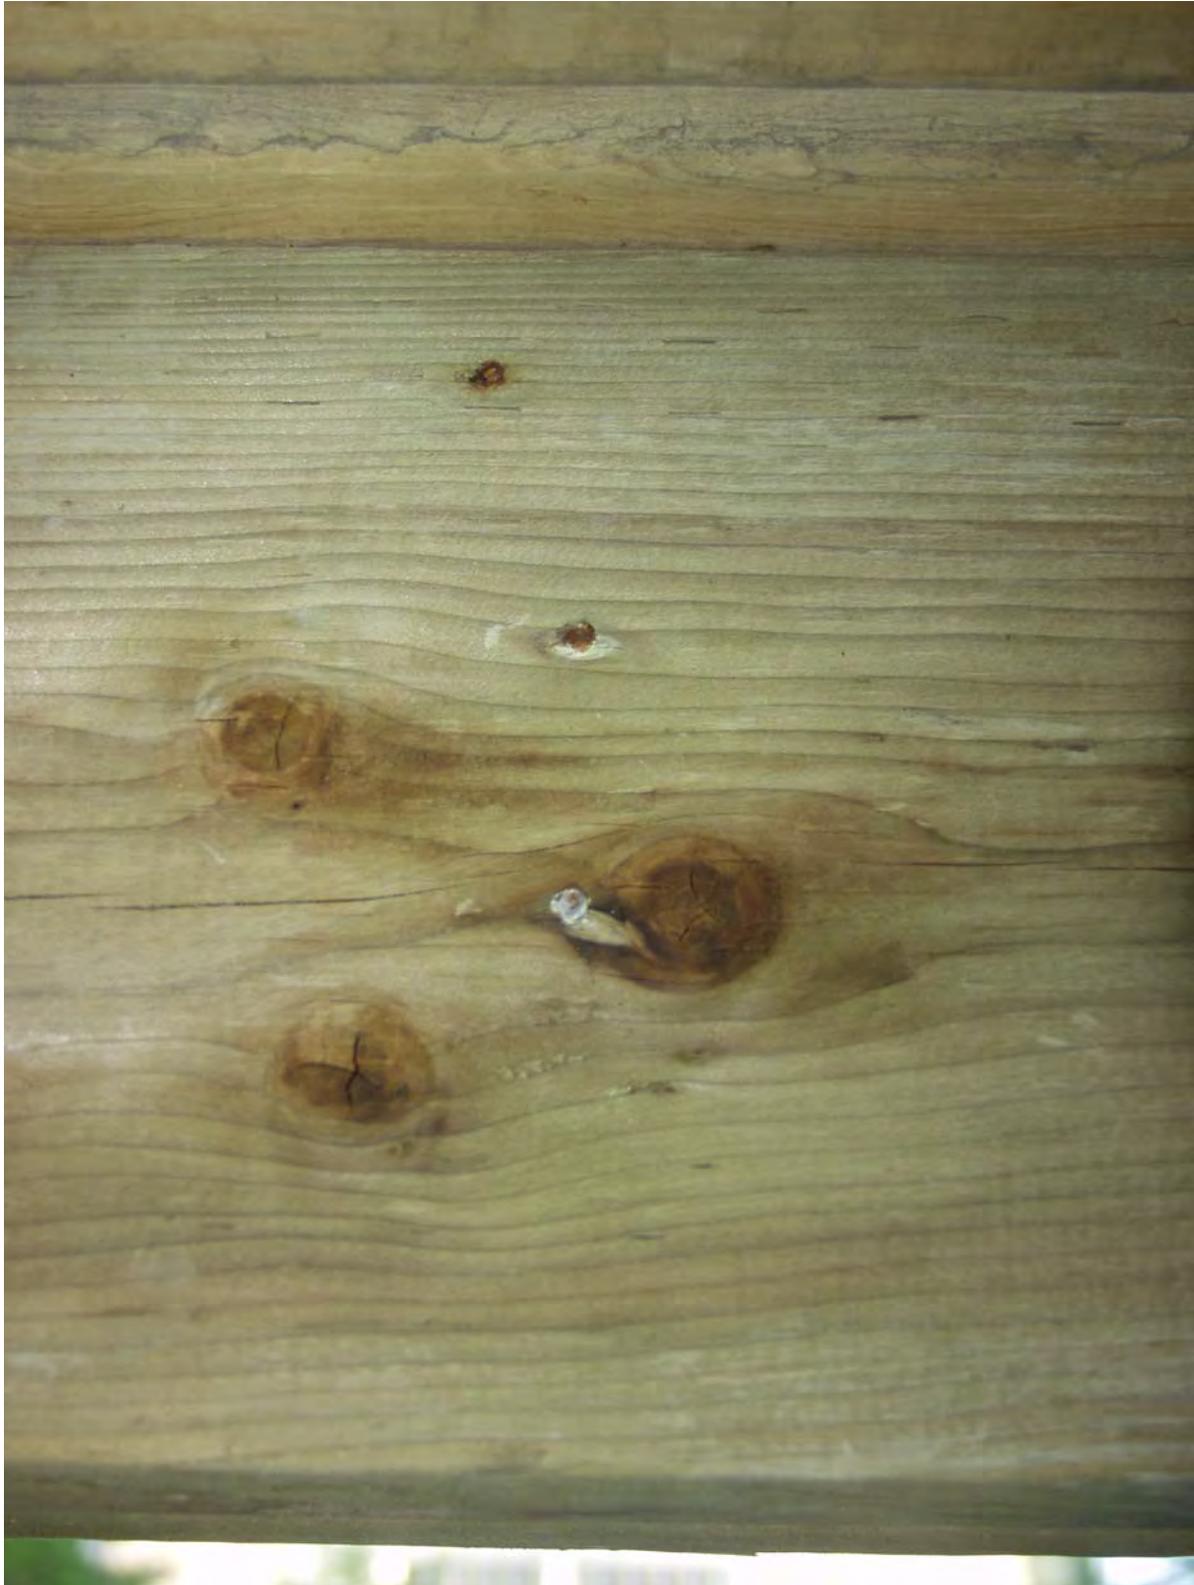
Figure 40. Galvanized fasteners showing red rust on their heads due to loss of zinc during nailing in incised ACQ lumber

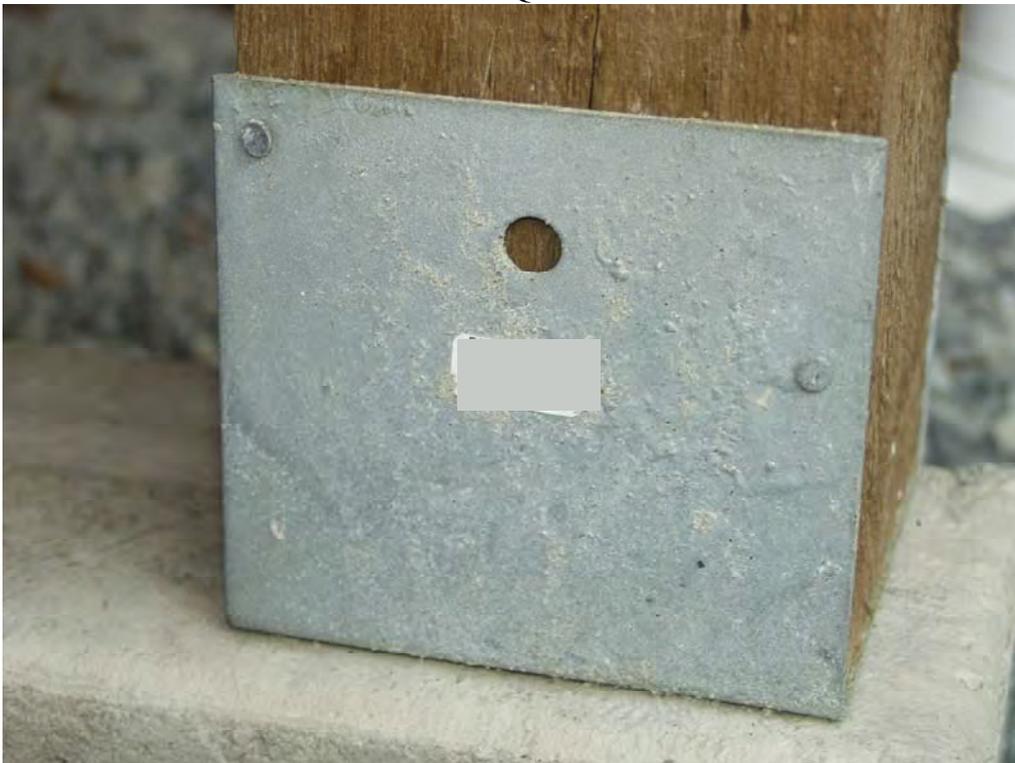
Figure 42. Galvanized post base connector and fasteners showing no corrosion

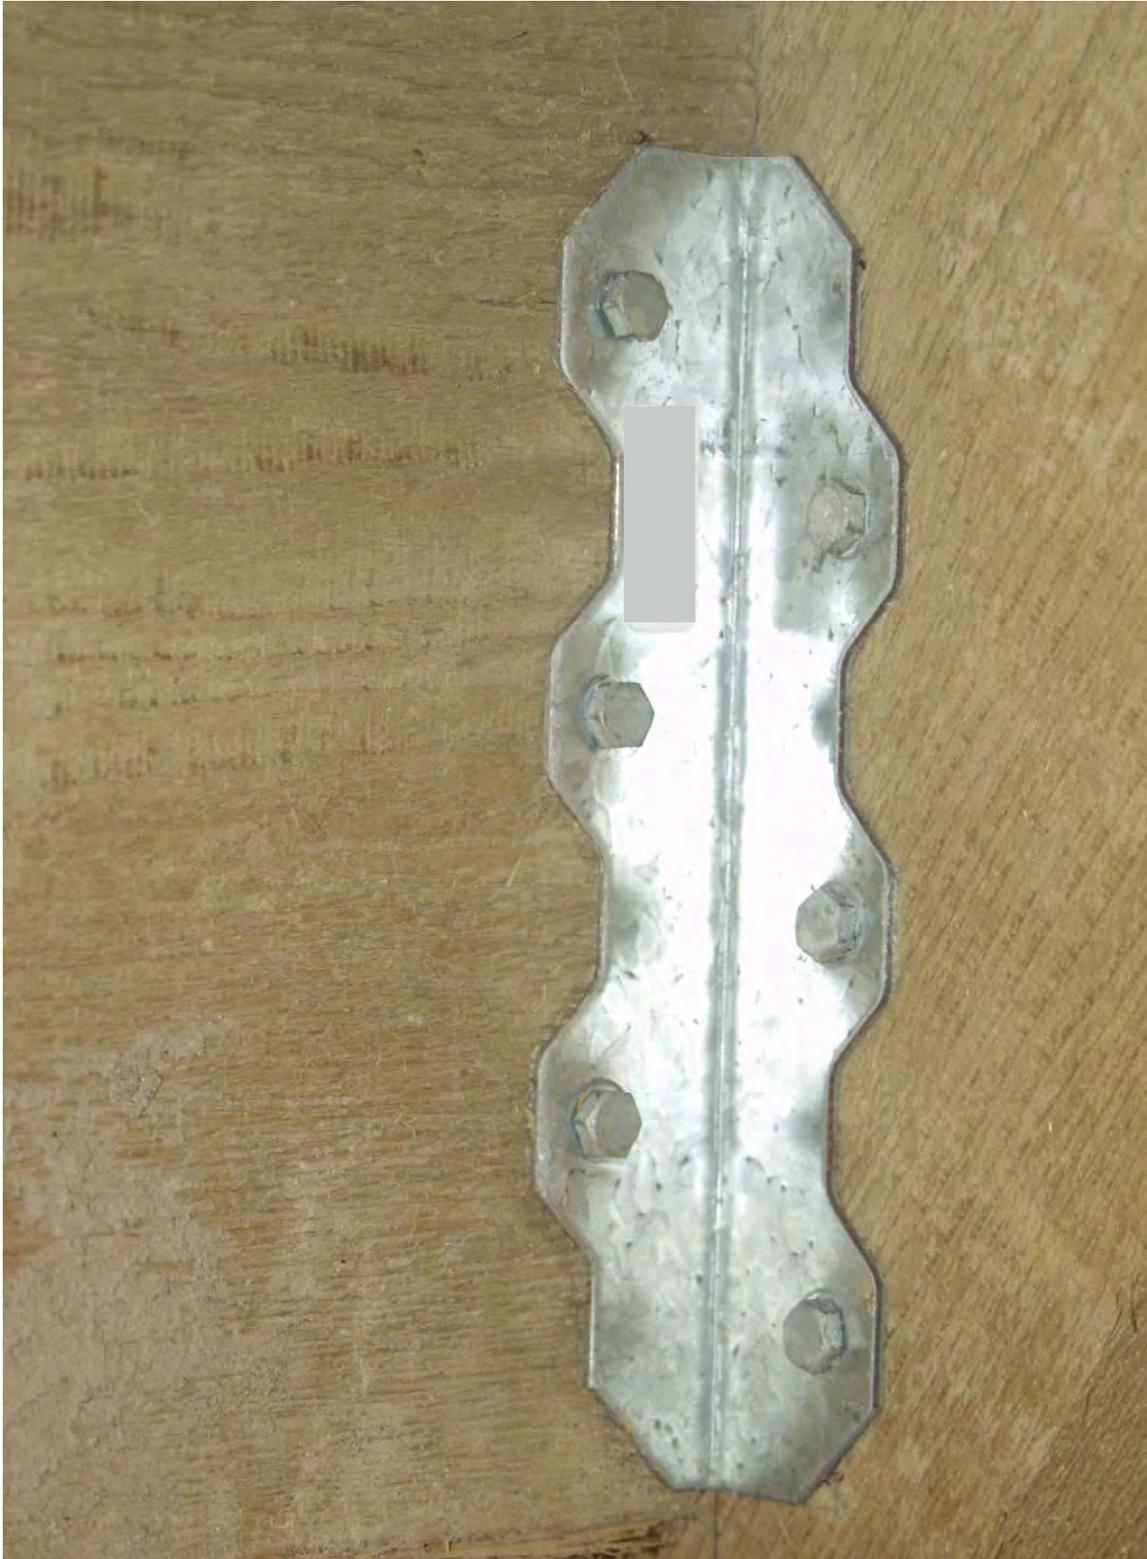
Figure 43. Galvanized connectors showing red rust on the edge. Note lack of watermarking of timber
