Field investigations on the application of ACQ treated wood and use of metal fasteners and connectors in residential construction

**Dr. John N.R. Ruddick
Mychem Wood Protection Consultants Ltd.,
1365 Ottawa Ave.,
West Vancouver,
BC V7T 2H6**

December 2006

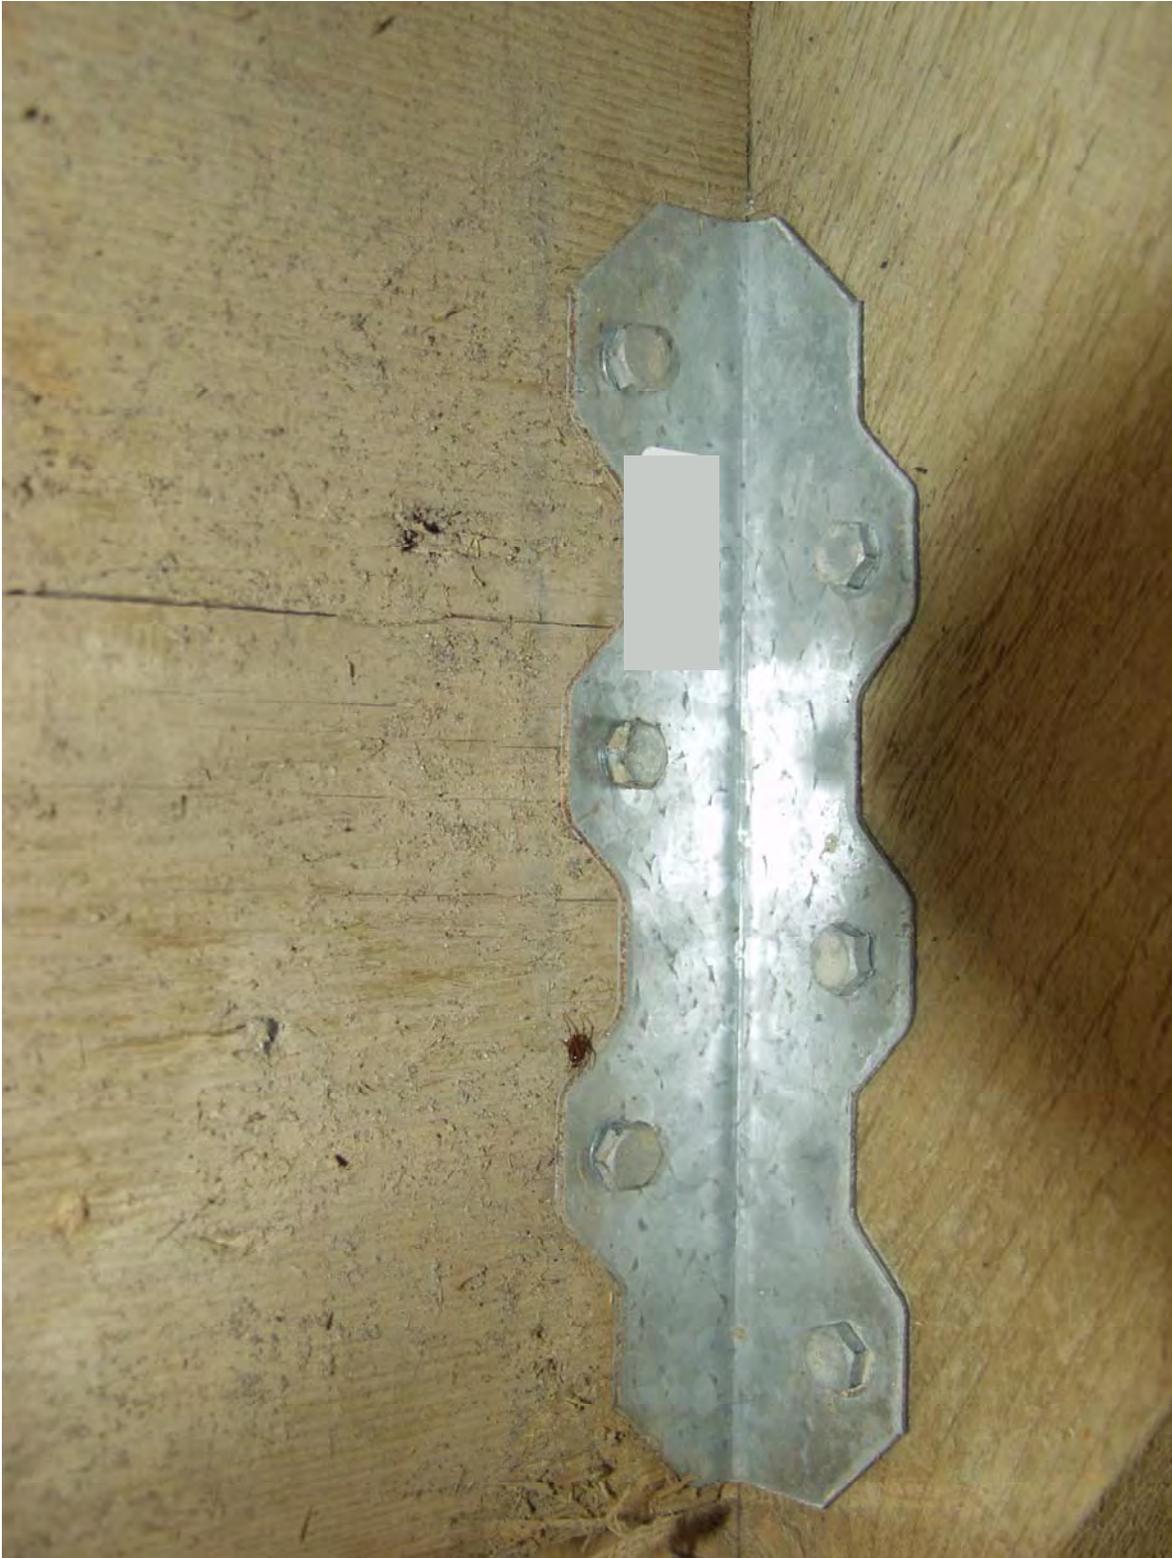
Figure 44. Galvanized connectors showing red rust on the edge. Note lack of watermarking of timber

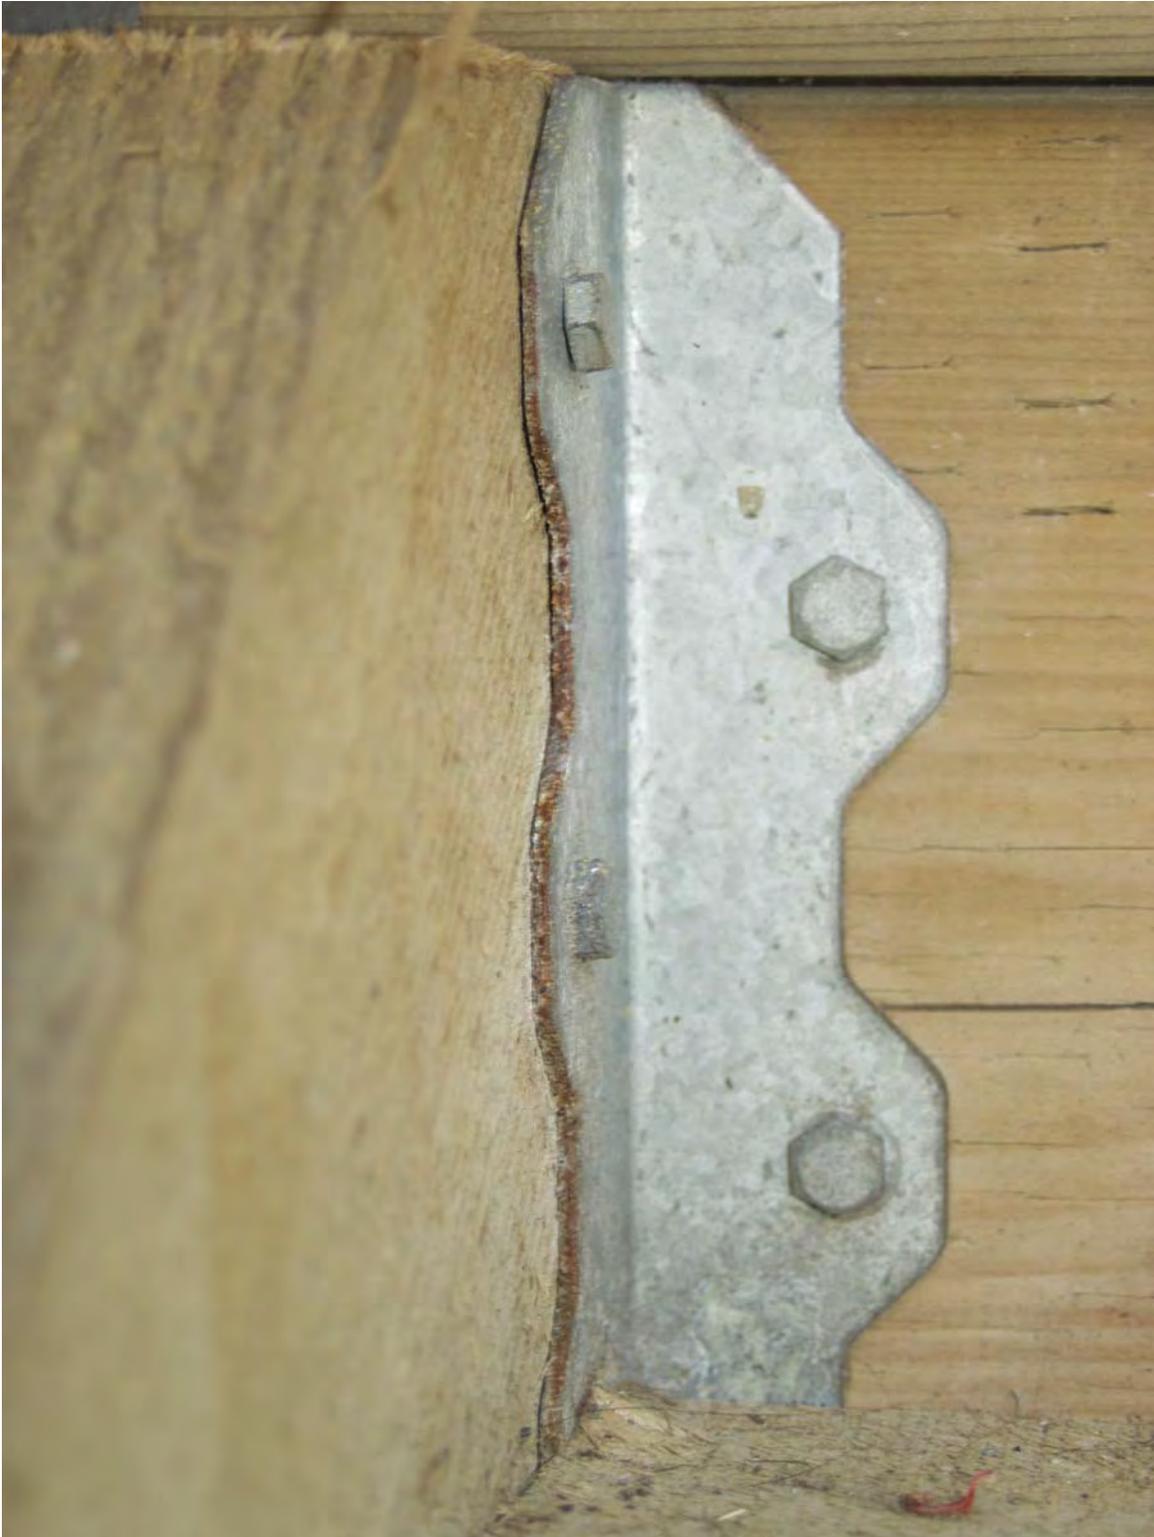
Figure 45 Galvanized connectors showing red rust on the edge. Note lack of watermarking of timber

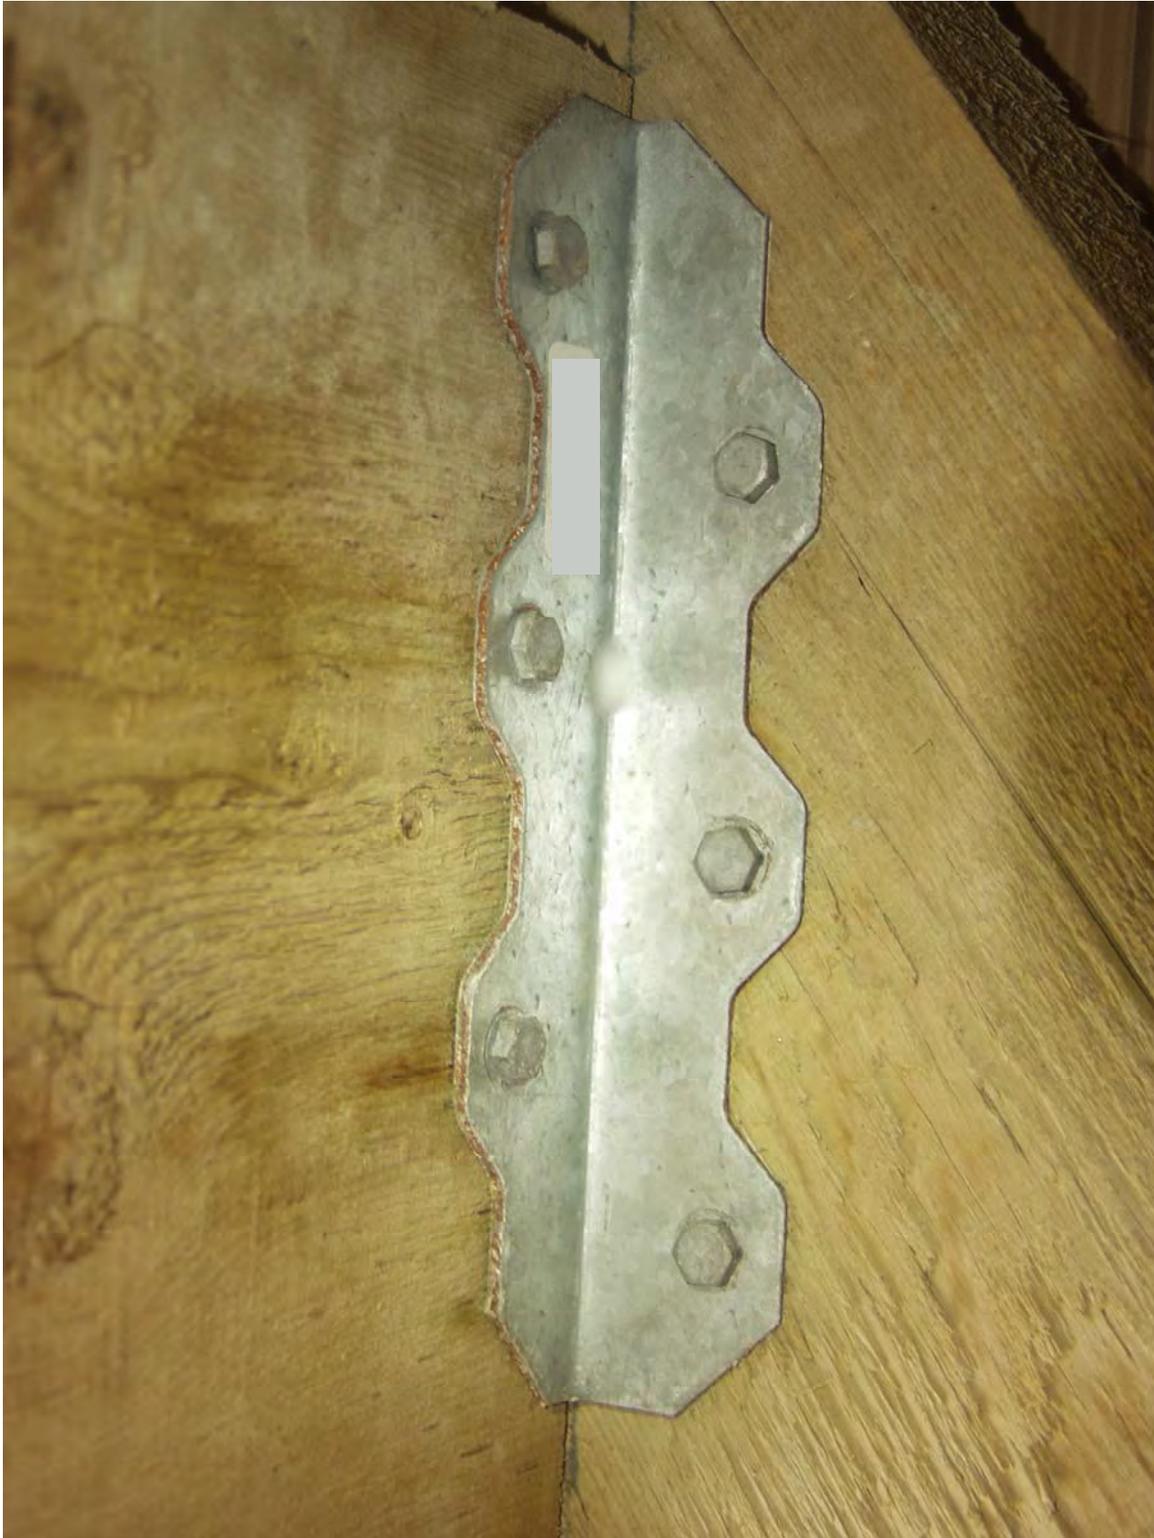
Figure 46. Galvanized connectors showing red rust on the edge. Note lack of copper deposits on wood and lack of corrosion on face.

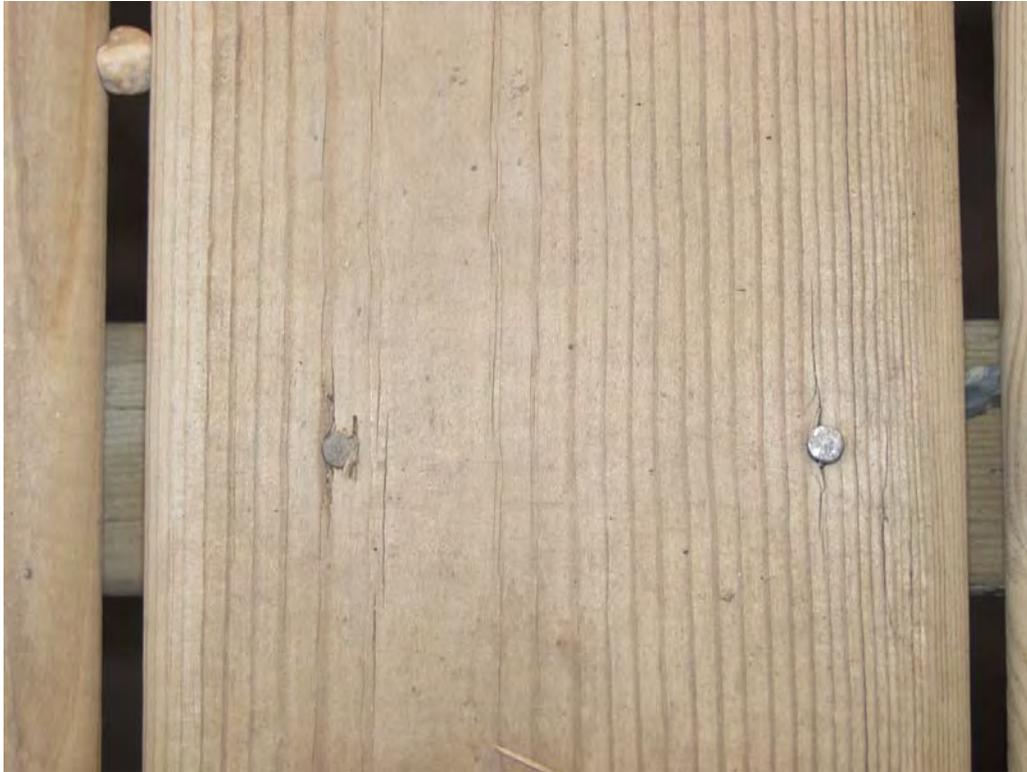
Figure 47. Galvanized fasteners on decking – no corrosion visible

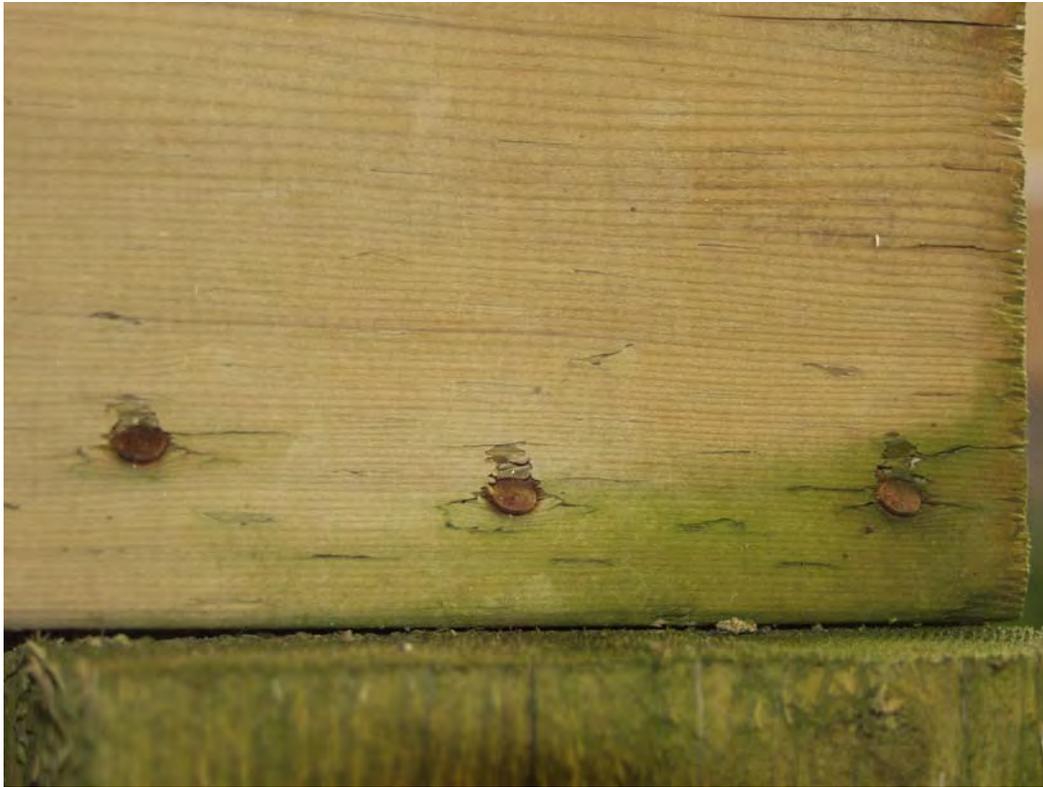
Figure 48. Corrosion (red rust) on mild steel fasteners in contact with incised ACQ treated wood.

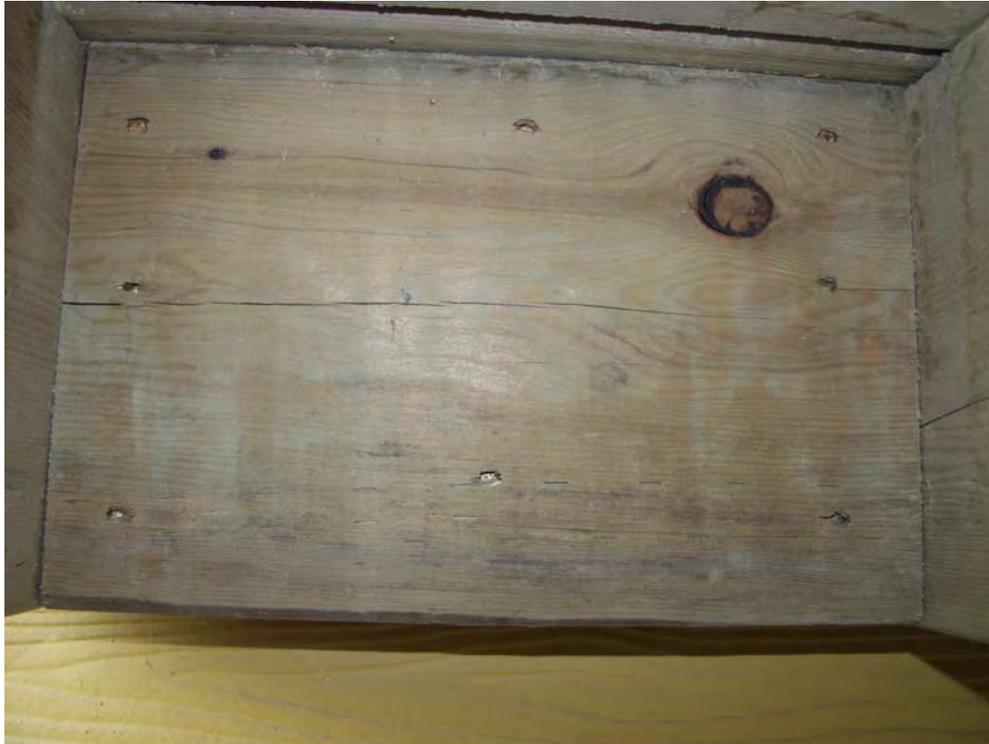
Figure 49. Galvanized fasteners showing no corrosion

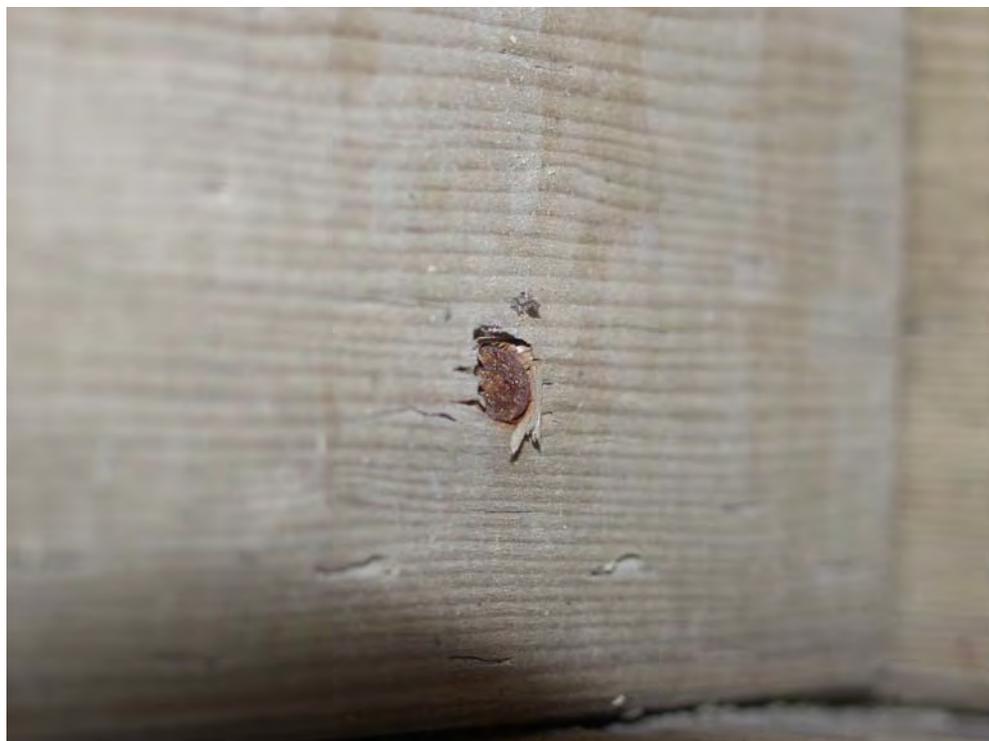
Figure 50. Corrosion (red rust) on the head of common (mild steel) fasteners in contact with unincised ACQ treated lumber

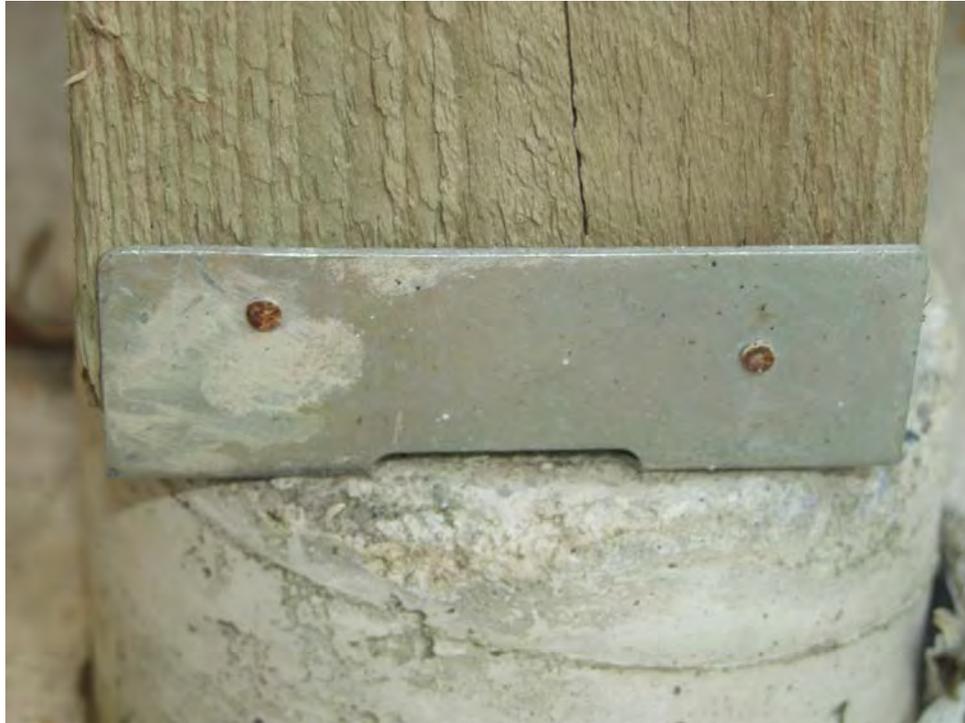
Figure 51. Galvanized post base connector showing no corrosion. Galvanized fastener heads show red rust due to loss of zing during nailing

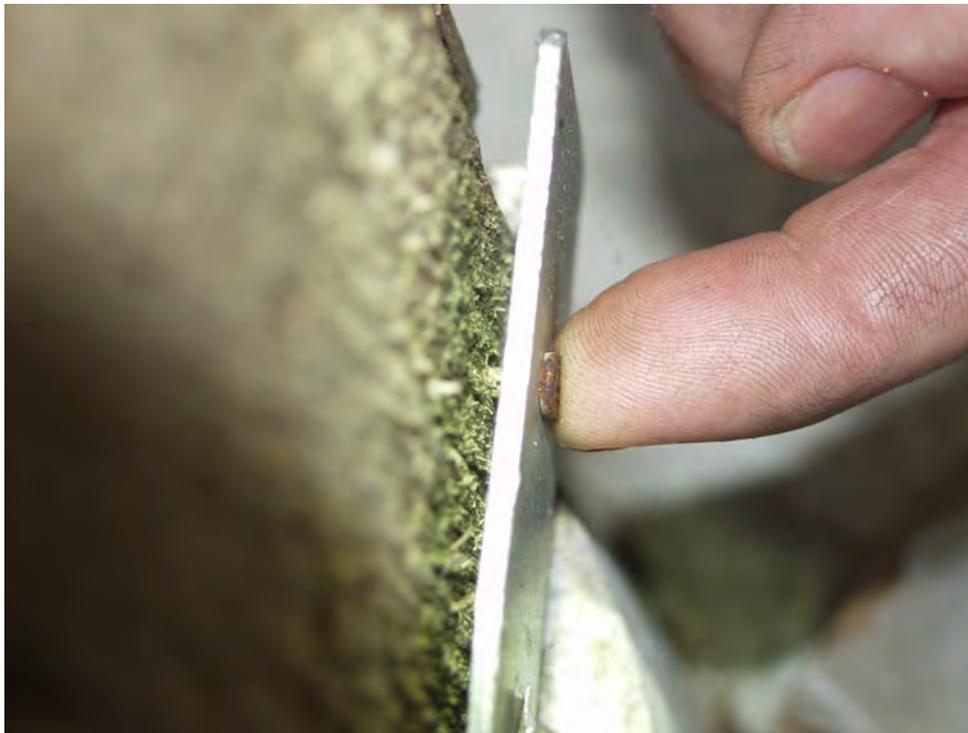
Figure 52. Galvanized fastener show white and red rust due to loss of zing during nailing

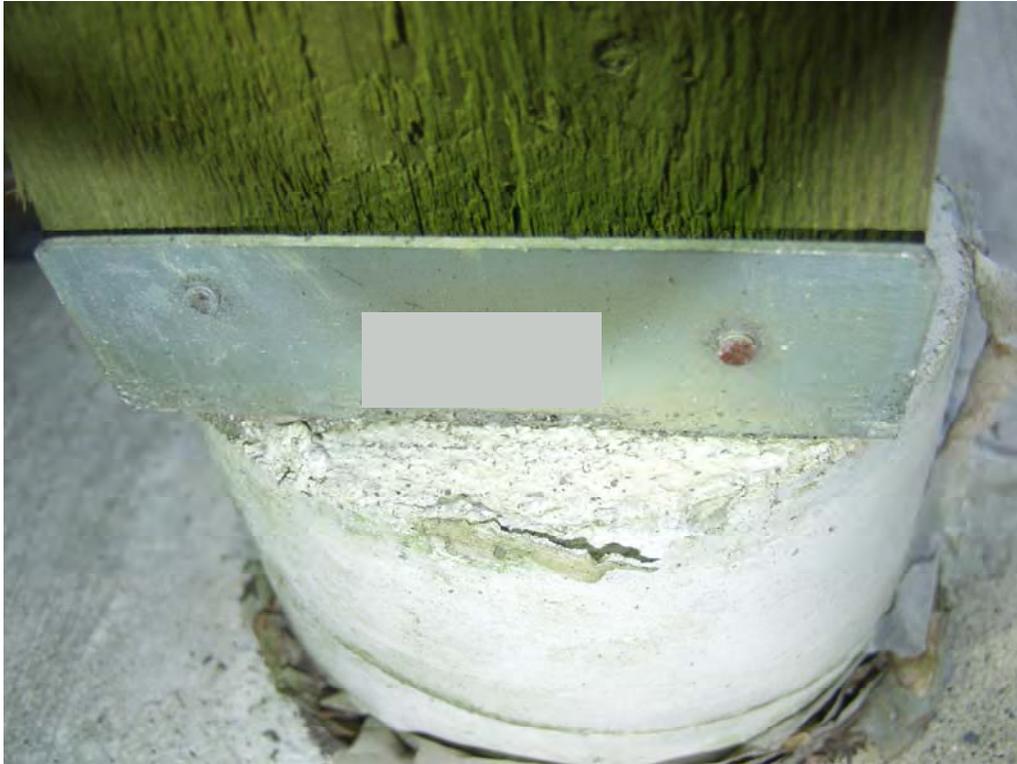
Figure 53. Galvanized post base connector showing no corrosion. Galvanized fastener heads show red rust due to loss of zing during nailing

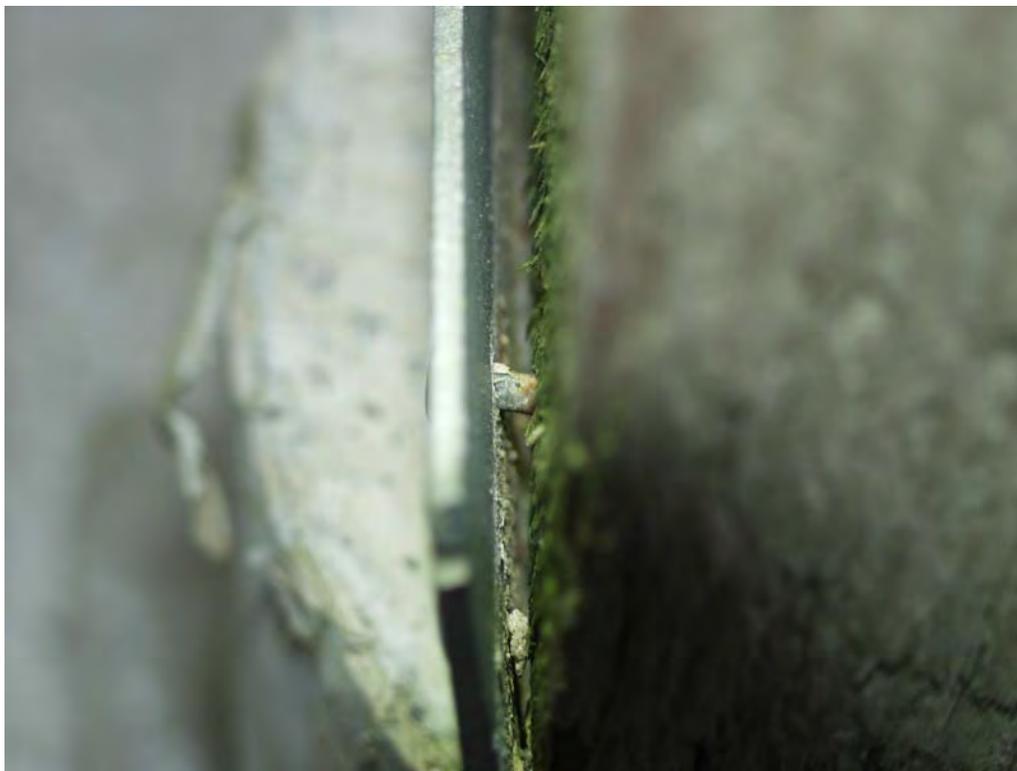
Figure 54. Galvanized fastener show white and red rust due to loss of zing during nailing

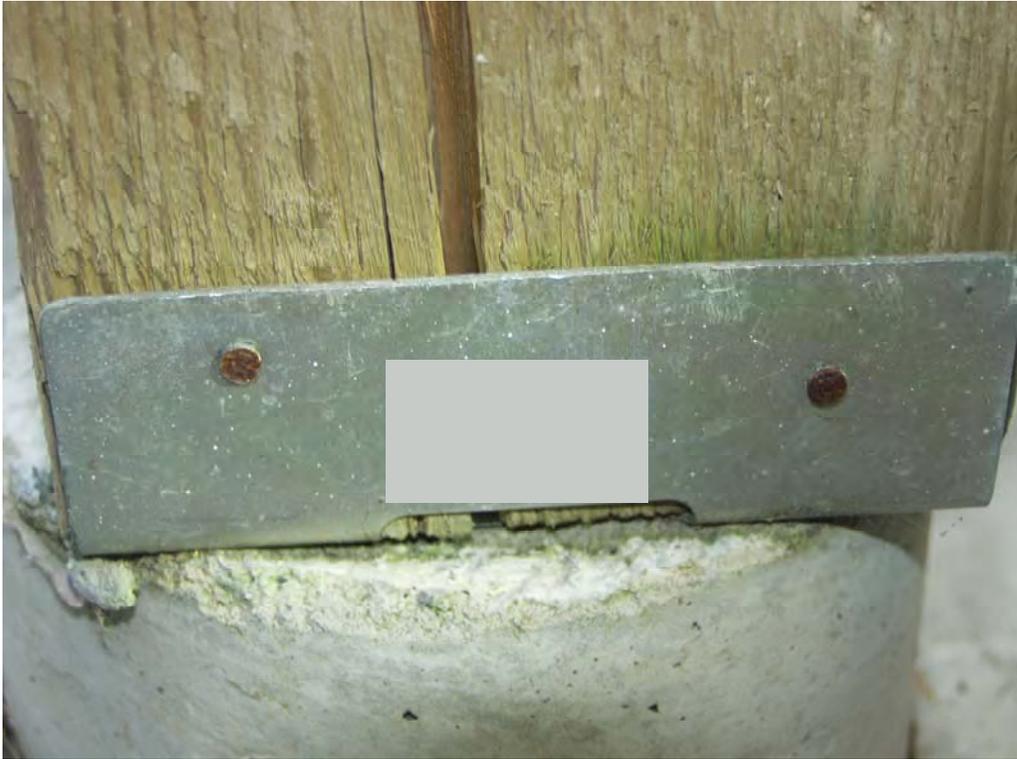
Figure 55. Galvanized post base connector showing no corrosion. Galvanized fastener heads show red rust due to loss of zing during nailing

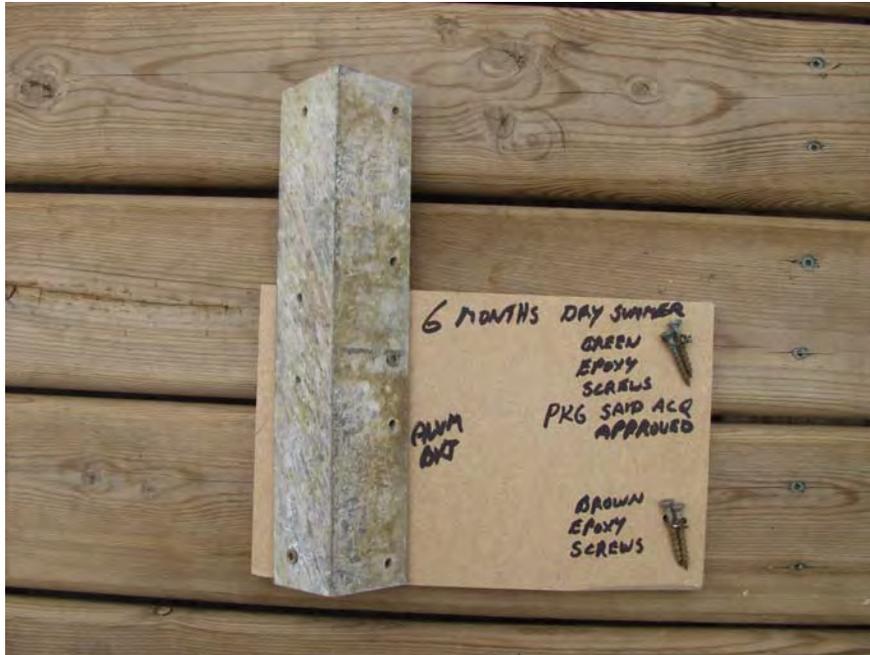
In 2006, a bracket and several epoxy coated screws were provided by a builder in Vancouver Island. According to the builder the package for the screws had indicated that they were suitable for use with ACQ treated wood. He also indicated that they had been in a structure for 6 months (Figures 56 and 57). The screws show heavy red rust on their shank. The heads were free of corrosion. Clearly the corrosion resistance is not sufficient for this use. The bracket was made from aluminum and so was heavily corroded. It is well known that aluminum materials should not be used in contact with copper containing materials.

Figure 56. Corrosion of aluminum bracket and decking screws after 6 months service in ACQ decking

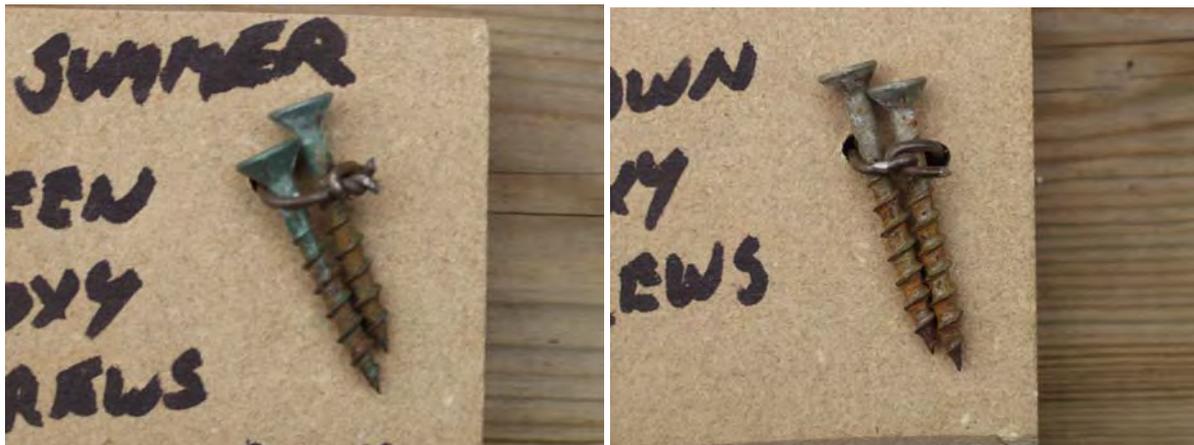
Figure 57. Corrosion of green and brown epoxy coated decking screws

- Epoxy coated decking screws which had no zinc coating beneath, were susceptible to corrosion during use. Presumably in the samples examined the coating had become damaged during installation.

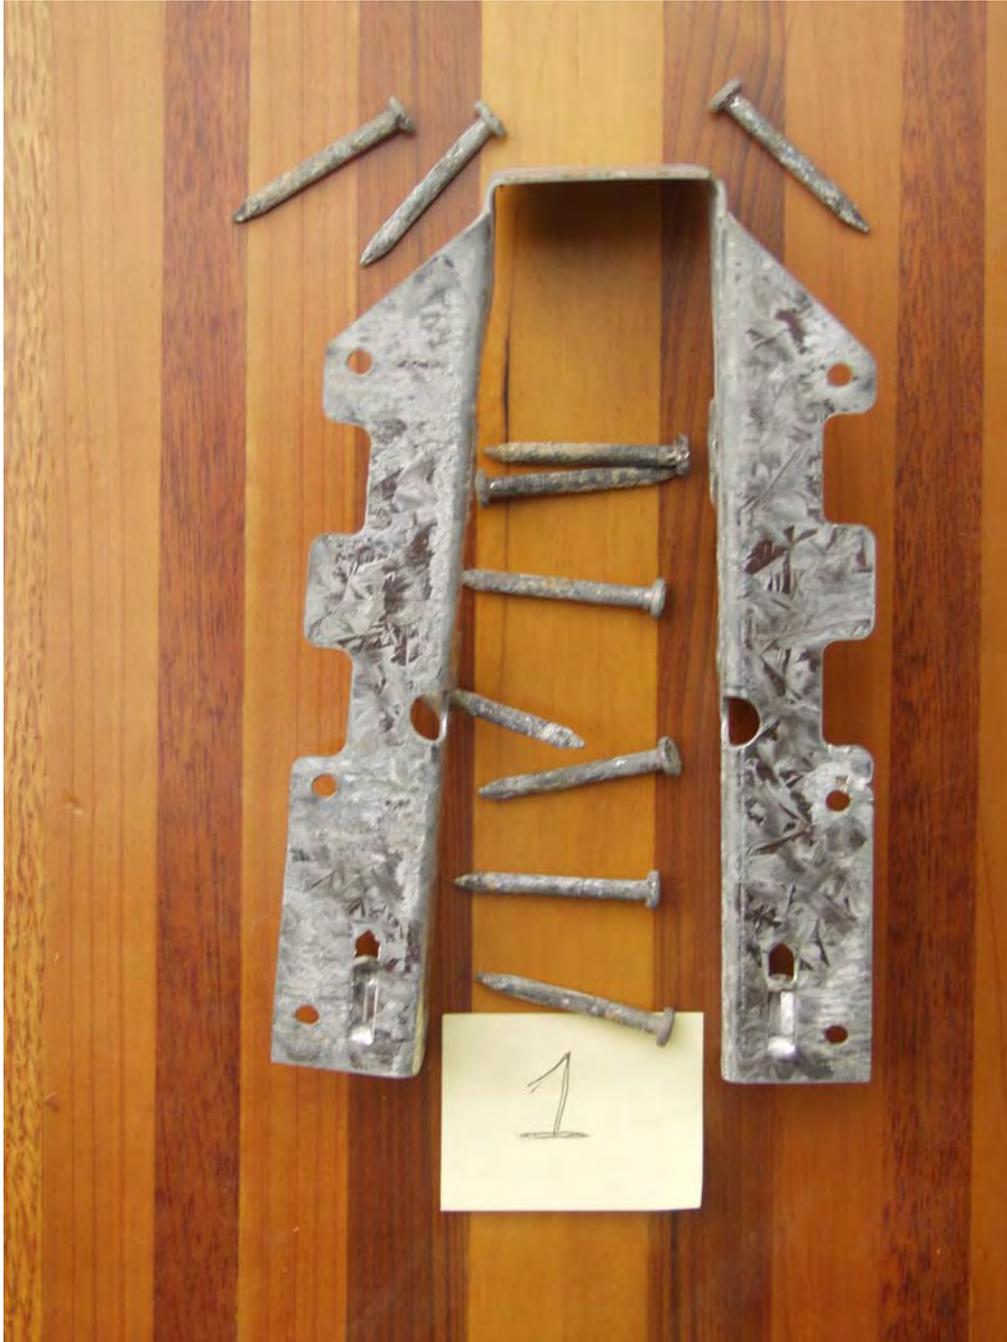
The second set of samples was recovered by a builder in the Lower Mainland from a rear drip deck of a structure after 11 months in use. The first of the hangers (#1) had been installed on a building ledger and so had no direct exposure to weather. The nails and hanger were in good condition with no corrosion visible (Figure 58). The nails too retained a good coating of zinc with no sign of white rust.

Figure 58. Galvanized hanger the specifications of which meet the G 185 requirement removed from deck protected from weather.

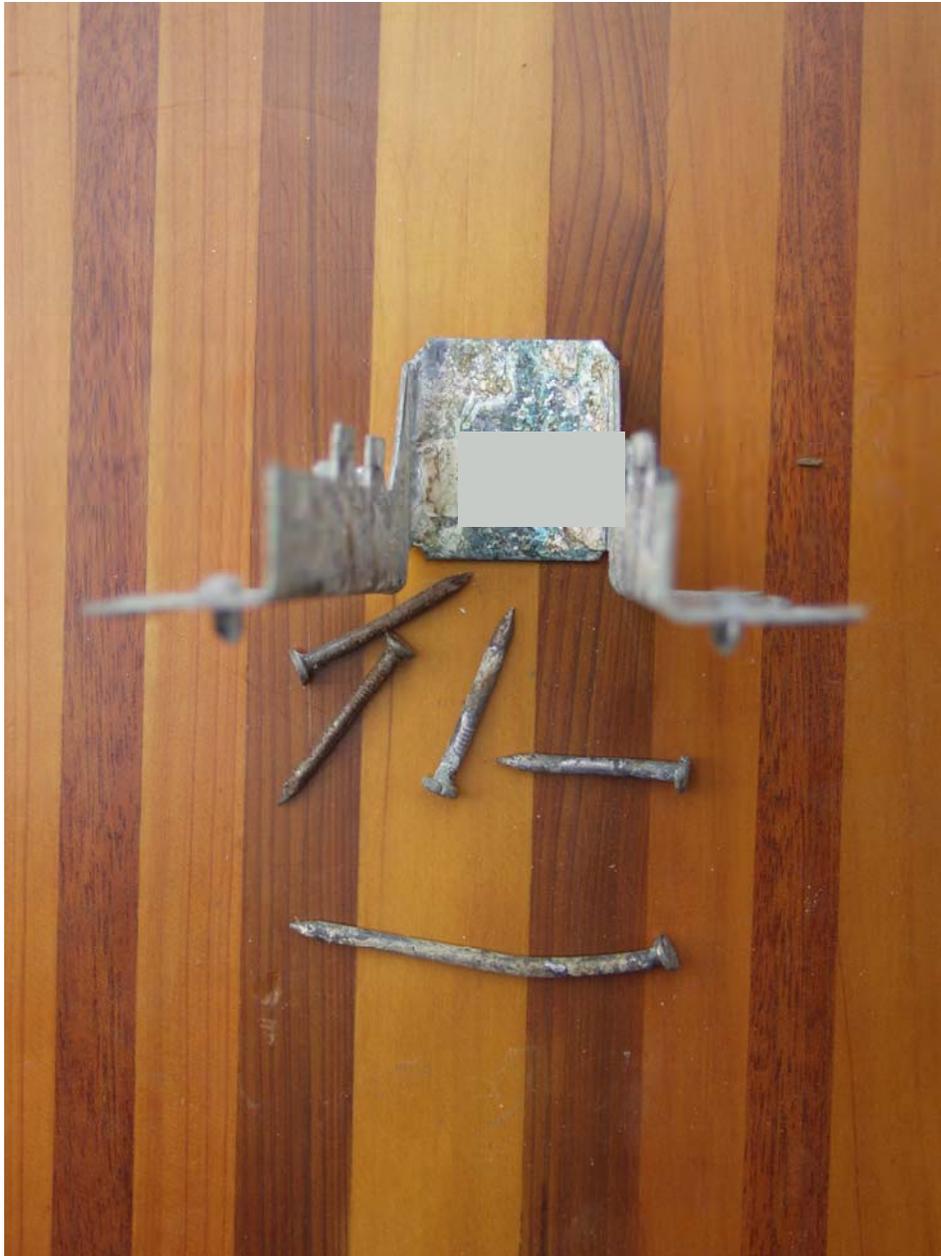
The second and third samples were removed from the rim joist of the deck where they had been exposed to the weather (Figures 59 to 63). In this case extensive corrosion has taken place on the inner surface in contact with the ACQ treated wood. Some red rust is visible on the edge of the hanger and also on the inner surface. The nails have in some cases lost almost all the zinc galvanic coating. A green deposit of copper chemical is seen on the surface of the hanger. Casing nails used in ACQ stair treads show some white rust but no advanced corrosion. A galvanized lag bolt shows small red rust spots on the screw thread but almost no corrosion of the head or washer.

Figure 59. Corrosion of hot dipped galvanized hanger proprietary hanger, (the specifications of which meets the G185 requirement) and fasteners after 11 months exposure.

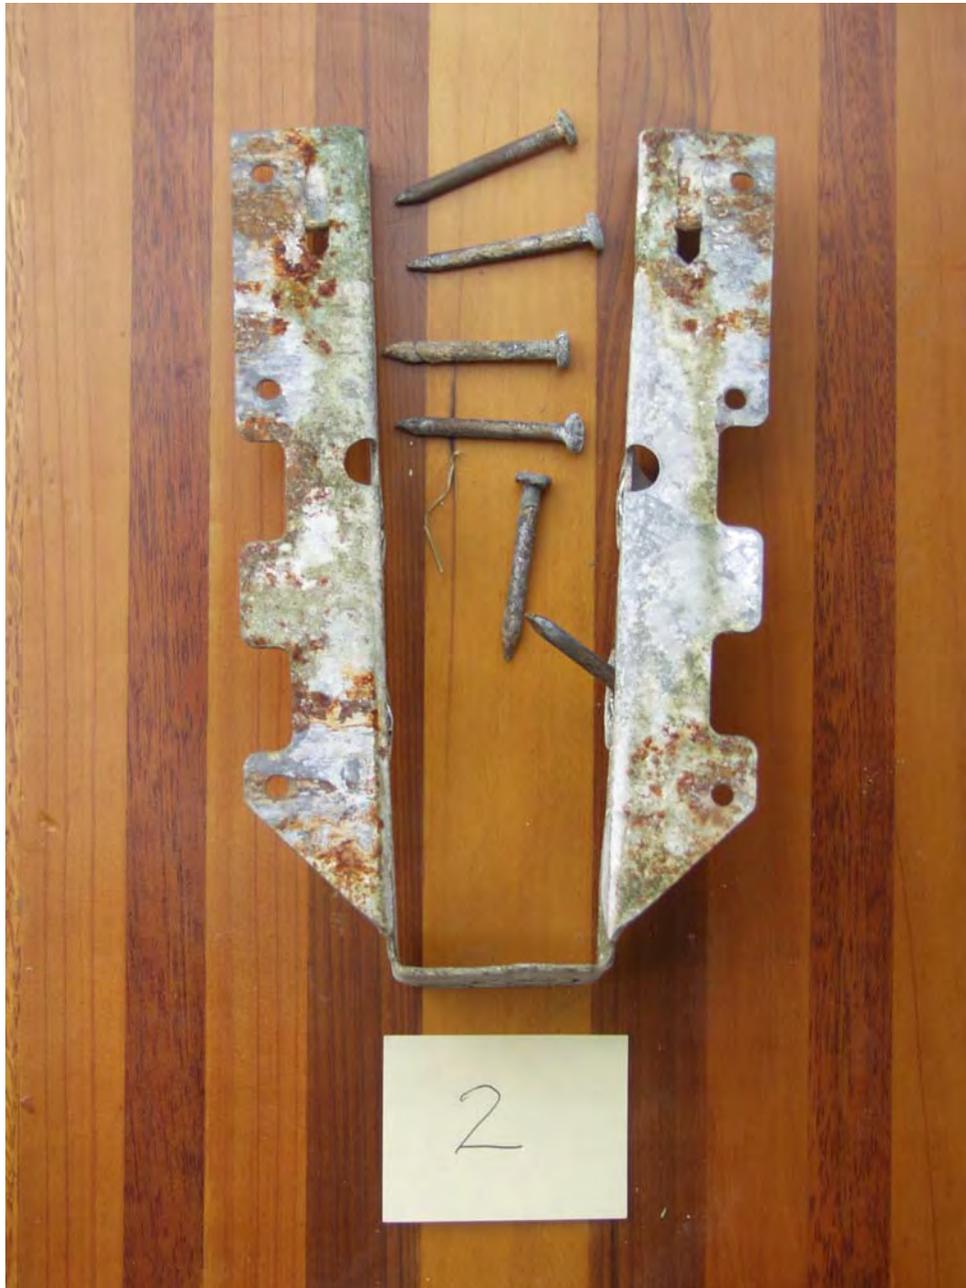
Figure 60. Corrosion of hot dipped galvanized hanger proprietary hanger, (the specifications of which meets the G185 requirement) and fasteners after 11 months exposure.

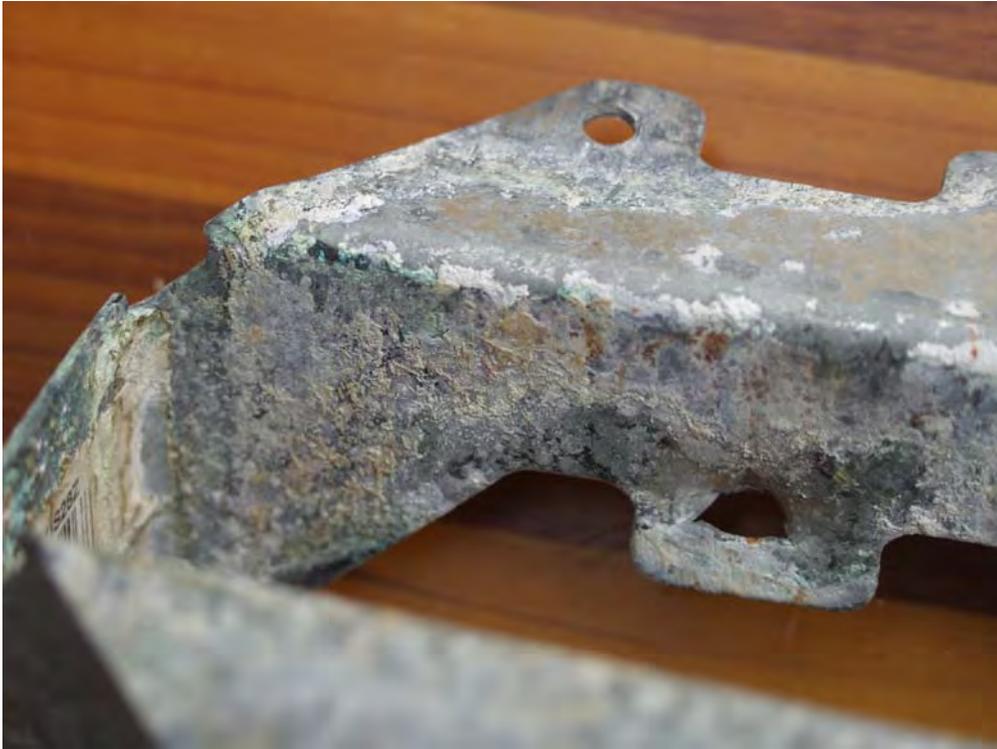
Figure 61. Corrosion of proprietary hot dipped galvanized hanger, (the specifications of which meets the G185 requirement) after 11 months exposure in contact with ACQ treated wood.

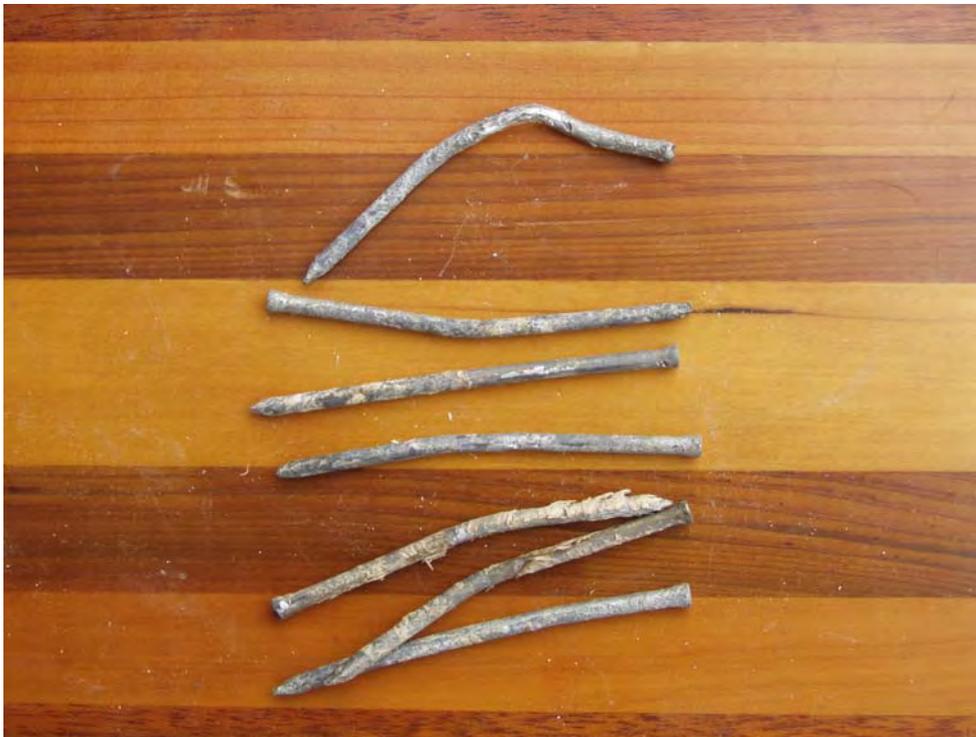
Figure 62. Galvanized casing nails removed from ACQ stair tread

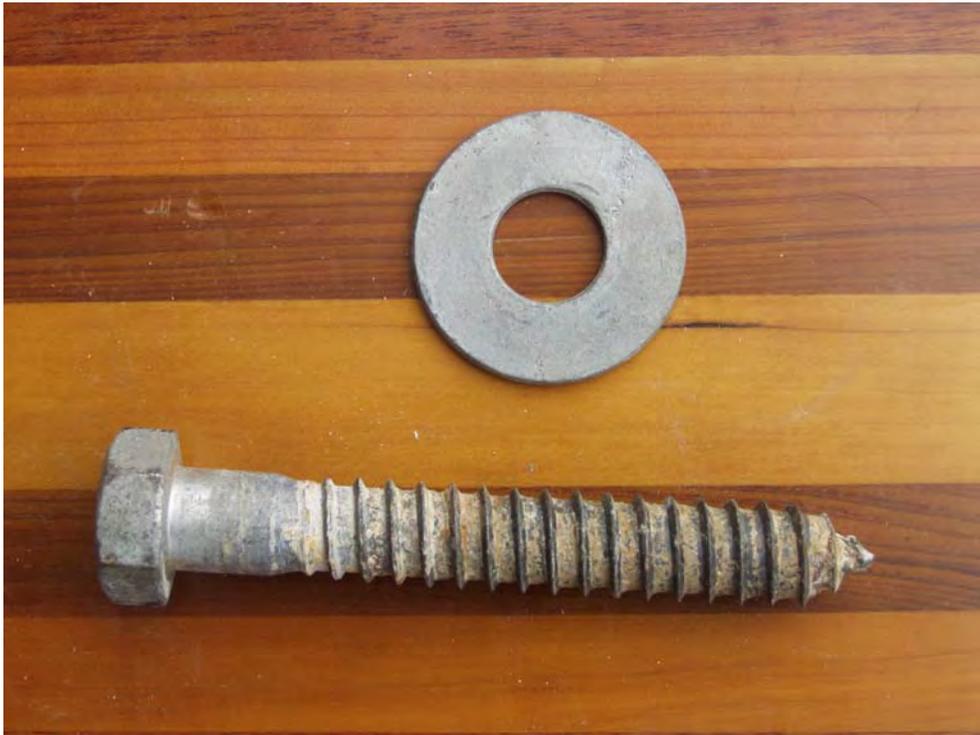
Figure 63. Galvanized lag bolt removed from deck bracket into ACQ rim joist.
