Study of High-Rise Envelope Performance in the Coastal Climate of British Columbia

October 2, 2001

STUDY OF HIGH-RISE ENVELOPE PERFORMANCE IN THE COASTAL CLIMATE OF BRITISH COLUMBIA

RDH Building Engineering Limited

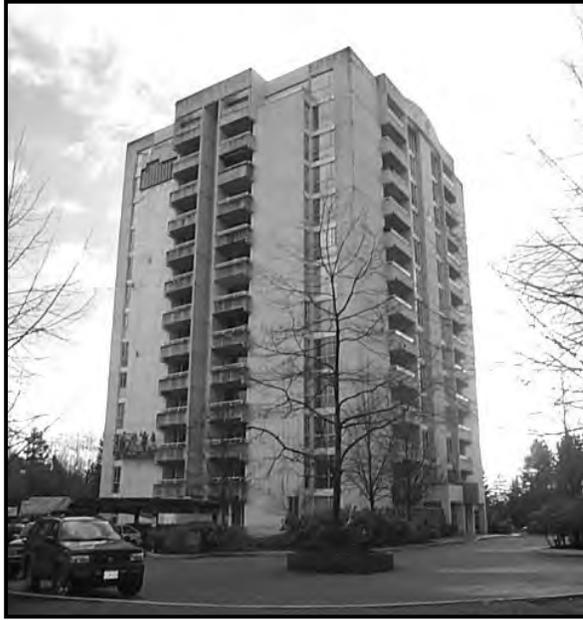
The most prevalent structural impact of moisture in high-rise residential buildings is on the attachment of the cladding to the primary and secondary structural system. Moisture damage can manifest itself in softening and loss of strength and stiffness in gypsum sheathing products, corrosion of steel studs, and corrosion of fasteners that attach the cladding and window assemblies to the building. The implications of this damage in the worst-case scenario can result in the cladding and window elements being unable to resist the intended design loads. This loss of attachment capacity does not necessarily result in failure or collapse, although clearly the risk increases. In order for failure to occur the assemblies must be subjected to loads that exceed the resistance of the attachment. Due to margins of safety that are inherent both in the determination of loads and in the assessment of capacity, collapse or other catastrophic failures rarely occur. However, there have been examples of cladding falling from high-rise buildings due to the presence of damage and loads that approach the design values. See Photos A-1 and A-2.

Photo A-1: Stucco cladding fell from north side of this high-rise building during high winds in late November 1998. The yellow indicates new sheathing in the area where cladding fell.

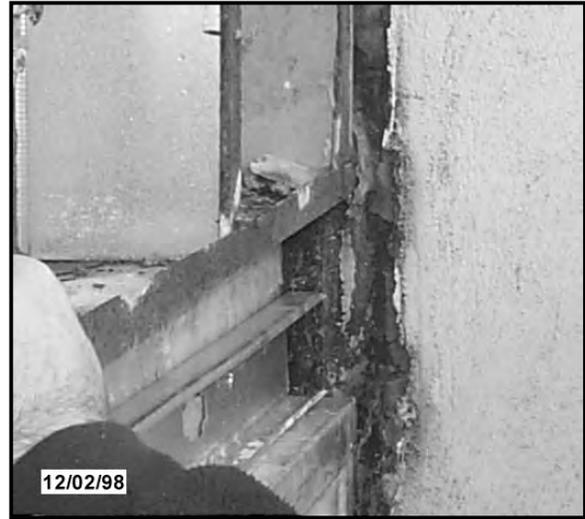
Photo A-2: Wet gypsum board sheathing, corrosion of steel studs and fasteners result in lower capacity of attachment. When combined with high winds (considerably below design loads) failure occurred.
