ICF Field Testing Report

BC Ready-Mixed
CONCRETE
ASSOCIATION

RDH BUILDING
SCIENCE

ASTM E1105 Window Test Report: HPO Test Module 1
ICF Testing Phase 3

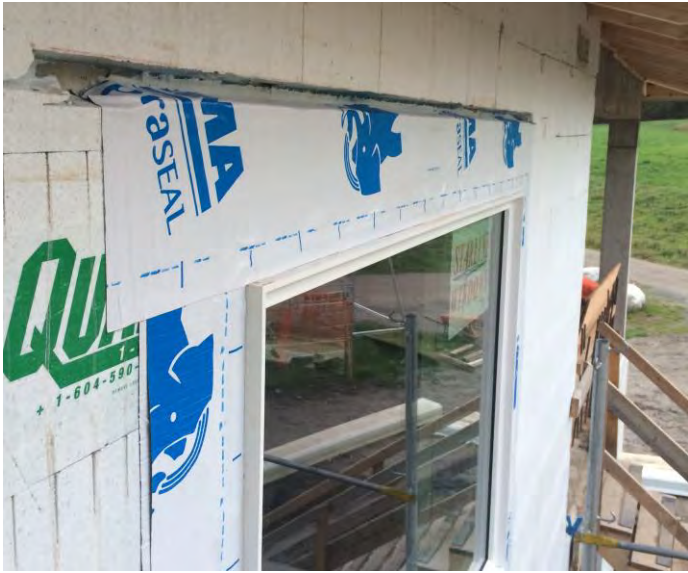
Fig. 3.1.5 Reglet cut into EPS, sealed to concrete, and sloped at 15 degrees to facilitate water shedding and drainage.

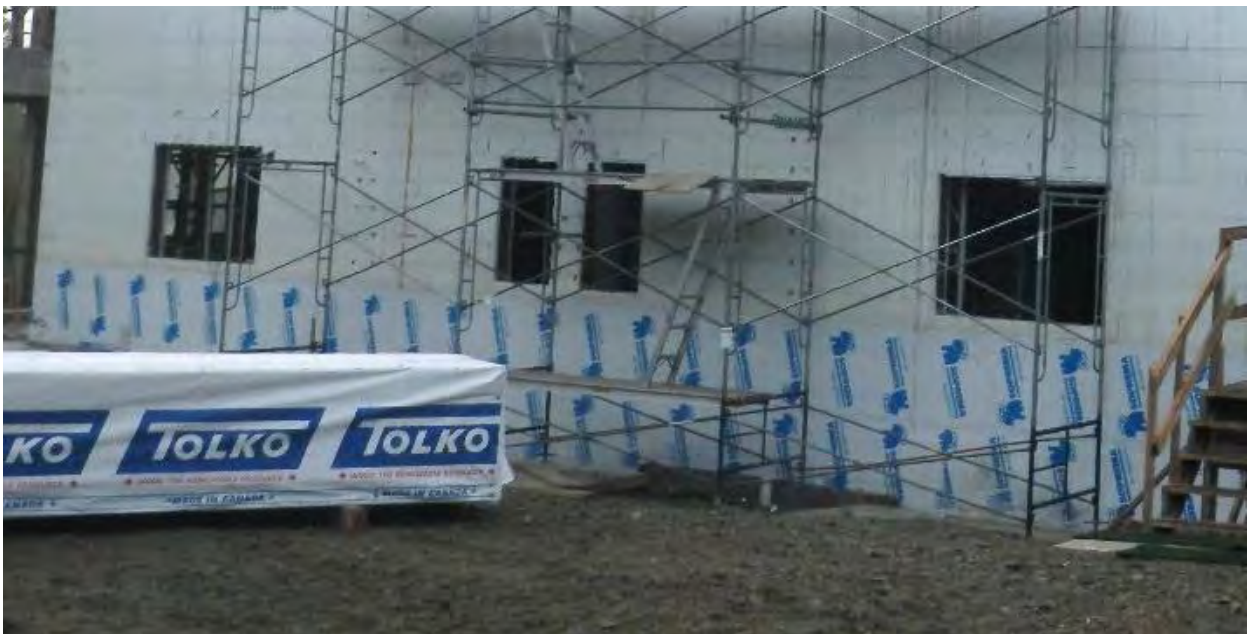
In addition to testing the four window installation methods, the below grade waterproofing membrane and interior of the ICF was also inspected for water penetration from the testing above. The below grade waterproofing membrane consisted of a self-adhesive bituminous membrane fully adhered to the exterior surface of the ICF (Figure 4.2.1).

Fig. 4.2.1 Waterproofing membrane terminating on exterior face of ICF foam, with leading edge fully adhered to ICF foam.

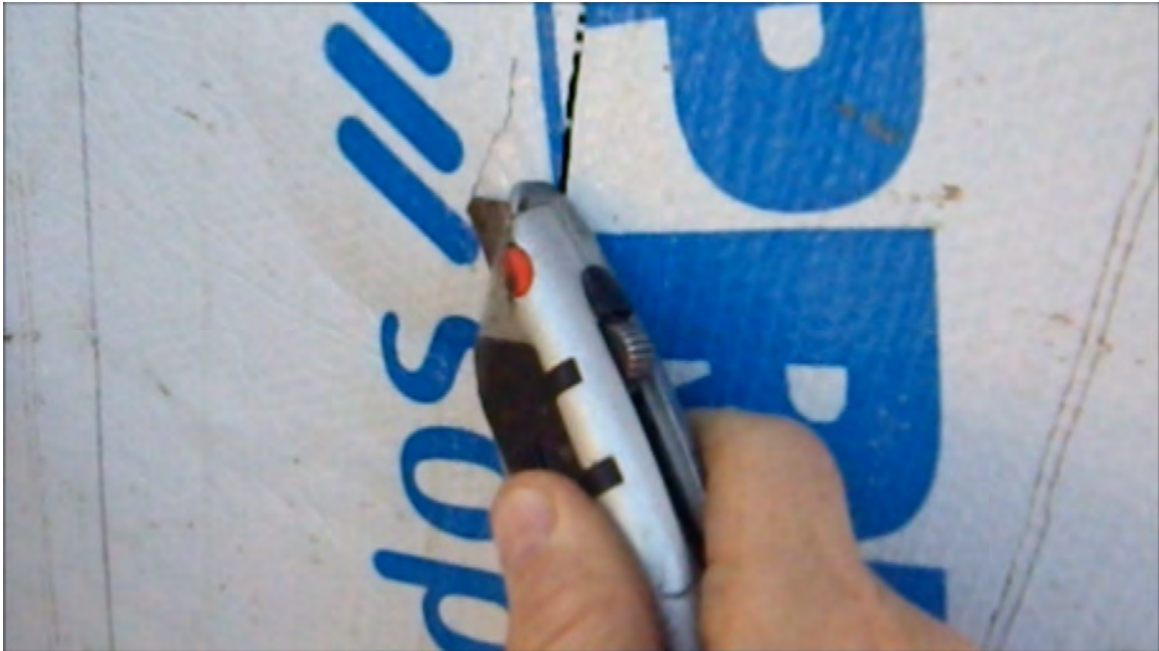
During the course of water penetration testing, water was sprayed on the exterior face of the ICF and was found to be infiltrating between the joints of the ICF units. Once in the ICF joints, the water was able to run down inside the ICF foam layer between the waterproofing membrane and the concrete core. This water was able to accumulate behind the waterproofing membrane and create water filled blisters. A small cut was made through the waterproofing membrane at a blister, and water immediately leaked out (Figure 4.2.2). The observed water leakage path is a result of utilizing a water-resistant core approach for the weather resistive barrier for the above grade portion of the ICF wall and a face sealed waterproofing membrane for the below grade portion of the wall without an effective tie in between the two systems. On the test building, a traditional breathable building wrap was specified for the weather resistive barrier. When this is installed and shingled over the waterproofing membrane at grade it will resolve this issue. If this building was designed to utilize a watertight core approach, the below grade waterproofing membrane could be sealed to the core similar to the head of Modules 1 and 3 and this would also resolve the same issue by eliminating the leakage path.

Fig. 4.2.2 Water leaking out from behind waterproofing membrane.

Where an ICF exterior surface waterproofing strategy such as Module 2 is not used, a suitable through wall flashing is recommended between the concrete core and the exterior surface of the ICF at all penetrations and horizontal transitions above adjacent enclosure assemblies such as windows and waterproofing.

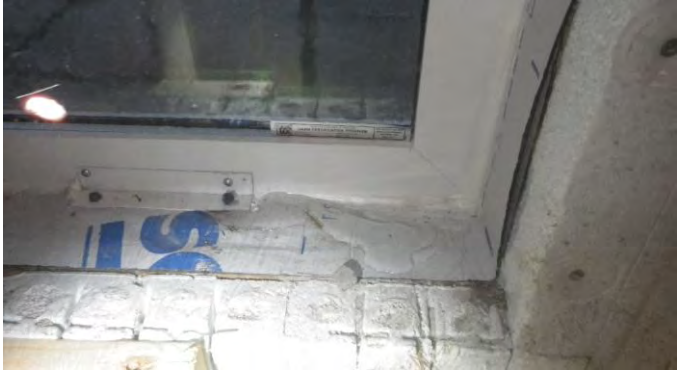
TABLE 3.3.1 WATER OBSERVATION POINT	
Water Penetration Point	P1
Location	Bottom right corner through a fastener that penetrates the window sill membrane. The water ingress was from between the membrane and the wood buck.
Time	1 minute
Volume of Water	Large pool
Photo

- After the test was completed the sill anchor at P1 location was removed and SAM window wrap was pulled up to confirm that the leakage that occurred at P1 was a result of water entering under the SAM and through the sill angle fastener onto the sill.
- The SAM wrap at the jamb was also removed and the water was found to be leaking from the top left corner of the window from between the wood buck and the SAM window wrap membrane

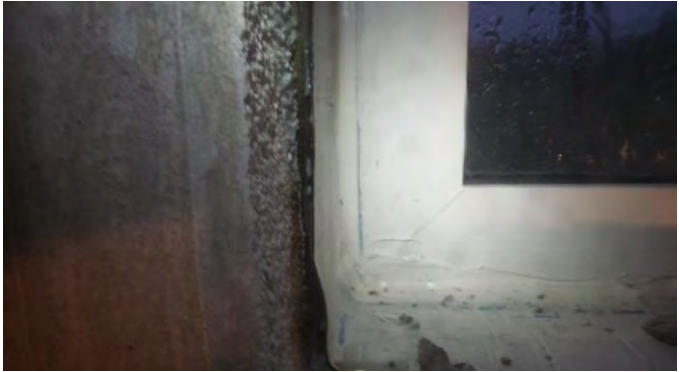
TABLE 3.3.2 WATER PENETRATION POINT	
Water Penetration Point	P2
Location	Top left corner between the wood buck and the SAM. The water ingress was from between the membrane and the wood buck.
Time	3 minutes
Volume of Water	Small pool
Photo

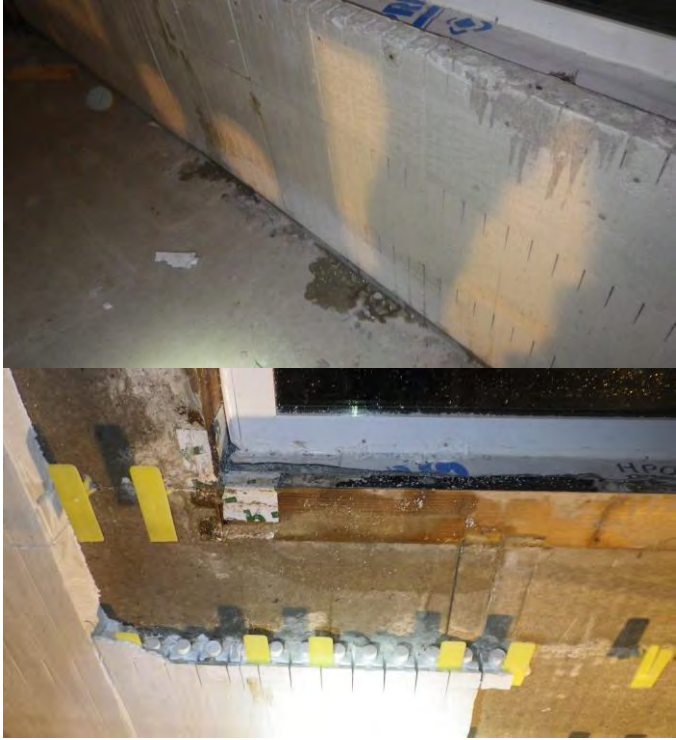
TABLE 3.3.3 WATER PENETRATION POINT	
Water Penetration Point	P3
Location	Bottom left corner between the wood buck and the ICF wall.
Time	Observed after test when the chamber was removed
Volume of Water	Large pool
Photo

TABLE 3.3.4 TEST RESULTS	
Result	Fail 700 Pa

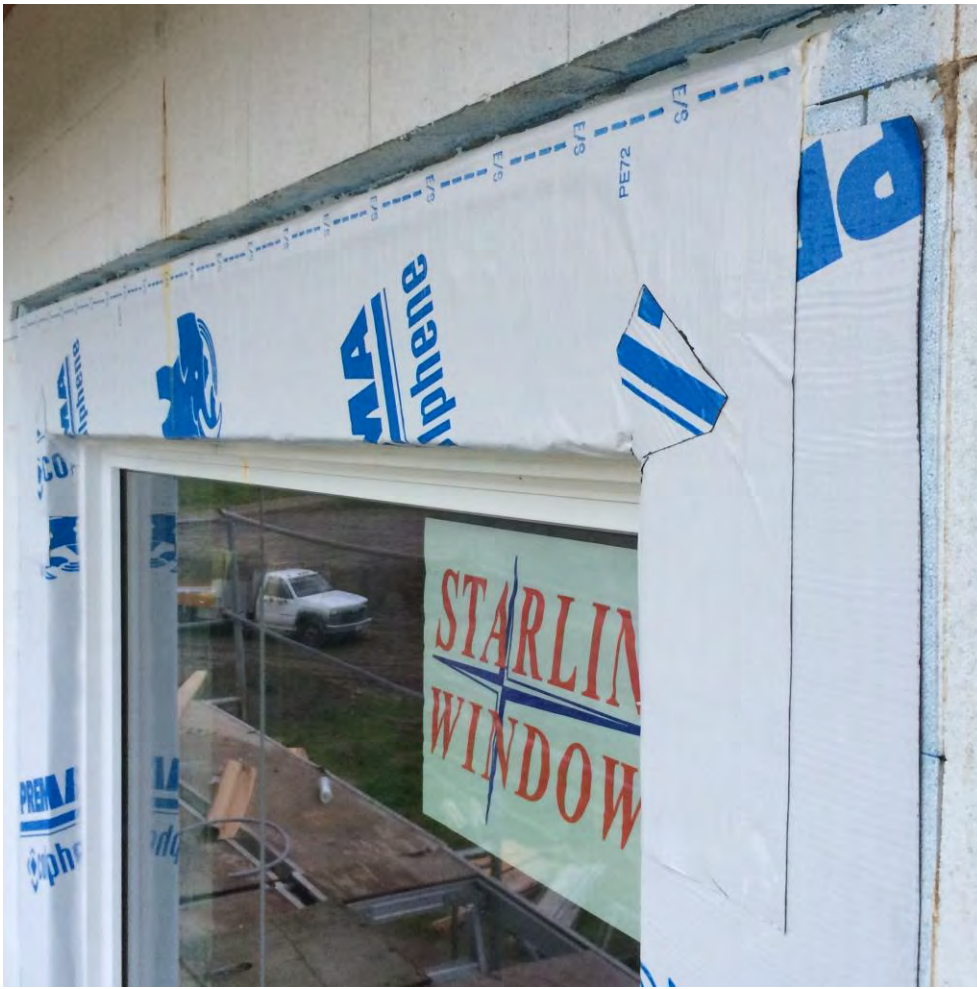
Figure II.1 Exterior of module 1 with window installed. Note reglet above window, sealing window head membrane flashing to concrete core.

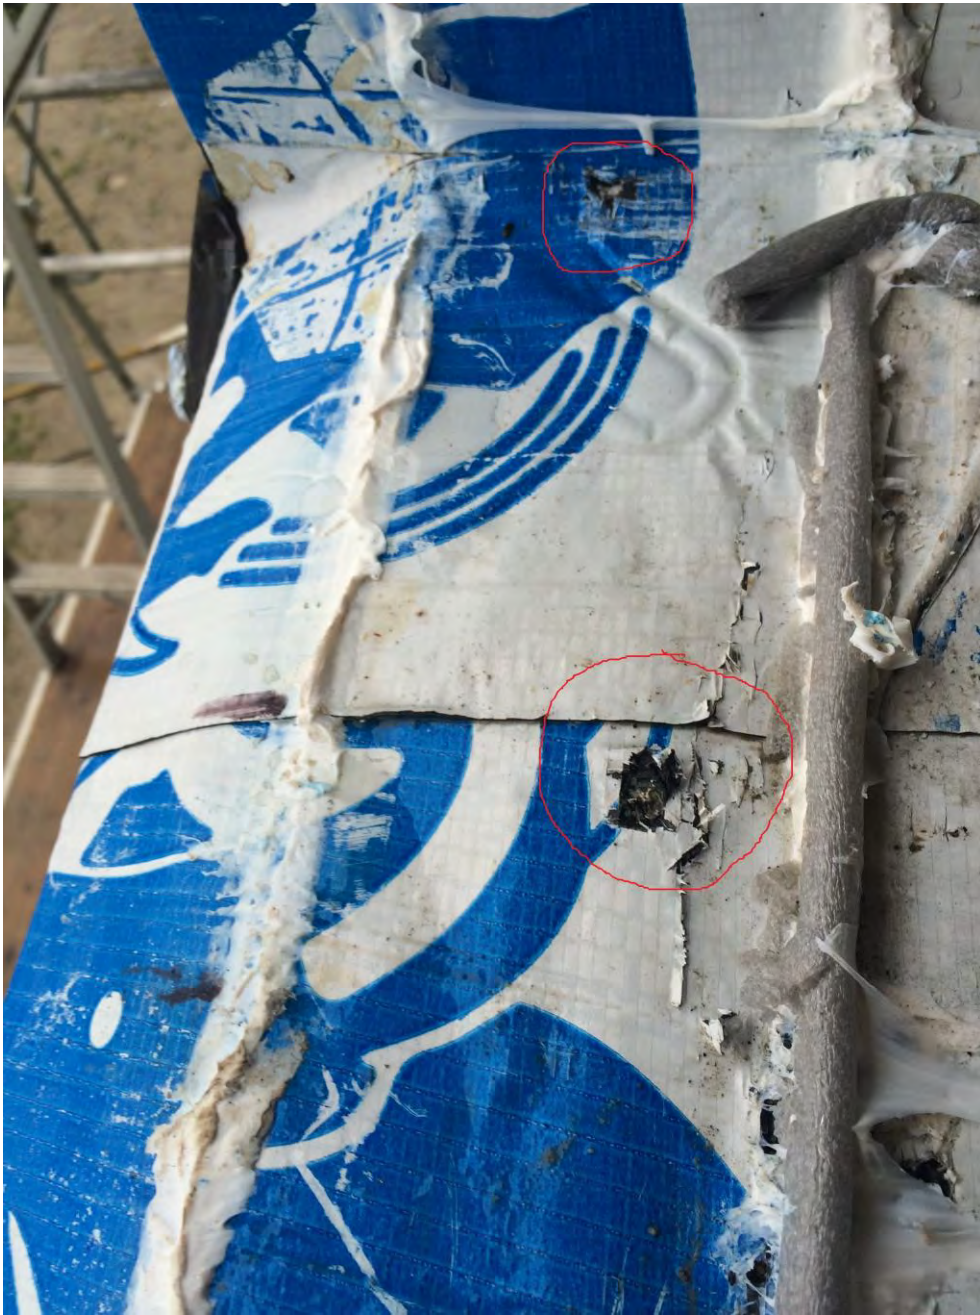
Figure II.2 Module 1 sill flashing after disassembly. Note that hole in membrane corresponds with leakage location.

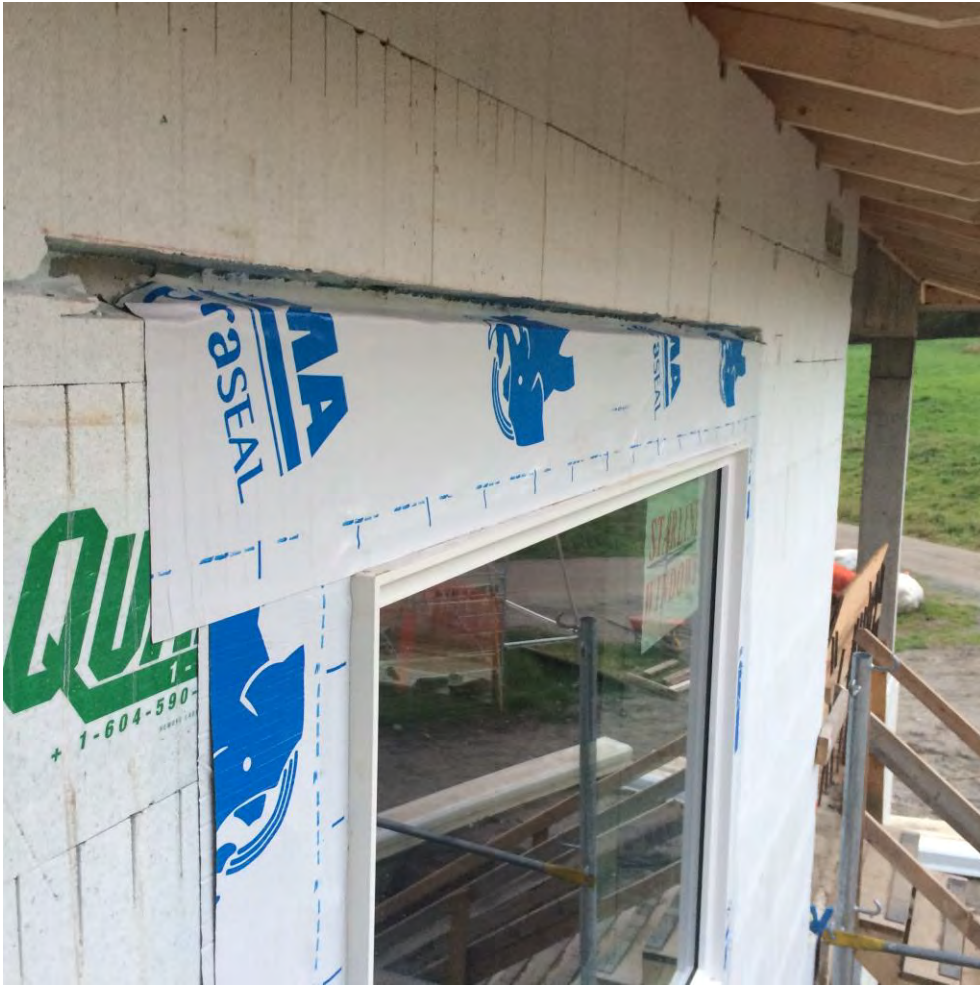
Figure II.7 Module 3 reglet above window head. Note that SAM is sealed to concrete core of ICF.

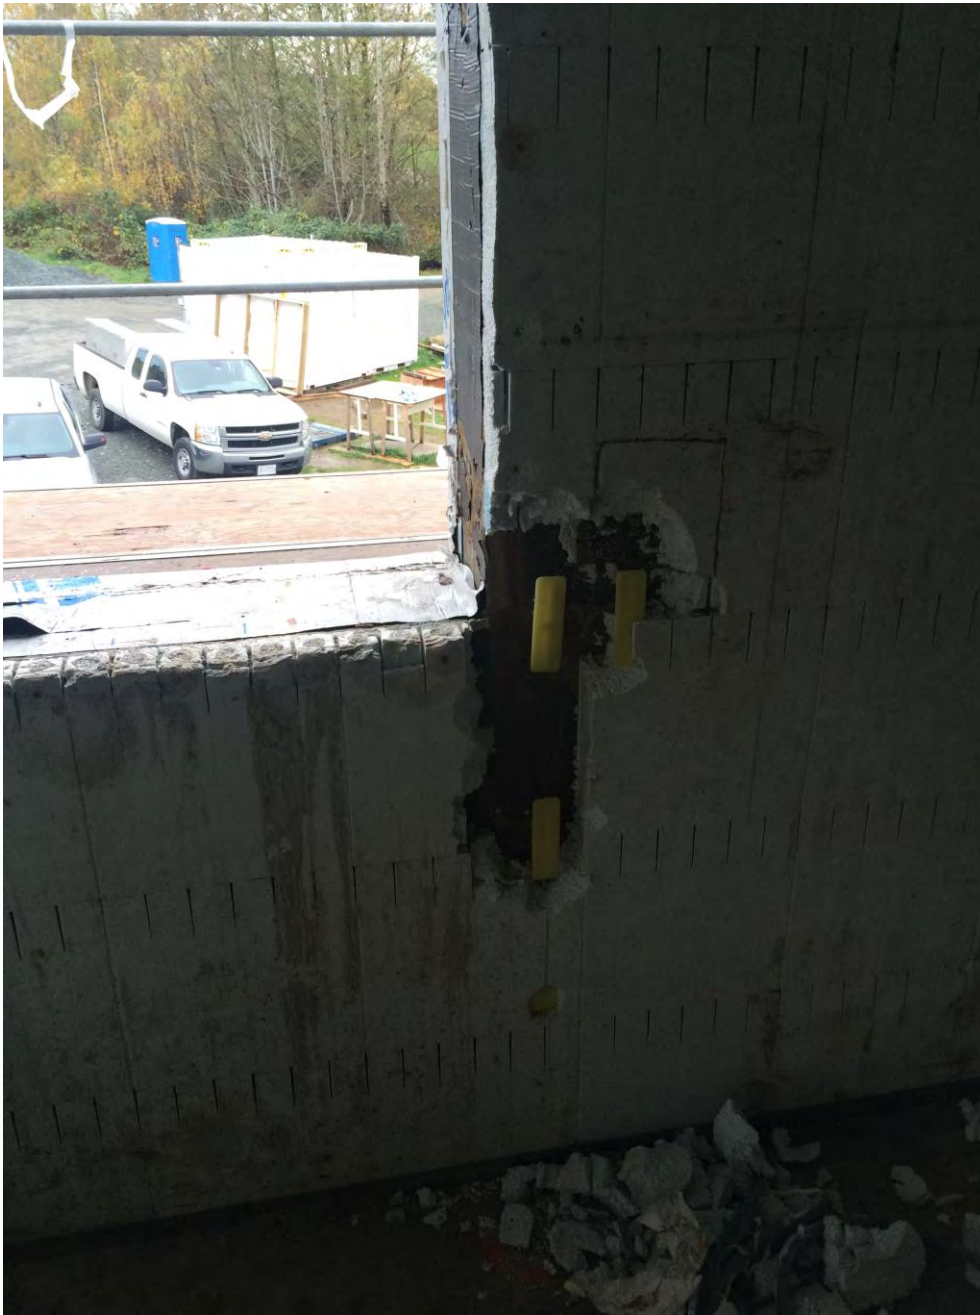
TABLE 3.3.4 TEST RESULTS	
Result	Fail 700 Pa

Figure II.8 Module 3 leakage location, below sill at corner.
