# Design Versus Actual Energy Performance in Social Housing Buildings

**BC HOUSING**

**RESEARCH CENTRE**

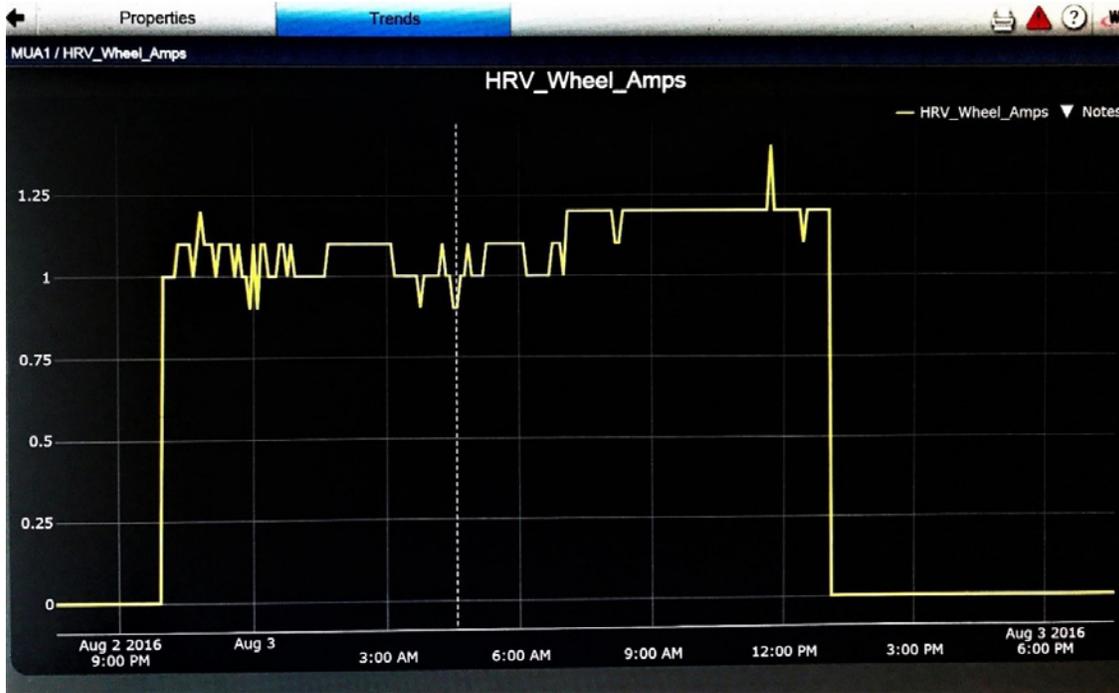
The control strategy for the thermal wheel of MAU-1 is to activate when the Outdoor Air Temperature (OAT) is lower than 18°C. During summer nights, the HRV wheel cycles between on and off based on the OAT as shown in Figure 4.39 and Figure 4.40. The operation of heat recovery during the cooling season can negatively impact energy consumption and possibly increase the maintenance costs due to equipment wear and tear. Free cooling by disabling the heat wheel is recommended during cooling months.

Figure 4.39: Trend Log Graph of Thermal Wheel Amps during August 2016

Figure 4.40: Trend Log Graph of Outdoor Air Temperature during August 2016
