## At-Grade and Below-Grade Assemblies

#### Maintaining your building envelope

This publication is one in a series of bulletins designed to provide practical information on the maintenance of the building envelope of multi-unit residential buildings, including townhouses, low and high-rise residential buildings.

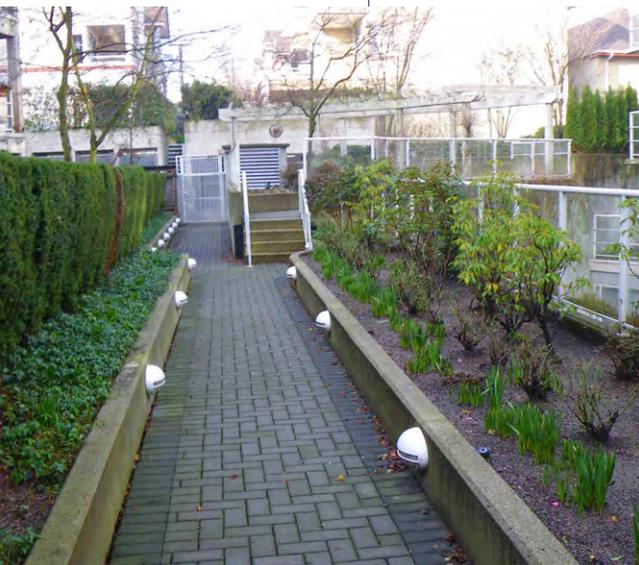
A typical courtyard at-grade assembly. This courtyard features many different types of overburden, making access to the underlying membrane difficult.

A typical at-grade assembly comprises overburden materials, a waterproofing membrane and a concrete slab forming the roof above the below-grade portion of the building. The concrete slab is often referred to as the podium. Examples of overburden materials include hard landscaping (patios, walkways, roads, stairs and planter walls) and soft landscaping (grass, shrubs and trees). Water features are also becoming increasingly common. Given these overburden features, it can be difficult and expensive to access the waterproofing membrane on the concrete podium slab for review, maintenance and renewal.

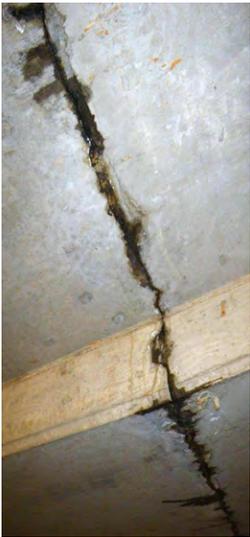
Water ingress through a crack in the concrete slab.

If it is not economical to access the membrane, and the extent of the water ingress, steel corrosion, and concrete delamination is acceptable, water ingress can be managed by sealing the leaking cracks in the concrete from the interior. A qualified contractor can be retained to inject the crack with epoxy or urethane, or the crack can be routed out and sealed with hydraulic grout. The goal is to try and push the injection material through the crack in the concrete and through the discontinuity in the waterproof membrane so that a seal is made on the wet side of the membrane. This provides the maximum protection for the reinforcing steel. However, care must be taken not to blow the waterproofing membrane completely off the concrete with the pressure of the injected material, thus creating an even larger path for water ingress.

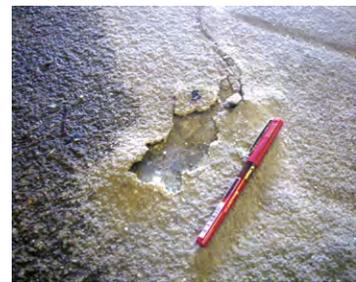
Delamination of suspended concrete slab membrane.

Unlike membranes on the podium and the foundation walls, the polyurethane traffic membrane on suspended concrete slabs is visible and can easily be reviewed and maintained. This system should be reviewed annually for signs of distress, such as tears, cracks, delamination and discoloration. Distressed areas, or areas with water leaks, can be repaired by a qualified contractor. The main areas of wear are typically drive isles and turning areas. In these areas the wearing surface, consisting of the top layer with embedded granules, will wear down over time. It is important to inspect this layer and renew it on an as-needed basis to prevent damage to the relatively fragile waterproof portion of the membrane below.

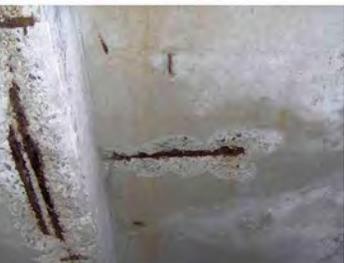
Corroding reinforcing steel and delaminated concrete.

Annual reviews for water ingress should also be conducted. If water leakage has caused visible rust stains on the concrete, the areas around the stains should be sounded by tapping the concrete with a hammer and listening for hollow sounds. Hollow sounds indicate delaminated concrete. If water ingress is increasing in frequency and severity, or if concrete delamination or spalling is occurring, a knowledgeable contractor or consultant should be retained to investigate the issue.
