# BUILDER INSIGHT

## Bulletin No 11 | Vienna House

# Lessons Learned from Moisture Management

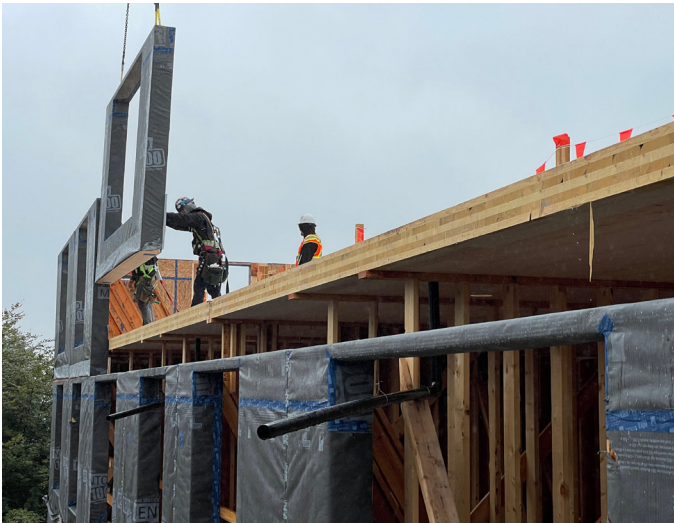
Figure 2. Installation of exterior wall panels (source: Scius)

The exterior panels are stacked and offset below the floor level to maximise panel, floor and balcony connection efficiency. The building was constructed by installing the exterior walls first, followed by the interior walls, and then the CLT floors for each of the six levels above the parkade. The balconies are prefabricated aluminum that is designed to clip onto brackets attached to the structural elements.

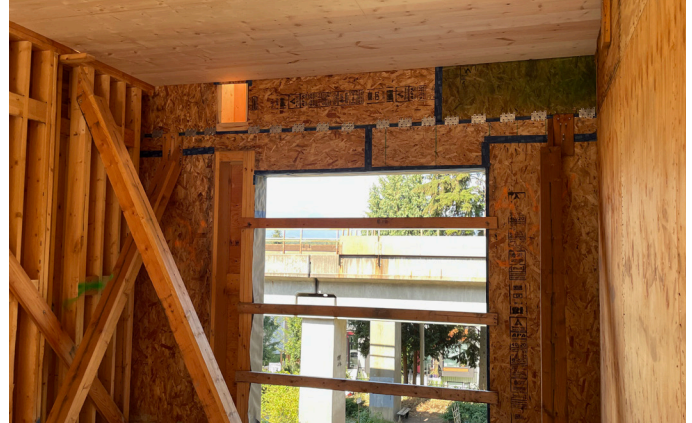
Figure 4. Interior of a suite with wall panel for above level attached. (source: Scius)

Figure 4 shows the interior of a courtyard-level (L2) suite with the exterior wall panel for L3 connected above the window opening. A cavity for tie-down rods remains open, to be filled with insulation at a later date. Figure 5 shows another suite with interior framing completed and insulation installed above the windows.

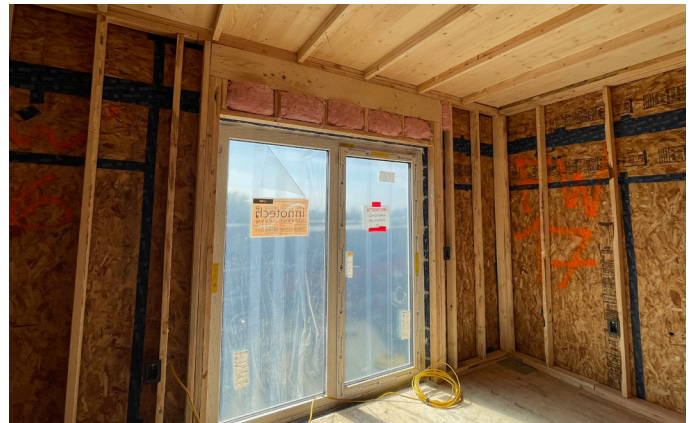
Figure 5. Another suite with interior of double-stud framing completed and second layer of insulation partially installed. (source: Scius)

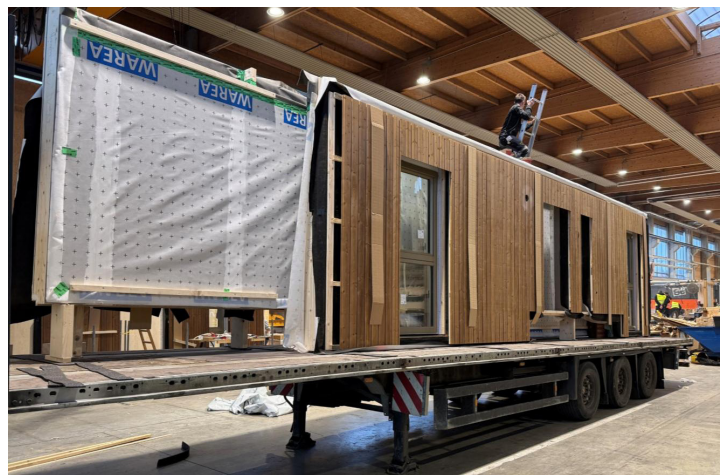
Figure 7. A wall panel at the factory loaded for delivery in Vienna, Austria (source: Rüdiger Lainer + Partner)

In Vienna, where the companion project, Vancouver House, is constructed, exterior walls often are delivered complete with windows and cladding (Figure 7), limiting their exposure to precipitation once ceilings are installed at each level. This approach requires transportation of the panels vertically, not stacked horizontally. It also requires extra care to prevent damage during craning into position and larger cranes to support the increased weight of the panels.

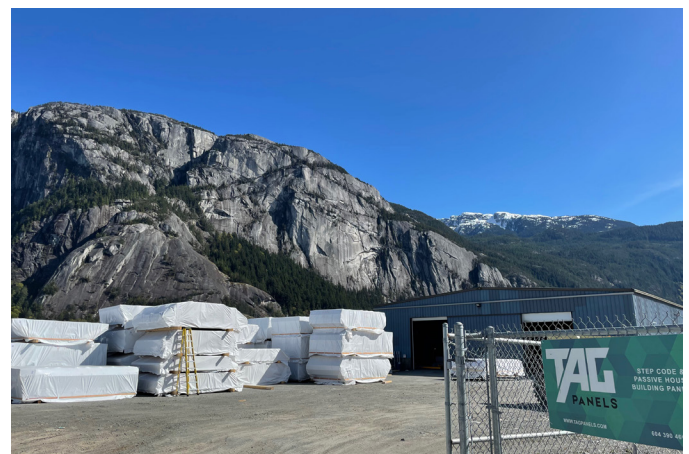
Figure 8. Panels stored inside protective coverings at the manufacturer (source: Scius)

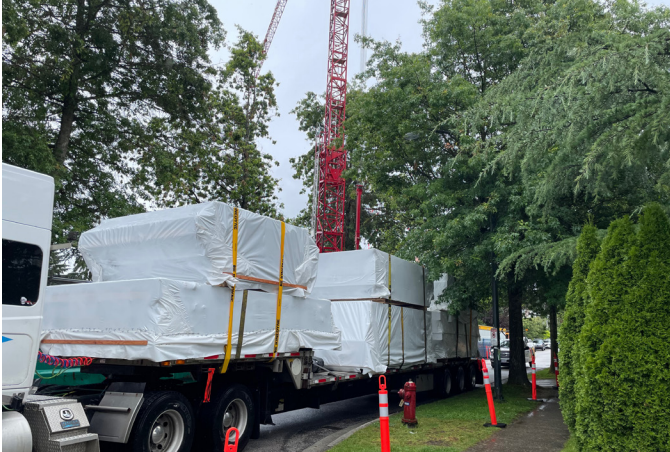
Figure 9. Panels arriving at Vienna House after transportation from Squamish (source: Scius)

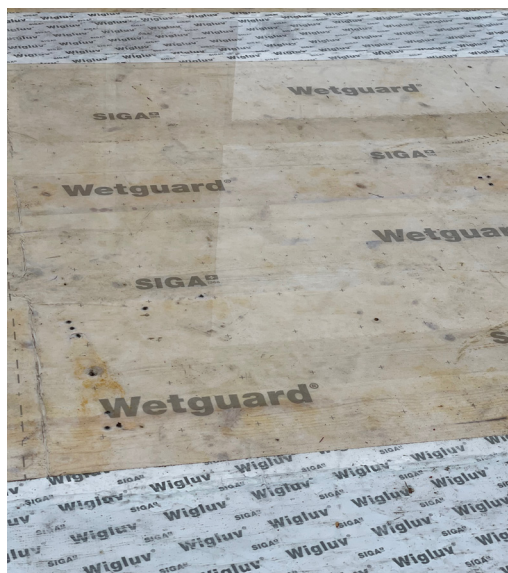
Figure 10. A weather protection membrane and taping on the top of installed CLT panels (source: Scius)

The CLT panels on every second level were delivered with a weather protection membrane to minimize exposure to moisture during installation. The moisture management plan included direction to seal joints and areas around columns with tape or a membrane to ensure a continuous moisture barrier.

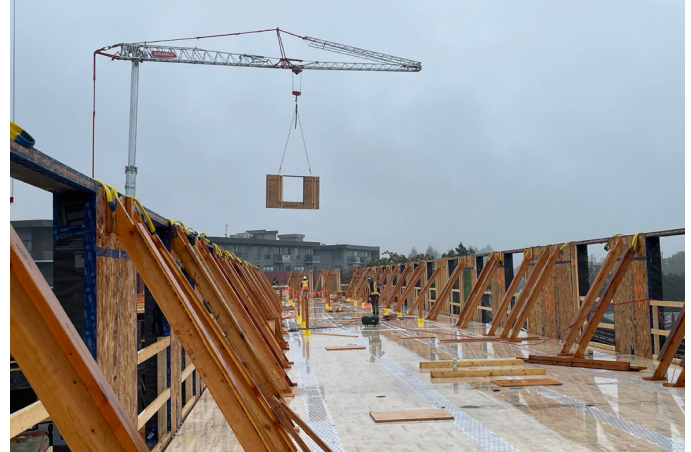
Figure 11. Exterior wall panels being installed (source: Scius)

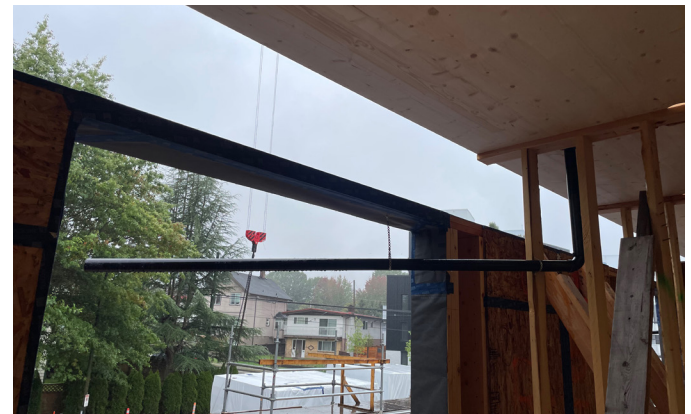
Figure 12. Water being routed to the exterior of the building with a temporary drain (source: Scius)

Pre-drilled openings in the CLT, such as those intended for future bathtub drains should be used to create temporary drains to direct water away from the building envelope.

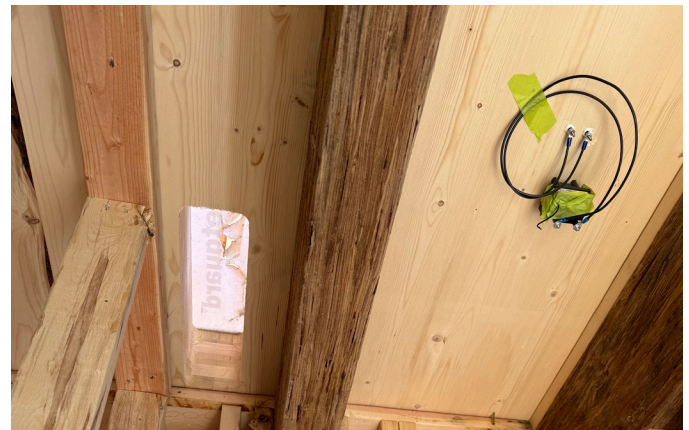
Figure 15. Sensor installed on CLT in electrical closet (source: FPIInnovations)

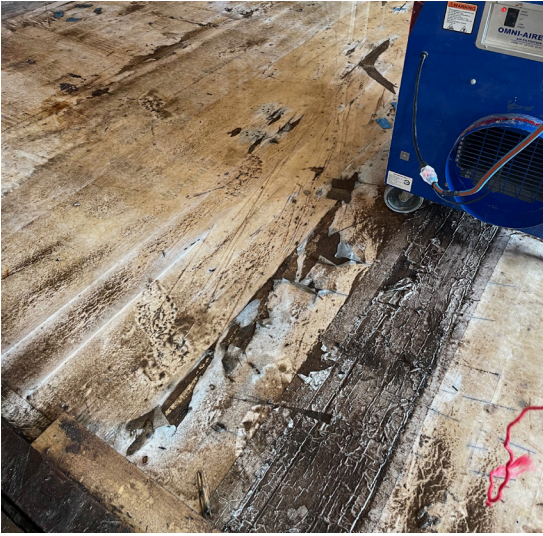
Figure 17. Damage to weather protection membrane on the CLT (source: Scius)

- The window openings and the gaps between the top of the exterior panel and the floor above exposed large areas to wind-driven rain that caused ponding on the interior and allowed water to drip down the side of the wall panels.
- Weather protection membranes on the CLT panels were damaged during construction.
- The installation of mechanical equipment on the roof provided pathways for additional moisture ingress and coincided with periods of inclement weather. Many weeks passed before ducting, insulation, and waterproofing were completed on the roof. Some water leaked through openings and down wall panels.
- Lifting points on the panels may not have been sealed, which could have provided a route for water ingress.
- Window preparations were modified after fabrication of the panels, exposing some areas to moisture.

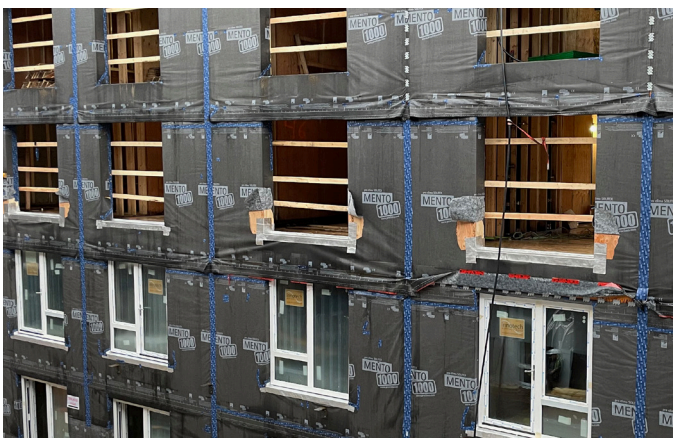
Figure 18. Preparations for window installation (source: Scius)

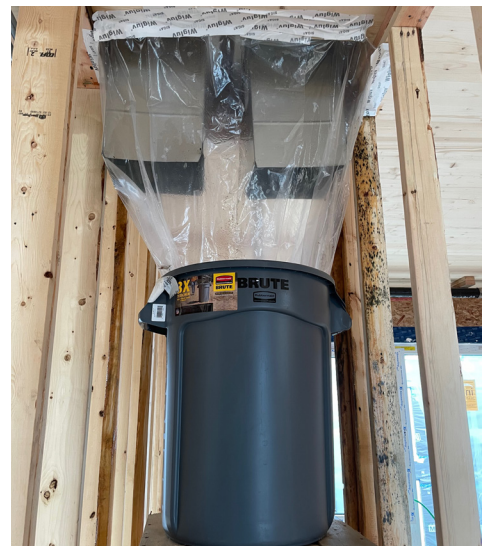
Figure 19. Collection of water seeping in from ducts (source: Scius)

Kindred Construction worked to remove moisture as it was encountered. Openings for bathroom drains were used to create temporary drains that directed water away from the building. Water was swept to these drains to minimize standing water on the floor panels. Water entering the building through roof ducts during installation was collected and removed (Figure 19). Tarps and window coverings protected openings and horizontal surfaces, but were limited because they did not remain affixed during high winds, posing a threat to the neighbouring tracks for the commuter train. Fans and heaters were used in combination with a dehumidification system (Figure 20) to gradually draw the moisture out of the walls. This effort was limited by available power with temporary electrical service and the neighbourhood mandate to avoid the use of generators outside of normal construction hours.

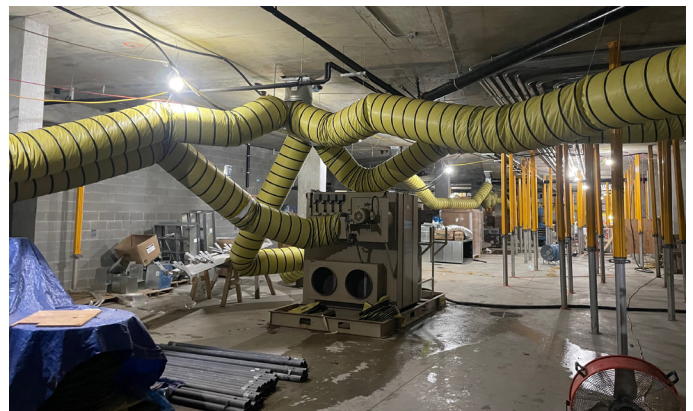
Figure 20. Dehumidification system installed in the parkade (source: Scius)
