Submitted May 12, 2017 by
RDH Building Science Inc.
224 West 8th Avenue
Vancouver BC V5Y 1N5

Executive Summary

To further explore this potential opportunity, a study was undertaken to identify how energy is consumed in mid- to high-rise (5 stories and higher) multi-unit residential buildings, and to assess the impacts of building enclosure renewals and rehabilitations on these buildings¹ (referred to as Parts 1 and 2). These findings were used to determine better building enclosure design strategies to reduce energy consumption and associated greenhouse gas emissions, while considering the other building functions for both new and existing buildings. The study found that significant energy savings can be achieved by incorporating energy conservation measures into a building enclosure renewal or retrofit project.

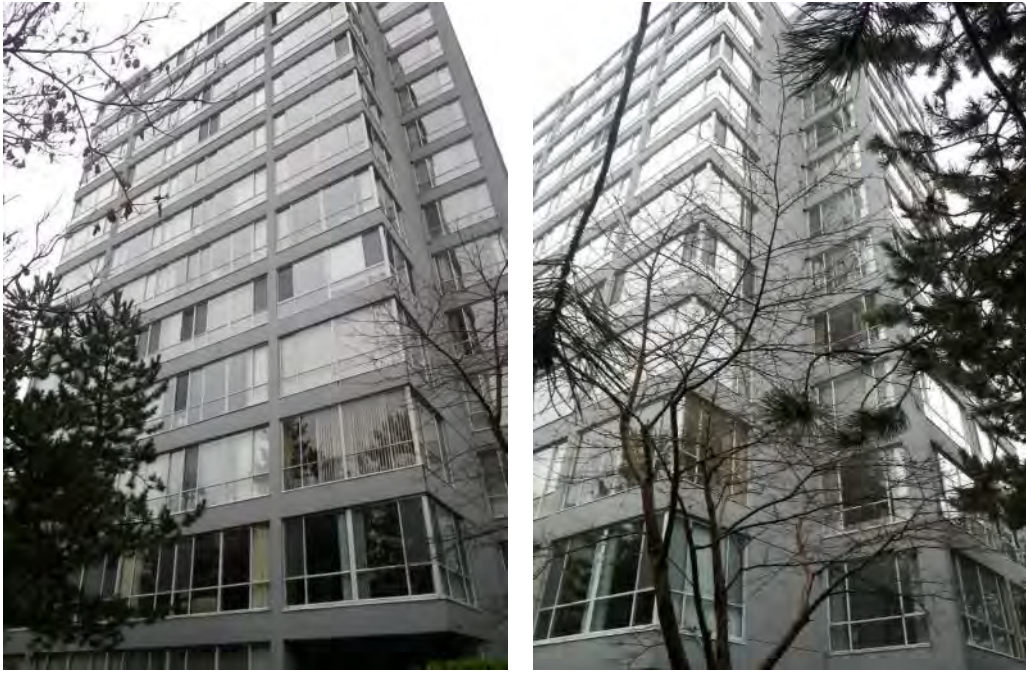
Figure 2.1 North elevation (left) and partial north and west elevations (right).

Originally constructed in 1986, the retrofit building is a 13-storey residential building on the west side of Vancouver. The building has a gross floor area of approximately 54,000 ft² (≈5,000m²), with 37 residential strata units. Glazed windows and doors make up 51% of the vertical enclosure area. Elevations are shown in Figure 2.1 and Figure 2.2, prior to the retrofit work. Figure 2.3 shows a drawing of the retrofit building with the proposed retrofit colour scheme and the partial floor plan.

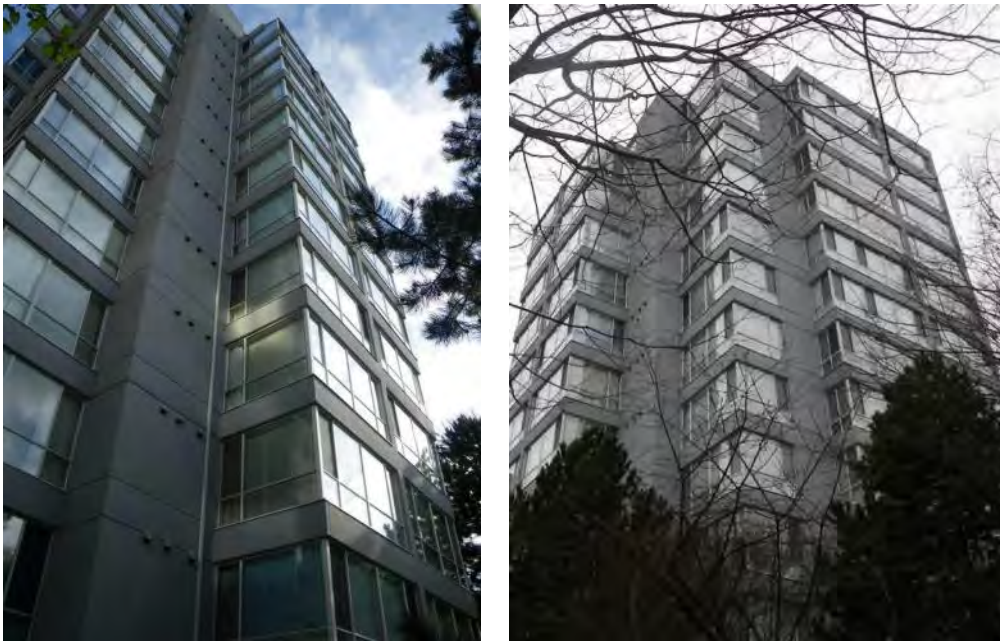
Figure 2.2 Partial south elevation (left) and partial south and east elevations (right).

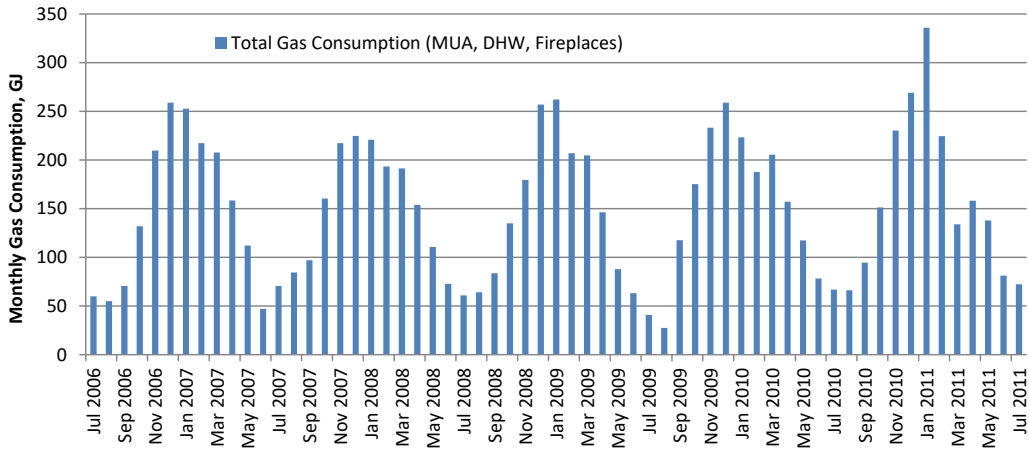
Figure 2.7 Electricity consumption, July 2006 through August 2011.

Figure 2.7 and Figure 2.8 show the metered monthly electricity (kWh) and gas (GJ) consumption for July 2006 through July 2011. Electricity consumption is shown for all suites combined (labeled "suites"), and all common usage (labeled "common"). Total gas and electricity consumption is shown in Figure 2.9 in common energy equivalent units of kWh (measured GJ is multiplied by a conversion factor of 277.8). Analysis of the five years of data indicates that approximately 55% of the building energy consumption is from electricity, and 45% is from gas. Seasonal trends are observed in both the gas and electrical energy consumption at the building; gas is influenced primarily by the make-up air unit heating and fireplaces, while electricity is influenced primarily by the electric baseboard heaters in the suites and lobby. Other factors may result in lesser seasonal trends, such as varying municipal water temperatures impacting DHW and daylight hours impacting lighting energy. Water consumption was not obtained for this study.

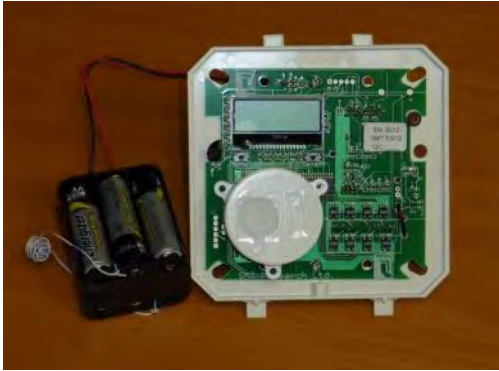
Figure 3.1 SMT-A3 unit with attached battery pack shown without faceplate. An LCD screen is provided to interact with the unit. Temperature and relative humidity sensors are located to the left of the LCD screen; the CO₂ sensor is round and white, and the pressure sensor is located on the back of the unit with a tube running out to a hole on the middle top of the right side.

The SMT-A2s and A3s were used in a variety of configurations as shown below in Figure 3.1 to Figure 3.5. Primarily the SMT-A3 configuration was used and mounted into the wall with a faceplate cover for aesthetics.

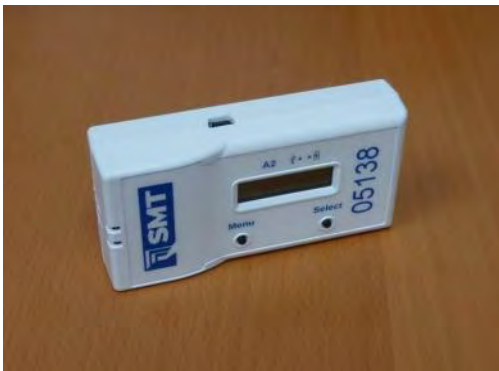
Figure 3.3 SMT-A2 unit. An LCD screen is provided to interact with the unit. Temperature and relative humidity sensors are located within the unit, and ports are provided on the bottom of the unit to attach external sensors.

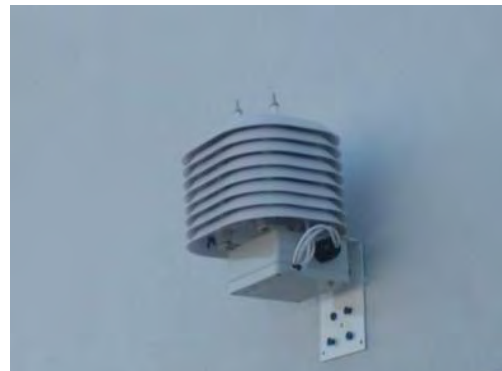
Figure 3.4 SMT-A3 unit installed in a waterproof enclosure for use outside. The SMT-A3 unit is contained in the box on the bottom, and the temperature, relative humidity, and CO₂ sensors are installed within the shroud on top of the box.

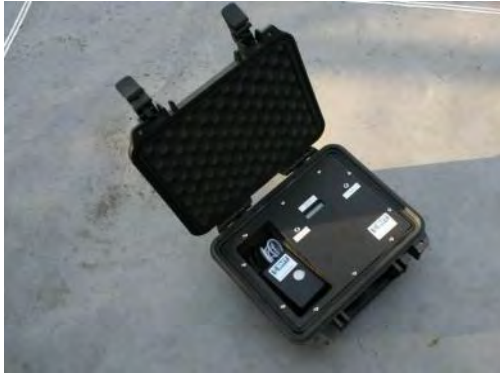
Figure 3.5 SMT-A3 floater unit in an outdoor waterproof case.

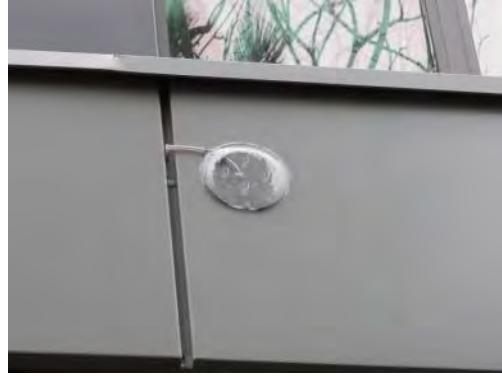
Figure 3.6 Exterior pressure tap with cover to protect the end of the tube from water.

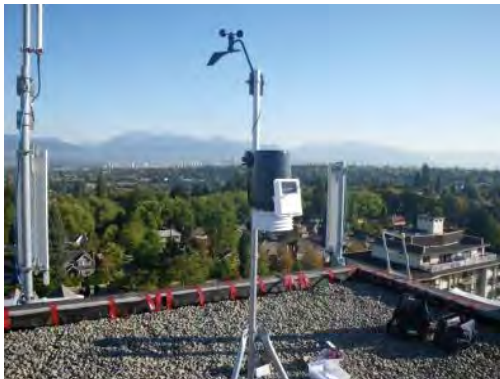
Figure 3.7 Weather station installed on roof of retrofit building to measure temperature, relative humidity, solar radiation, wind speed and direction, and barometric pressure.

The weather station was manufactured by Davis Instruments Corp. and configured to upload data to Building Analytics for ease of access to the data. The weather station and one of the two BiGs are shown in Figure 3.7 and Figure 3.8 respectively.

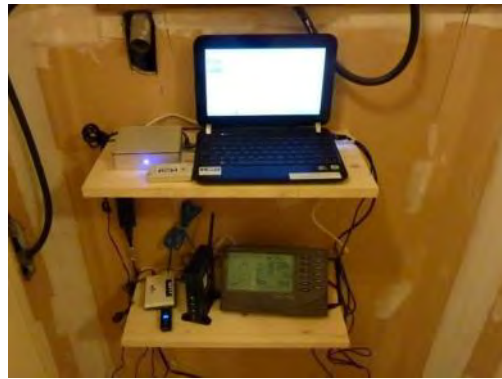
Figure 3.8 One of two BiGs (laptop) located in an electrical closet to communicate with data acquisition units distributed throughout building. The weather station console and communications equipment (to access the internet) are also visible on the lower shelf.

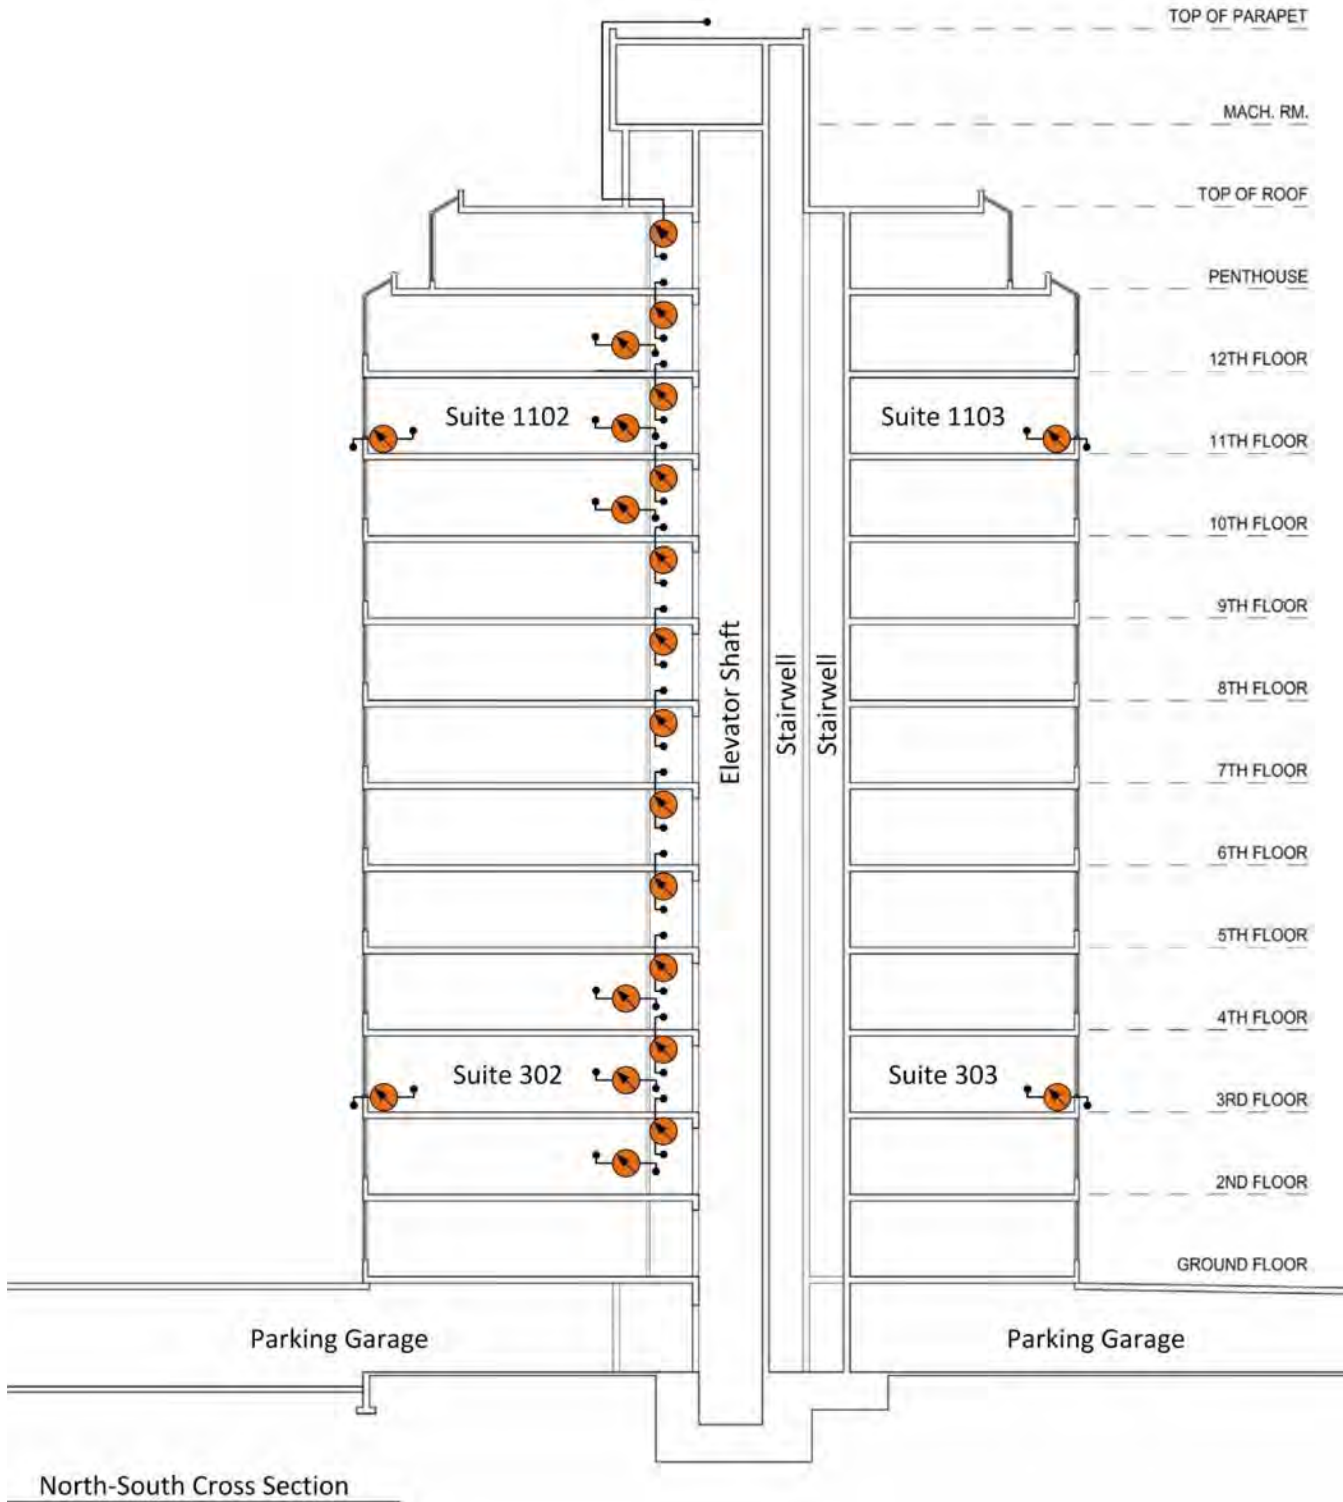
Figure 3.17 North-South cross-section showing schematic pressure sensor layout. The pressure sensors can all be referenced to each other since they “hop” from one zone to the next. (Note that not all pressure sensors are shown.)

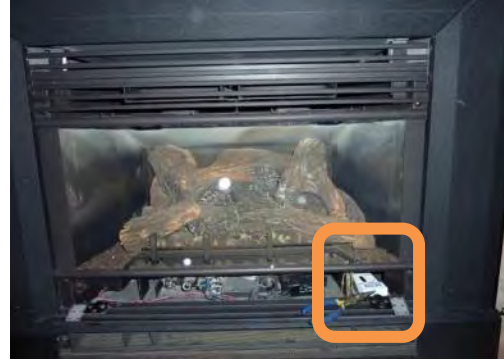
Figure 3.19 Typical SMT-A2 installed under a fireplace. A temperature sensor is installed near the pilot light to provide an indicator of fireplace use.

Installed sensors are shown in Figure 3.18 and Figure 3.19.

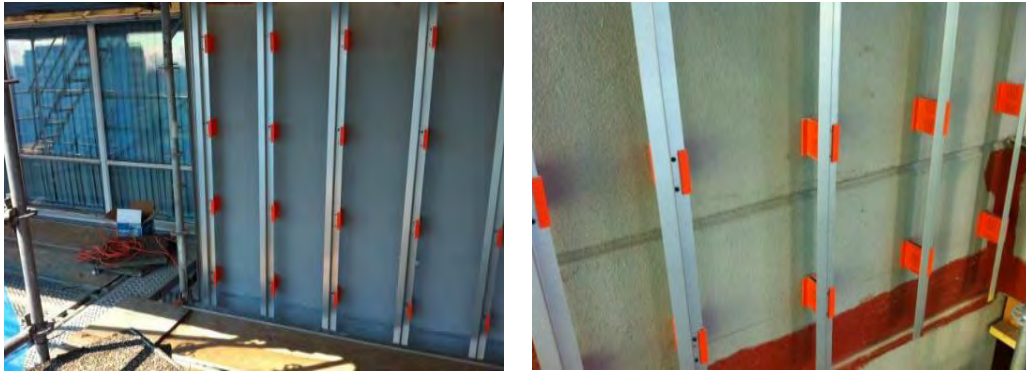
Figure 4.1 Fibreglass clips and z-girts are screwed to the exterior concrete walls.

The walls were insulated with 3.5 inches of mineral wool insulation at the exterior. A key component of this assembly was the use of fiberglass clips to attach the cladding outside of the insulation, to reduce thermal bridging and result in a better insulated wall assembly (refer to Section 2 for details). New cladding was installed, which consisted of a combination of stucco and metal panels. Figure 4.1, Figure 4.2 and Figure 4.3 show photos of the insulation and overcladding installation.

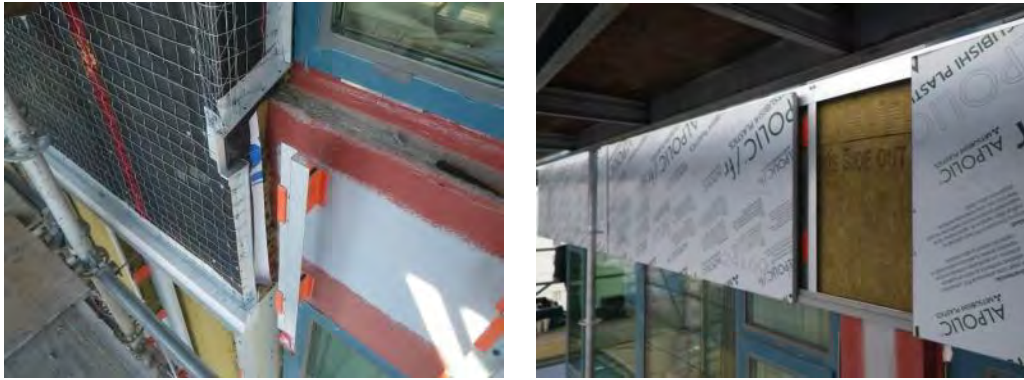
Figure 4.3 Stucco (left) and metal panels (right) are installed over the insulation.

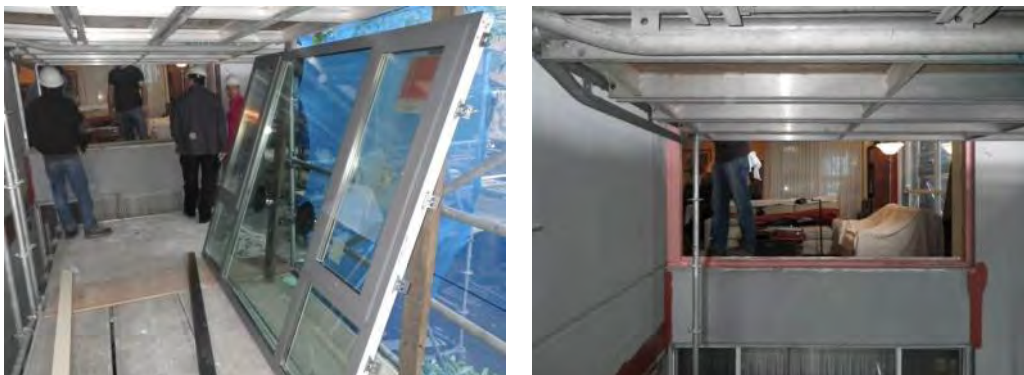
Figure 4.4 Installing the new triple glazed fiberglass frame windows.

The window installation was planned such that each unit's windows were changed within a single day, so that owners only needed to provide suite access on one day, with one additional follow-up visit needed to perform interior repairs (though this scheduling may not be possible on all projects). Water testing was performed on a sample of installed windows to ensure that the installation and window met water penetration resistance requirements. Figure 4.4 and Figure 4.5 show photos of the window installation and the water testing.

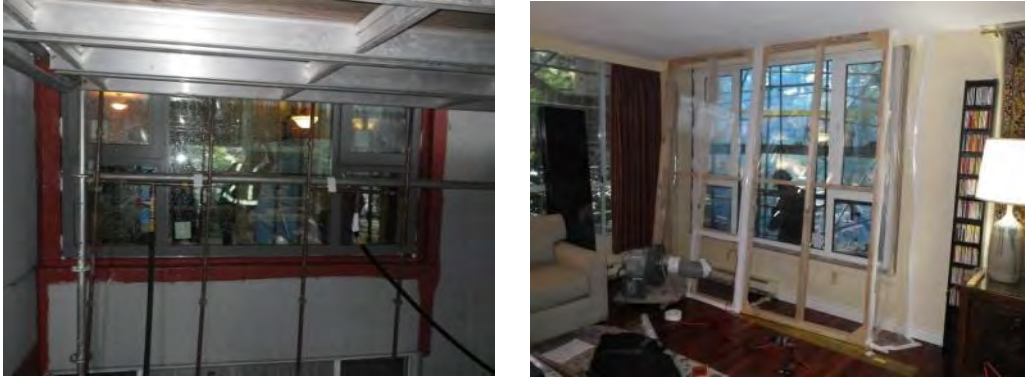
Figure 4.5 Testing the new windows for water penetration resistance.

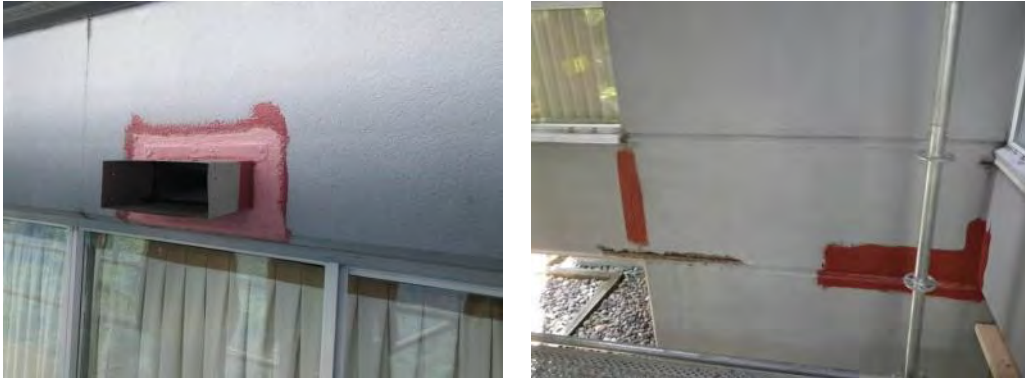
Figure 4.6 Airtight detailing around vents (left) and partial installation of a liquid applied barrier over concrete cracks and cold joints (right).

The cast in place concrete walls at the existing building were relatively air tight; however, air leakage occurred through joints and penetrations, particularly at the windows. As a result, the design decision was made to utilize the existing concrete wall as the air barrier and backup water resistive barrier. In order to do so, liquid-applied membrane was typically installed at cracks and cold joints in this wall. Air-tight architectural details were developed for joints and interfaces at the building. The details at all windows, joints, and penetrations included continuous air barrier achieved through a combination of products including liquid applied membranes, self-adhered membrane, and sealant. Figure 4.6 shows examples of the air barrier installation at cracks, joints and penetrations.

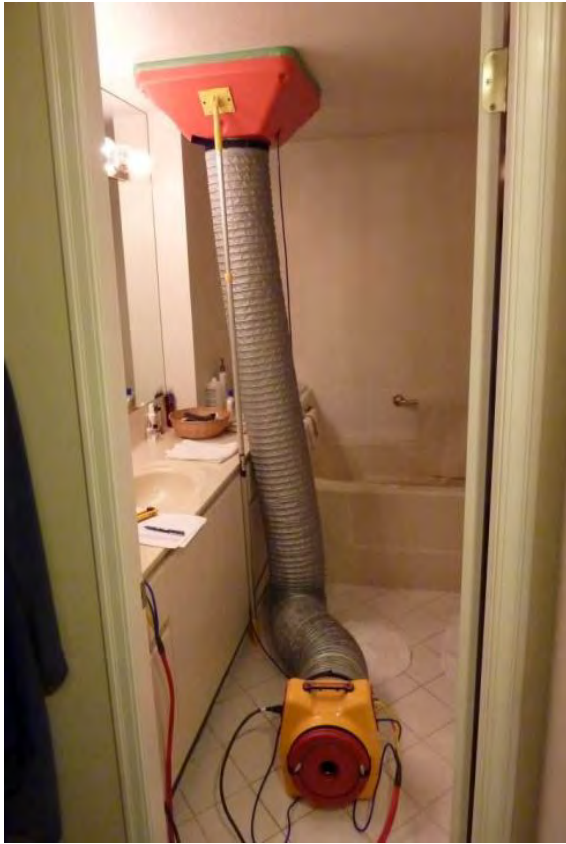
Figure 5.1 Retrotec DucTester being used to test a bathroom fan.

To test the bathroom fans, a single point was measured at a pressure difference of 25, 50, 75, and 100 Pa using the Retrotec Inc. (Retrotec) DU200 DucTester, flex-duct, and flow hood as shown in Figure 5.1. This apparatus allows for the application of a pressure difference across the fan and duct and the measurement of the airflow rate using the calibrated fan. This testing was initially conducted as part of building investigations not part of the scope of this project; however, the data collected from the tests that is applicable to the analysis of the enclosure airtightness testing results is provided in this report.

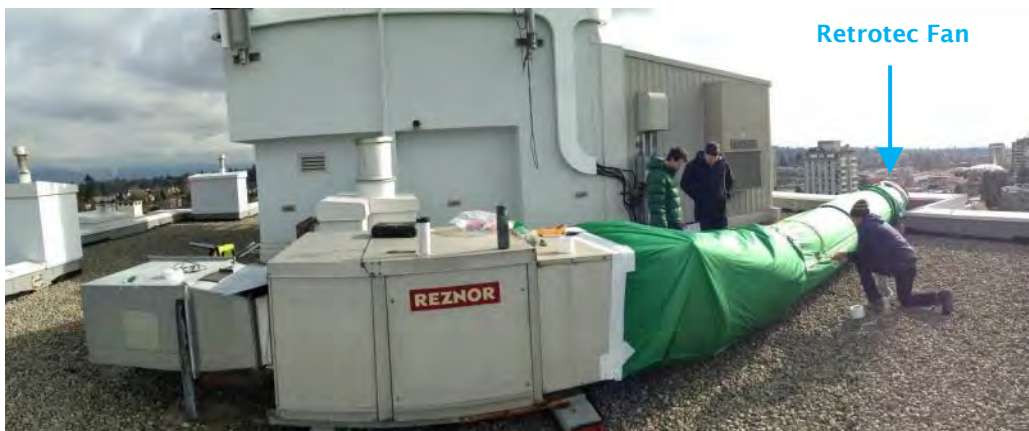
Figure 5.2 Custom made MAU testing apparatus with green flex-duct to attach Retrotec fan to the MAU intake.

A similar apparatus to that used for the bathroom fan measurements was used to measure the intake airflow rate of the make-up air unit (MAU). Since the flow rate of the MAU is much higher than that of a bathroom fan, a larger Retrotec fan typically used for airtightness testing was used to measure the flow rate. It was connected to the MAU intake with a custom-made flex duct system as shown in Figure 5.2.

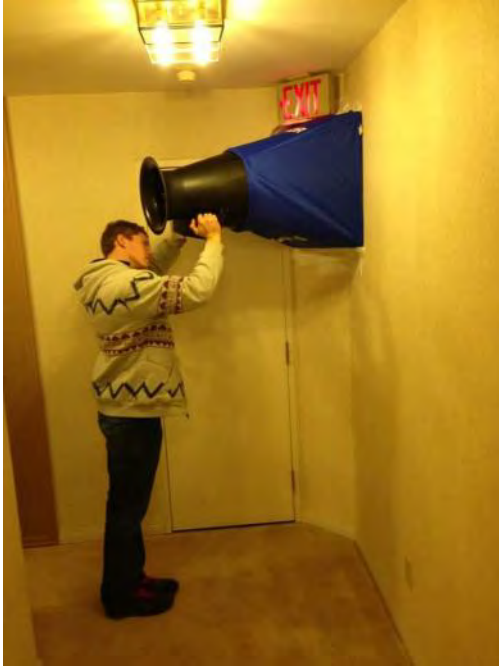
Figure 5.3 Balometer being used to measure airflow supply rate to a corridor from the MAU.

The MAU supply flow rate to each corridor was also measured using a balometer, and a smoke pencil was used to confirm the flow direction as shown in Figure 5.3 and Figure 5.4.

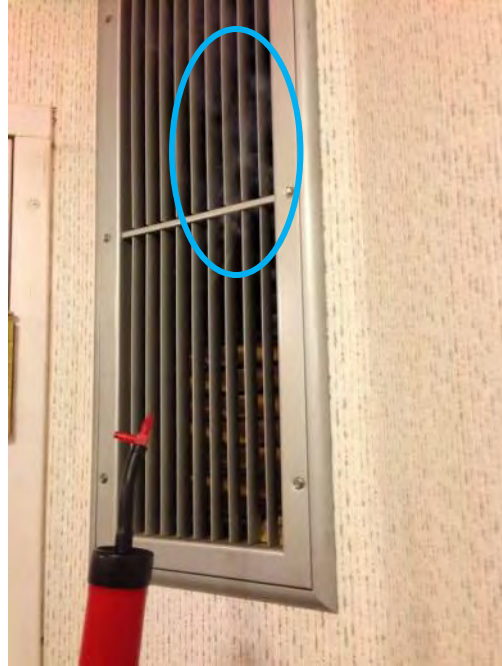
Figure 5.4 A smoke pencil being used to check the airflow direction out of the MAU grille with the MAU off showing smoke flowing back into the MAU duct.

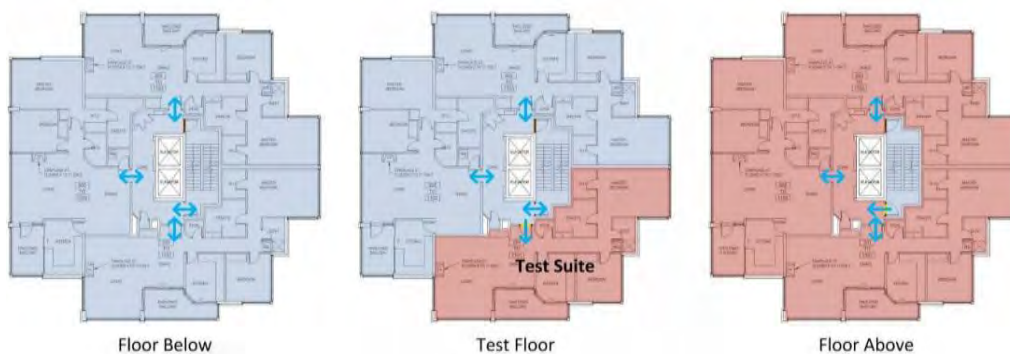
Figure 5.5 Airtightness testing layout for pressurization of an -01 suite while equalizing the floor above showing the direction or airflow between zones either through open doors to allow for free movement of air, or as forced into zones by the testing fans.

Figure 5.5 shows a schematic of the airtightness testing layout for pressurizing an -01 suite while pressure equalizing the floor above. Schematics for each step of testing an -01 suite are provided in Appendix E, and these steps are similar for -02 and -03 type suites. (-01, -02, and -03 suites refer to suites ending in these values respectively. For example, -01 suites would include 101, 201, 301, 401, etc.)

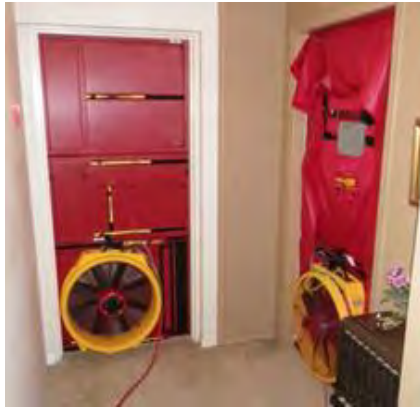
Figure 5.6 Two fan-doors used for airtightness testing. The soft-door with fan installed in the entrance door of a test suite (right door) was used for the test zones as they are more airtight than the hard door units (left door) which were used for the pressure equalized zones where airtightness of the door fan is not as important. Tape was used to seal around the door when necessary.

Pre-retrofit testing was generally performed with pressurization and depressurization to 10, 30, 50, and 60 Pa with readings taken, using a computer and associated software, as frequently as the equipment would allow (minimum 1 reading per second) for 10 seconds. Measurement of the bias pressure was taken before and after testing for 30 seconds. Post-retrofit testing followed the same procedure except that pressurization and depressurization was conducted at 20, 30, 50, and 60 Pa. The change to the lowest pressure was made because during analysis of the pre-retrofit tests it was noted that frequently the 10 Pa measurements displayed the most error, thus the pressure magnitude was increased with the aim of decreasing the error for the post-retrofit tests. Additionally, measurements were generally taken for 20 seconds for the post-retrofit testing because the bias pressure was observed to be more variable and the longer measurement period is intended to compensate. General images of the testing equipment and set-up are provided in Figure 5.6 and Figure 5.7.

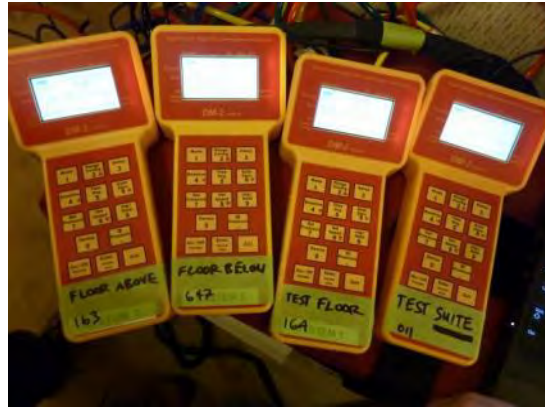
Figure 5.7 Four Retrotec DM-2 gauges used for control of the fans and pressure measurements during the testing. The gauge for the test zone is connected to a laptop running Retrotec's FanTestic airtightness testing software to record data points.

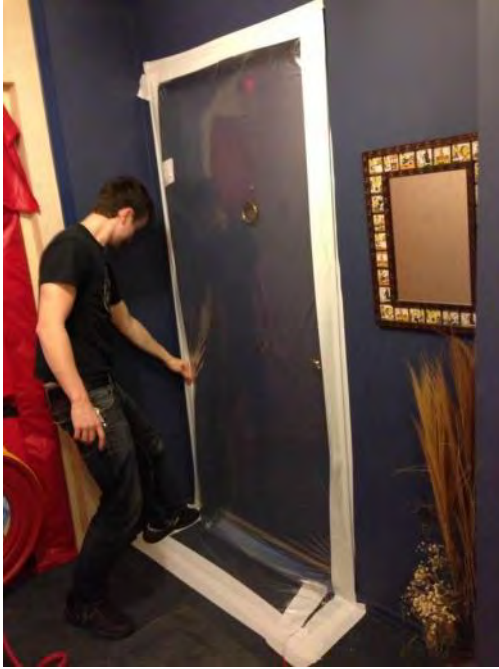
Figure 5.8 Typical suite entrance door sealed with a polyethylene sheet and tape to prevent airflow. By measuring the corridor air leakage with and without each this door sealed, the airflow rate through the door to the suite can be determined.

The airtightness testing methodology for the corridors is similar to that for the suites and floors. Pressure equalization was used to prevent and measure leakage to the floors above and below; then various openings from the corridor to adjacent zones were sequentially sealed and the airflow rates measured to determine the airflow associated with each opening. Schematics of the testing layout for each of the test steps are provided in Appendix E. Sealing of a typical suite door and of elevator doors are shown in Figure 5.8 and Figure 5.9.

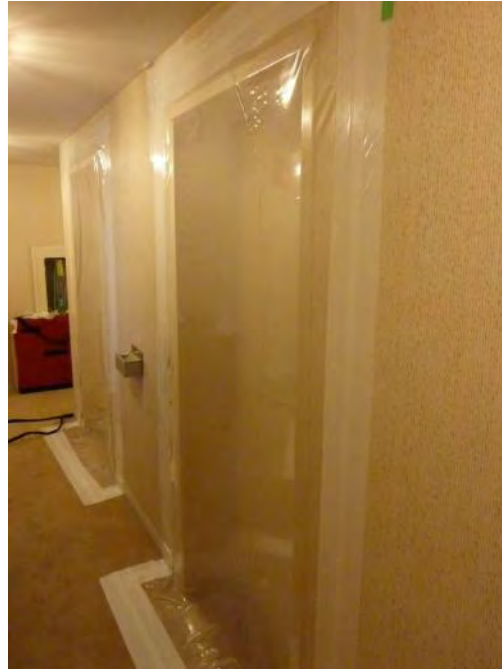
Figure 5.9 Typical sealing of elevator doors to eliminate airflow through the elevator doors to the shaft. A significant amount of corridor air leakage was found to be to the elevator shaft through these doors.

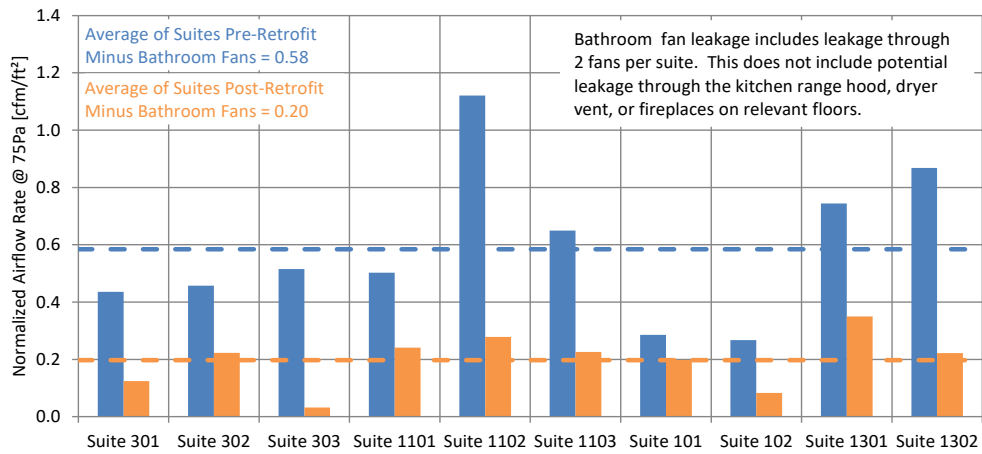
Figure 5.13 Graph showing results of enclosure airtightness testing of suites minus leakage attributable to bathroom fans.

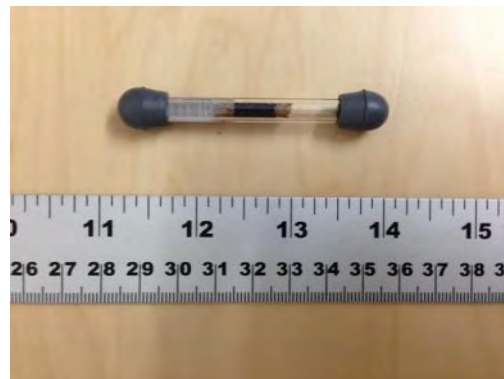
Figure 7.2 Typical CATS used for PFT testing at the case study building

To measure the airflow between zones, PFT testing was conducted which provides time-averaged flow rates. The PFT test method used was developed by Brookhaven National Laboratory and uses seven distinct perfluorocarbon tracers. These tracers are released into the air and then absorbed by capillary absorption tube samplers (CATS). The laboratory is then able to determine the how much of the tracer the CATS absorbed. Using these absorbed volumes and the known release rates of the PFTs, the airflow between zones can be determined. The PFT equipment and processing of the CATS samplers was provided by Brookhaven National Laboratory through Meadowbrook Partners Inc. (MPI). Figure 7.1 shows the PFT sources and Figure 7.2 shows a typical CATS used for this testing.

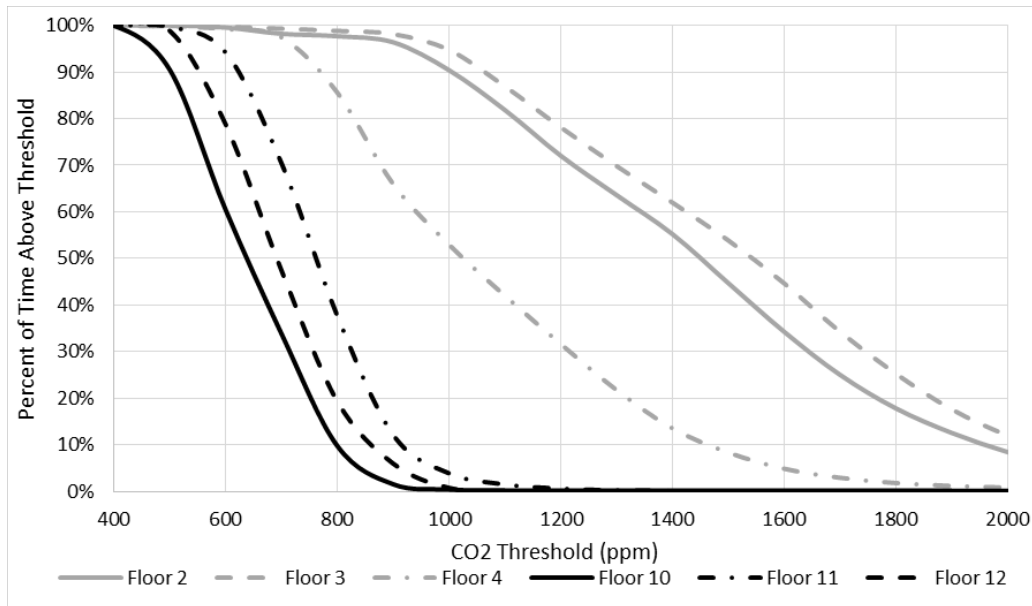
Figure 7.15 Average monthly CO₂ concentration in suites on each floor

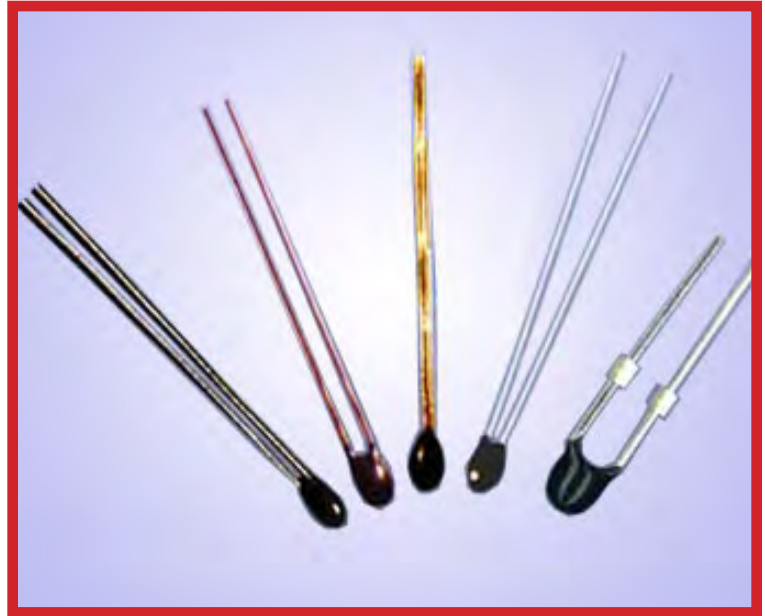
MF52 Pearl-Shaped Precision NTC Thermistor for Temperature Measurement

The MF52 series of Pearl-Shaped NTC Thermistors is ethoxyline resin coated. The small size is made possible by new materials and manufacturing methods which provide the benefit of close tolerances and fast response. MF52 thermistors are available with 5 lead styles in standard or custom lengths.

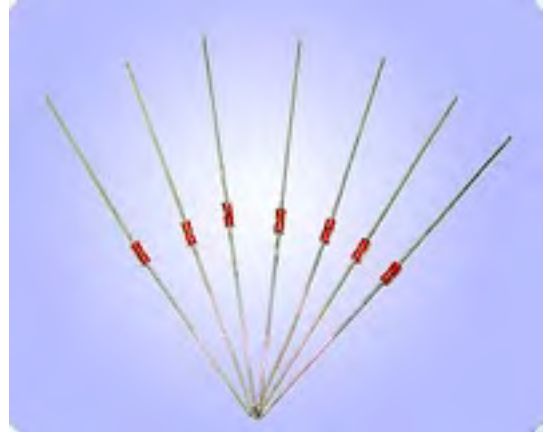
MF58 Glass Shell Precision NTC Thermistors

The MF58 is a NTC thermistor which is manufactured using a combination of ceramic and semiconductor techniques. It is equipped with tinned axial leads and then wrapped with purified glass.

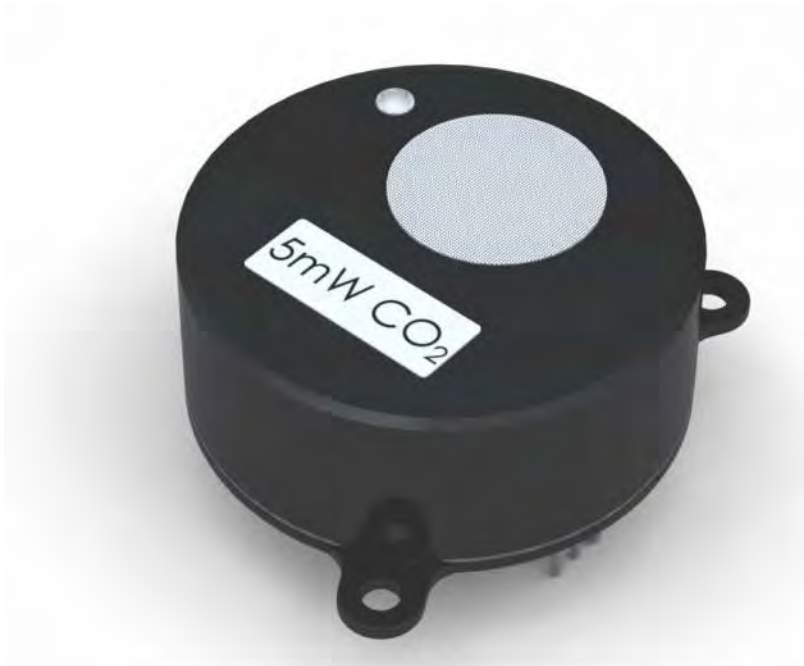
Ultra Low Power Carbon Dioxide Sensor

COZIR is an ultra low power (3.5mW^4), high performance CO_2 sensor, ideally suited for battery operation, portable instruments and HVAC. Based on GSS IR LED and Detector technology, and innovative optical designs, the *COZIR* offers the lowest power NDIR sensor available. Optional temperature, humidity and light sensing are available. *COZIR* is a third generation product from GSS – leaders in IR LED CO_2 sensing.

- Ultra-low Power 3.5mW
- Measurement ranges from 2000ppm to 2%
- Low noise measurement (<10ppm)
- 3.3V supply.
- Peak current only 33mA.
- Optional Temperature and Humidity Output

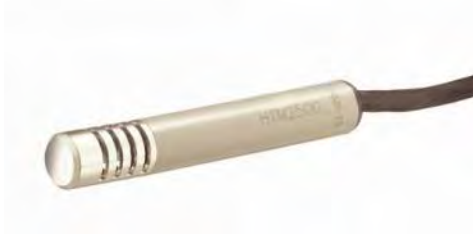
HTM25X0LF – Temperature and Relative Humidity Module

- Hermetic Housing
- Humidity calibrated within +/-2% @55%RH
- Temperature measurement through NTC 10kOhms +/- 1% direct output
- Small size product
- Typical 1 to 4 Volt DC output for 0 to 100%RH at 5Vdc

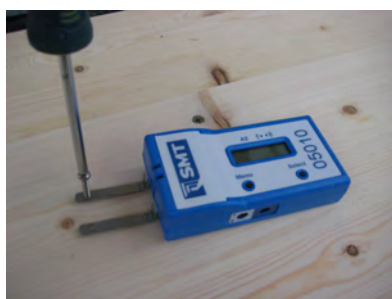
The SMT-A2 can be housed in a mobile unit used for indoor applications, sealed in an IP67 enclosure or mounted on a double gang face plate.

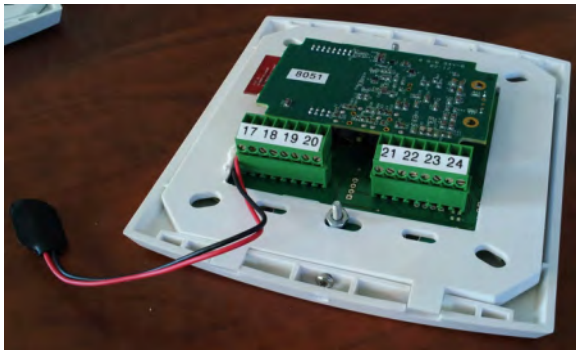
Resistance based sensors such as PMM's, EMS sensors, thermistors and linear displacement potentiometers can be used.

Connect sensors to ports 17 to 24. Polarity is not important unless specified by the sensor. Unused ports can be left open or factory negated. Sensors that require temperature compensation should have the temperature inserted into the lower number (so it is recorded first). For example, a PMM should connect temperature to port 17 and moisture content to port 18.

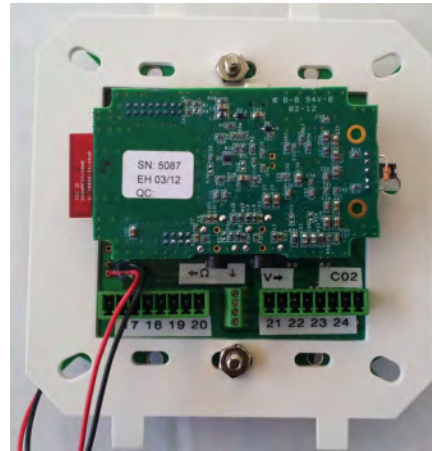
0-5V sensors such as RH sensors, differential pressure sensors and solar radiation sensors can be connected to the A3. The A3 can be configured to have 8 voltage ports (8R) or 4 resistance ports and 4 voltage ports (4R4V) as shown in the diagram below. Power is switched on individually to all connected sensors, each sensor is permitted to draw a maximum current of 50mA. Sensors have a warm up time of 3 seconds.

4R4V unit with CO2. Install resistance sensors in 17-20 and voltage sensors in 21 to 24 using the centre connector as a ground bar. Connect the CO2 sensor to input 24.

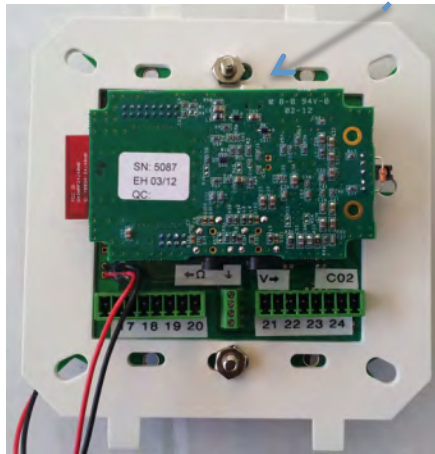
If an SMT-I2 isn't available to facilitate a wireless data download to BiG, data can be collected using the onboard USB port.

Connect the SMT-A3 mini USB port to a computer running the Building Intelligence Gateway software. The A3 serial number should show up under the Devices tab. If there are readings the data will automatically be transferred into the BiG database.

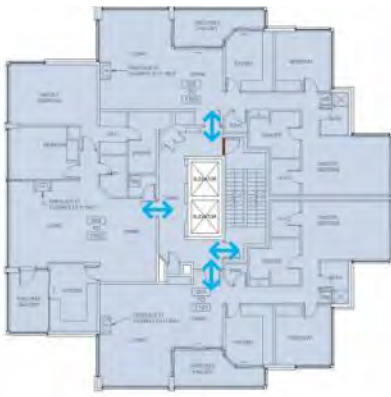
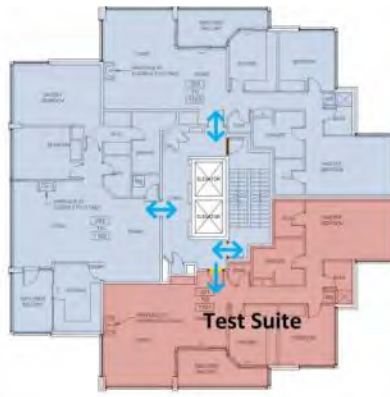
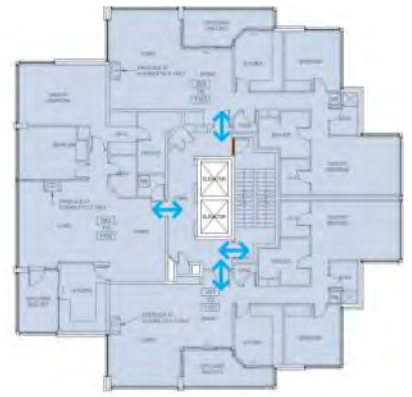
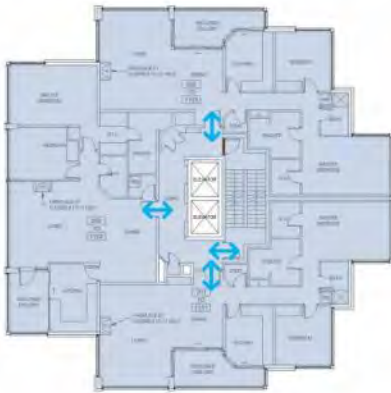
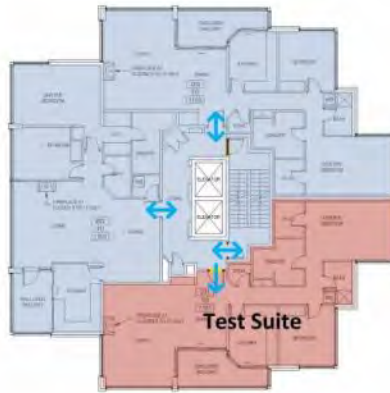
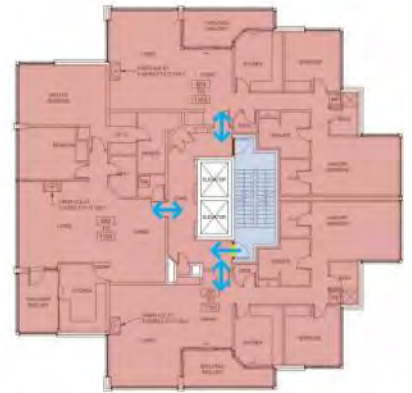
These steps were performed first for pressurization and then for depressurization. A schematic of the test set-up for these steps for pressurization testing of an -02 suite is shown in Fig. 1.2. The direction of the fans is simply reversed for the depressurization testing. A legend of the symbols used in these schematics is shown in Fig. 1.1.

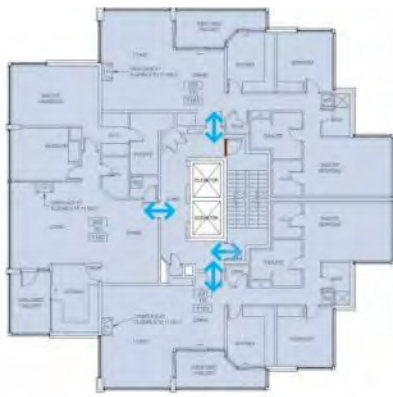
Step 1

A schematic of the test set-up for these steps is shown in Fig. 1.3. Note that the results for the Step 11 and Step 12, stairwell door are for one stairwell door since the testing fan is installed in the other door. It is assumed that the stairwell doors are similar and thus the quantity of airflow through this door is multiplied by two to account for both doors.

Fig. 1.3 Schematics of 20 testing steps for airtightness testing of a corridor.
