ICF Wall Testing and Modeling

LAB TESTING REPORT

RDH Building Engineering Ltd. (RDH) was retained by the Homeowner Protection Office (HPO), a branch of BC Housing, and the BC Ready-Mixed Concrete Association (BCRMCA) to perform testing and analysis of ICF walls and window interfaces. This report details the tests completed to help provide the necessary information to quantify the airtightness, water penetration resistance, and thermal resistance of sample wall assemblies, which included a fixed window and associated detailing.

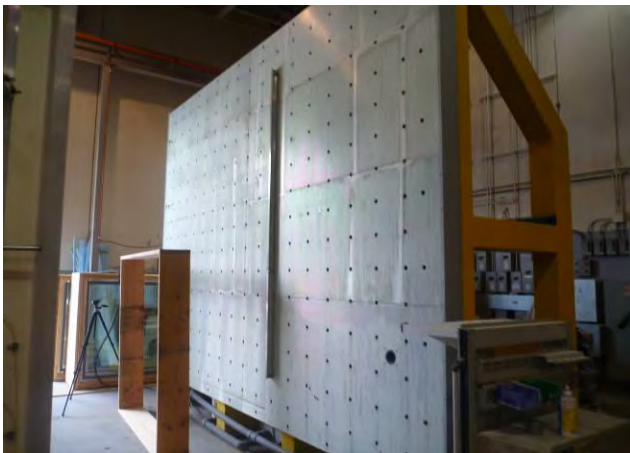
Fig. 2.1.1 Front view of test wall.

Testing of the ICF wall assemblies was undertaken using the testing facility at the Cascadia Windows Ltd.'s manufacturing facility in Langley, BC (Fig.2.1.1 and Fig.2.1.2). The test facility is capable of testing specimens as large as 16' x 12'. This apparatus can be used to perform water penetration resistance testing, air leakage testing, and structural testing.

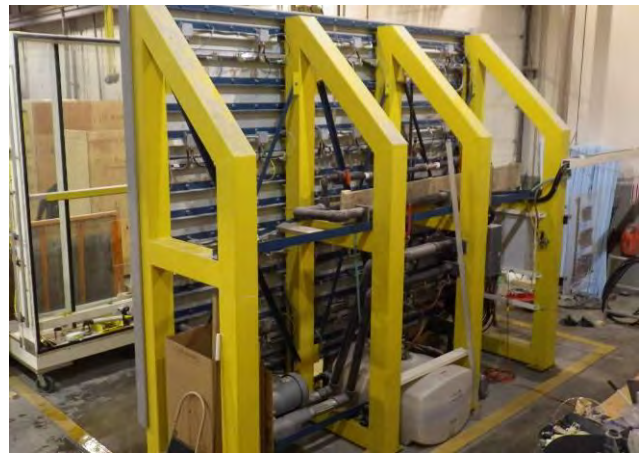
Fig. 2.1.2 Rear view of test wall.

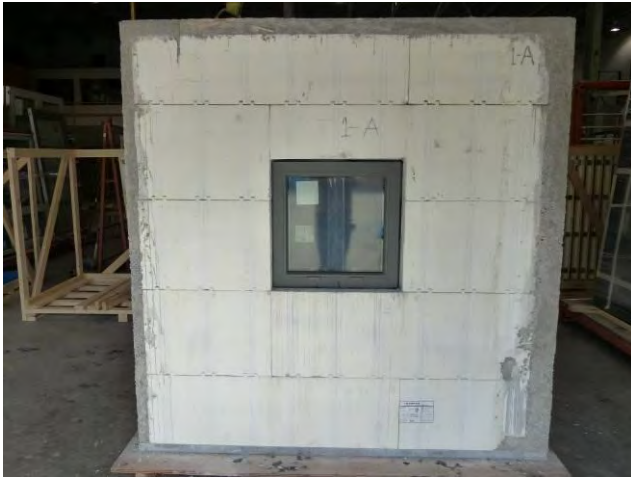
Fig. 2.2.1 Module 1A – Internal with Buck Flashing

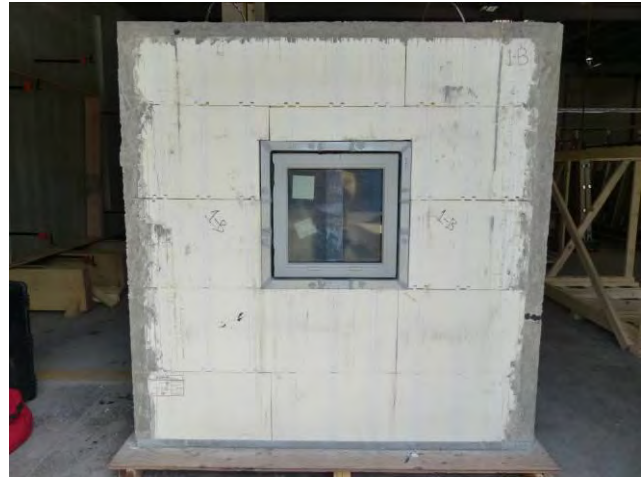
Fig. 2.2.2 Module 1B – External with Buck Flashing

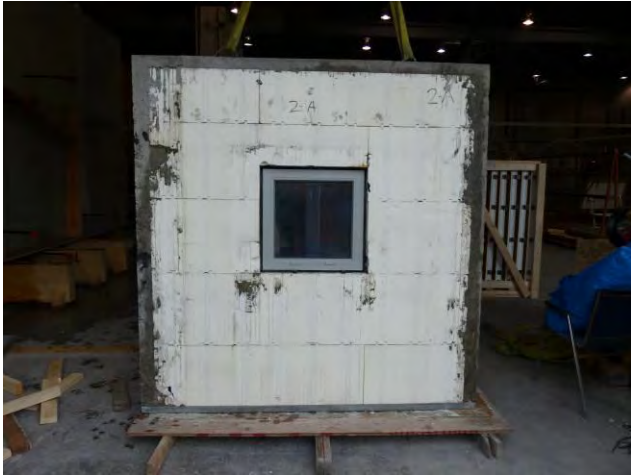
Fig. 2.2.3 Module 2A – Direct to Concrete

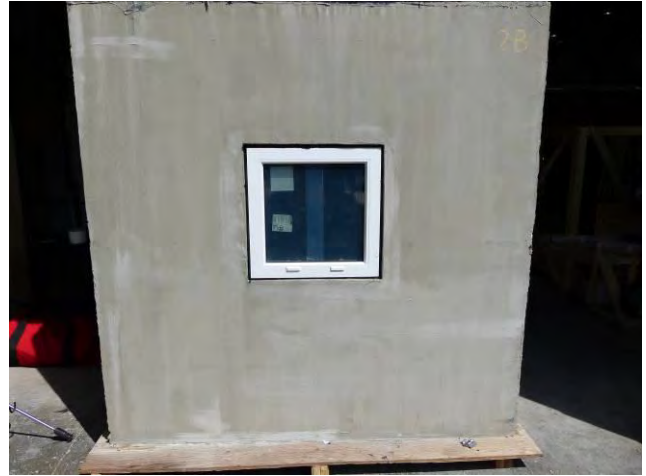
Fig. 2.2.4 Module 2B – EIFS Basecoat

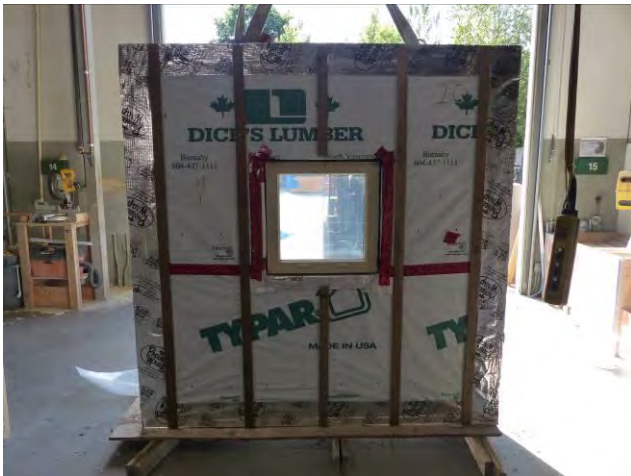
Fig. 2.2.5 Module 2C – Benchmark – Sheathing Paper with Vertical Strapping

- Module 2C: Benchmark – Strapping and Sheathing Paper. The module was constructed similarly to module 1B, with the exception of the galvanized metal flashing as well as the addition of sheathing paper installed on the exterior, foil faced self-adhered into the rough opening at the sill, and with vertical strapping at 16" o/c (Fig.2.2.5).

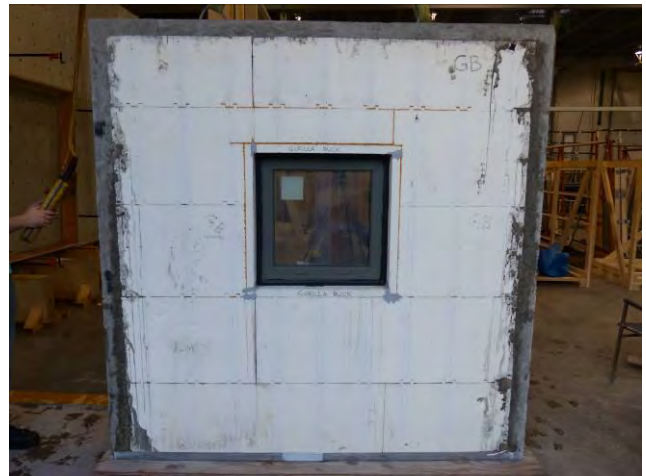
Fig. 2.2.6 Gorilla Buck Module

- Gorilla Buck Module: A Gorilla Buck, which is a proprietary buck for rough openings in ICF construction, was installed in the rough opening in place of the usual wooden buck (Fig.2.2.6).

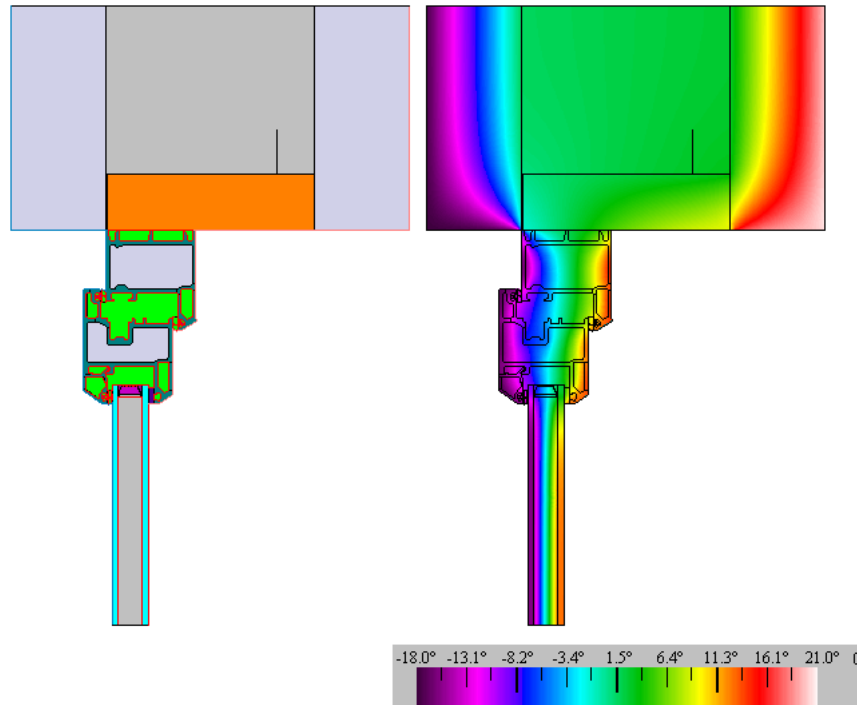
To model the effective R-value, two-dimensional heat transfer simulations of ICF walls were completed using the program THERM. THERM is a finite element analysis program used to calculate the effective R-value of building enclosure assemblies. THERM simulations were completed for each module. Module 1A and 1B were modeled with both galvanized metal flashing and PVC flashing. Each of the modules was modelled as they were constructed for testing; complete with a 23”x23” window installed to accurately model the interface between the window and the wall. Figure 3.1.1 shows the model and a temperature isotherm from a THERM simulation of the internal buck module with galvanized sheet steel (Module 1A).

Fig. 3.1.1 THERM simulation for the head of Module 1A –Internal with Flashing

THERM simulations were completed for the head, jambs, and sill for each module. Additionally, a section of the center of the wall was also modelled for calculation purposes. The U-values for each model were calculated for the frame, edge of glass, and edge of wall. Table 3.1.2 shows a summary of the results from the THERM simulation. The window perimeter is defined as 6” onto the wall from the rough opening at the head, jambs, and sill.

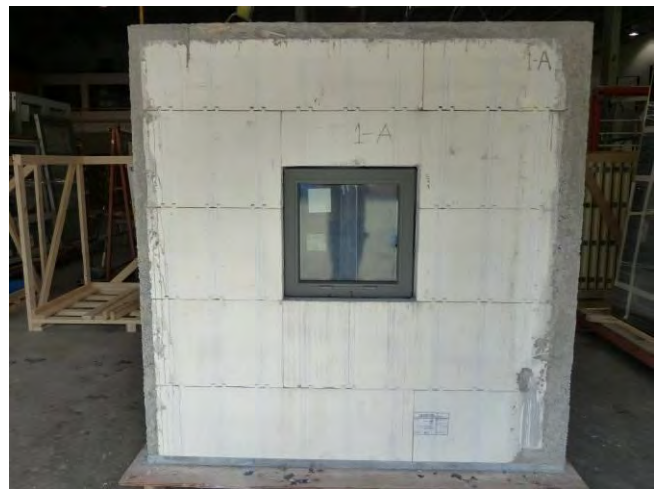
Fig. 1.2.1 Overall exterior view of Module 1A

An elevation drawing, section details, and the buck flash details can be found in Appendix B. Figure 1.2.1 illustrates the full view of module 1A as viewed from the exterior.

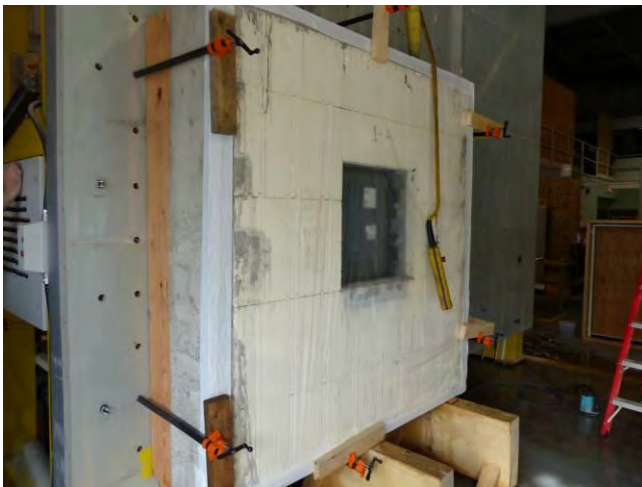
Results	
Air Leakage Rate per Total Area of Sample (qA)	Less than 0.0039 L/s·m ²

Fig. 3.1.1 Air Leakage Testing

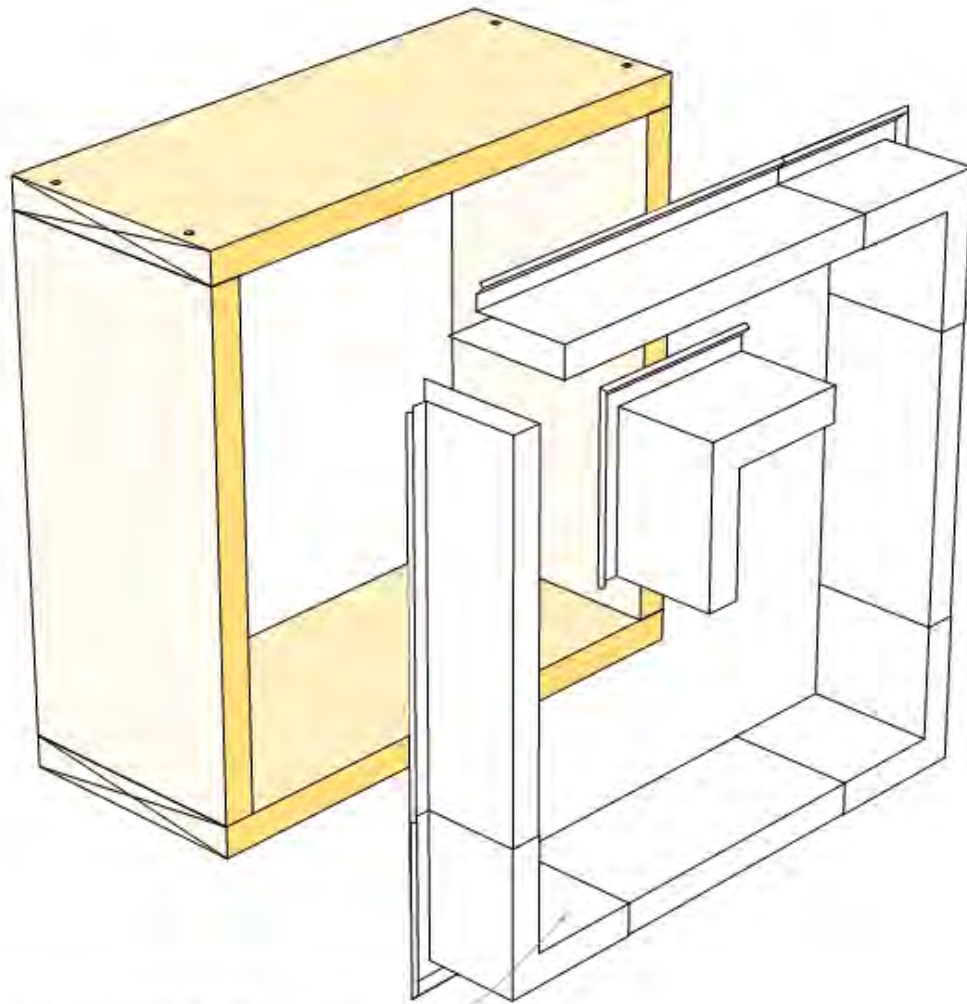
4" BUCK FLASH OVERLAP WITH PRIMER

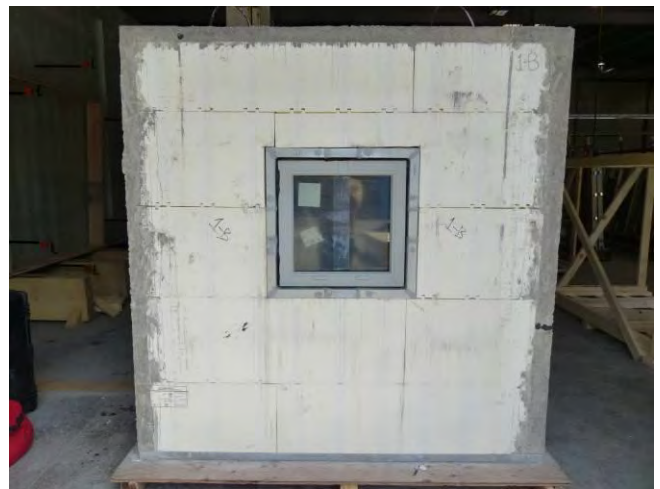
Module #1B	
Wall -Type	Module #1B – External with Buck Flash
- ICF Manufacturer	Plasti-Fab EPS Product and Solutions – Advantage ICF Systems
Window - Manufacturer	Cascadia Windows Ltd.
- Series	300A
Age	0
Overall Dimensions (Width x Height)	Window: 584 x 584 mm (23 x 23 in.) Wall: 1994 x 2032 mm (78 1/2 x 80 in.)
Frame Material	Fibreglass
Thermally Broken	Fibreglass integral to frame
Details Included	Fixed Lite, Perimeter interface, and ICF wall
Material List	The wall was constructed using light-weight EPS by Plasti-Fab Advantage ICF as formwork for the steel reinforced 6” thick concrete. A 23” x 23” fixed window was installed within the wall assembly.

Fig. 1.2.2 Overall exterior view of Module 1B

An elevation drawing, section details, and the buck flash details can be found in Appendix B. Figure 1.2.1 illustrates the full view of module 1B as viewed from the exterior.

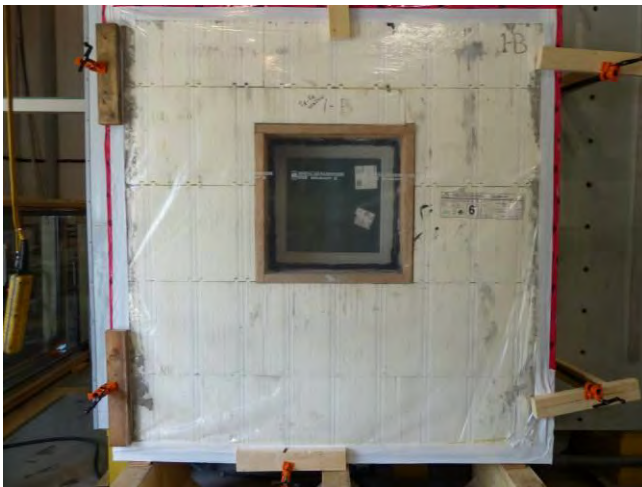
Results	
Air Leakage Rate per Total Area of Sample (qA)	Less than 0.0039 L/s·m ²

Fig. 3.1.1 Air Leakage Testing

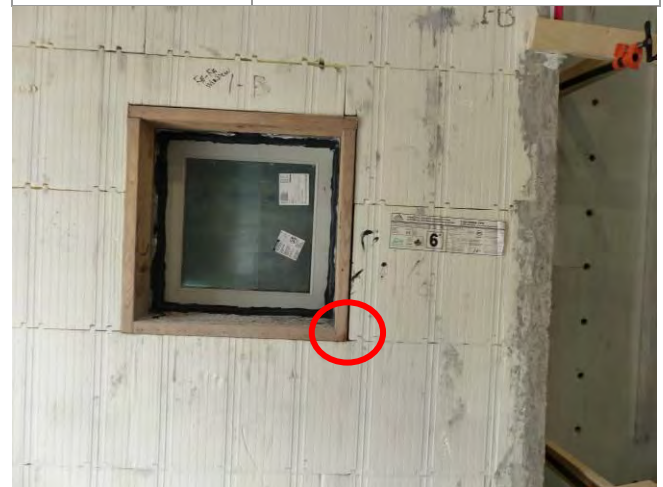
Penetration Point	
Water Penetration Point	P1
Penetration is a Failure Mode	Yes
Location	Lower right corner between wood buck and EPS formwork
Time	7 min
Volume of Water	Slow Trickle

Fig. 4.3.1 Water penetration point P1 for Module 1B at 700 Pa

When tested to the standard of ASTM E331, no water ingress was observed through the specimen at differential pressures of 150 and 300 Pa. Water ingress was observed through the specimen at a differential pressure of 700 Pa.

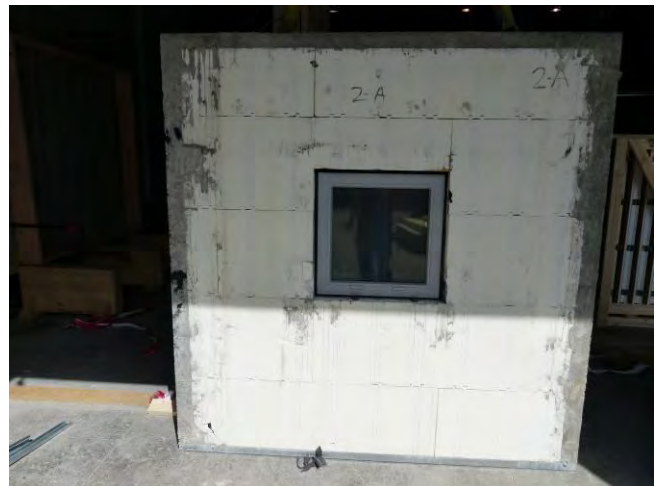
Module #2A	
Wall -Type	Module #2A – Direct to Concrete
- ICF Manufacturer	Plasti-Fab EPS Product and Solutions – Advantage ICF Systems
Window - Manufacturer	Cascadia Windows Ltd.
- Series	300A
Age	0
Overall Dimensions (Width x Height)	Window: 584 x 584 mm (23 x 23 in.) Wall: 1994 x 2032 mm (78 1/2 x 80 in.)
Frame Material	Fibreglass
Thermally Broken	Fibreglass integral to frame
Details Included	Fixed Lite, Perimeter interface, and ICF wall
Material List	The wall was constructed using light-weight EPS by Plasti-Fab Advantage ICF as formwork for the steel reinforced 6” thick concrete. A 23” x 23” fixed window was installed within the wall assembly.

Fig. 1.2.2 Overall exterior view of Module 2A

An elevation drawing and section details can be found in Appendix B. Figure 1.2.1 illustrates the full view of module 2A as viewed from the exterior.

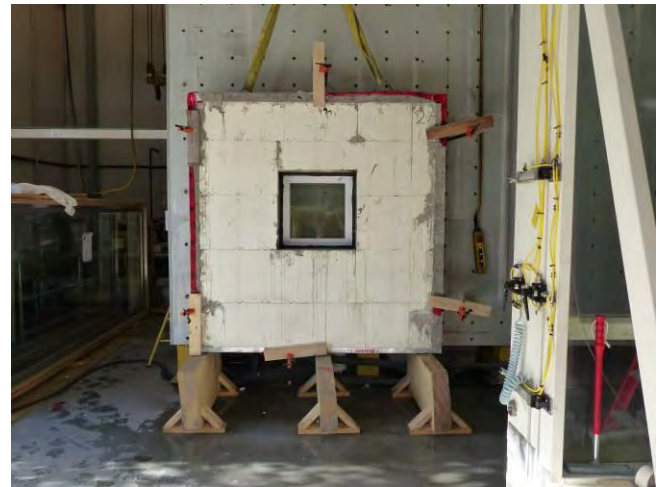
Results	
Result	Pass at 700 Pa

Fig. 4.3.1 Water Testing on Module 2A

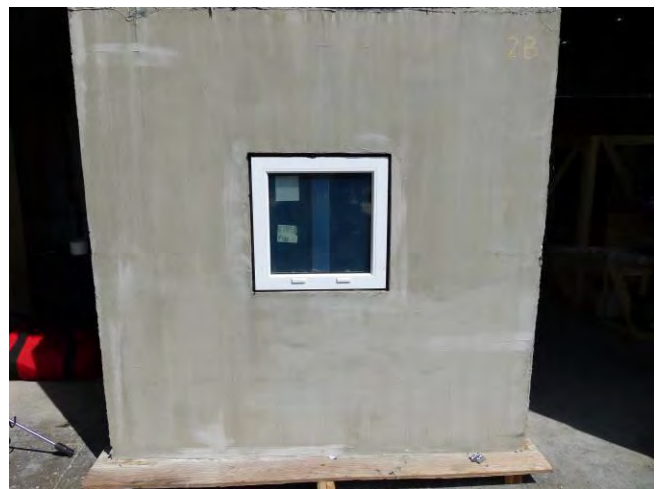
Module #2B	
Wall -Type	Module #2B – EIFS Basecoat
- ICF Manufacturer	Plasti-Fab EPS Product and Solutions – Advantage ICF Systems
- EIFS Manufacturer	Dryvit Systems Canada
Window - Manufacturer	Cascadia Windows Ltd.
- Series	300A
Age	0
Overall Dimensions (Width x Height)	Window: 584 x 584 mm (23 x 23 in.) Wall: 1994 x 2032 mm (78 1/2 x 80 in.)
Frame Material	Fibreglass
Thermally Broken	Fibreglass integral to frame
Details Included	Fixed Lite, Perimeter interface, and ICF wall
Material List	The wall was constructed using light-weight EPS by Plasti-Fab Advantage ICF as formwork for the steel reinforced 6” thick concrete. A 23” x 23” fixed window was installed within the wall assembly.

An elevation drawing and section details can be found in Appendix B. Figure 1.2.1 illustrates the full view of module 2B as viewed from the exterior. The EIFS basecoat was constructed with Genesis DM by Dryvit, Dryflex by Dryvit, Sandpebble DPR by Dryvit,

Fig. 1.2.1 Overall exterior view of Module 2B

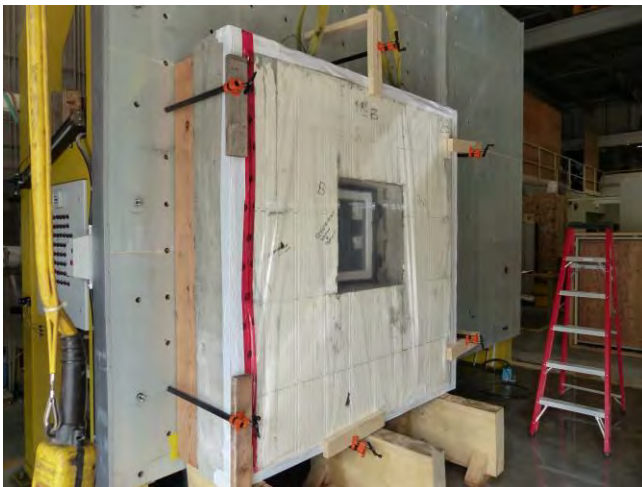
Results	
Air Leakage Rate per Total Area of Sample (qA)	Less than 0.0039 L/s·m ²

Fig. 3.1.2 Air Leakage Testing

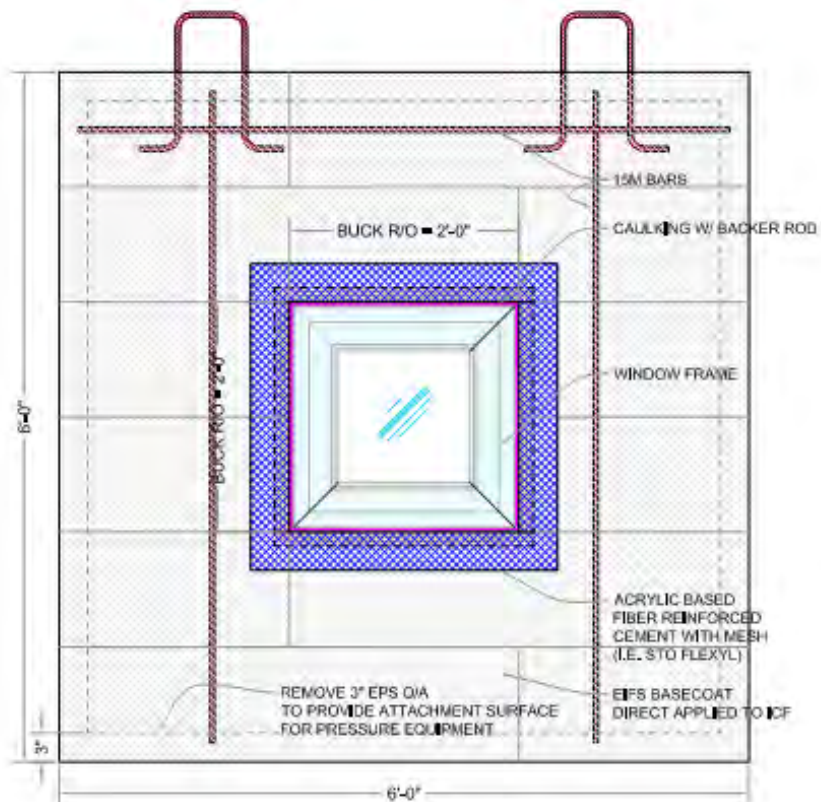
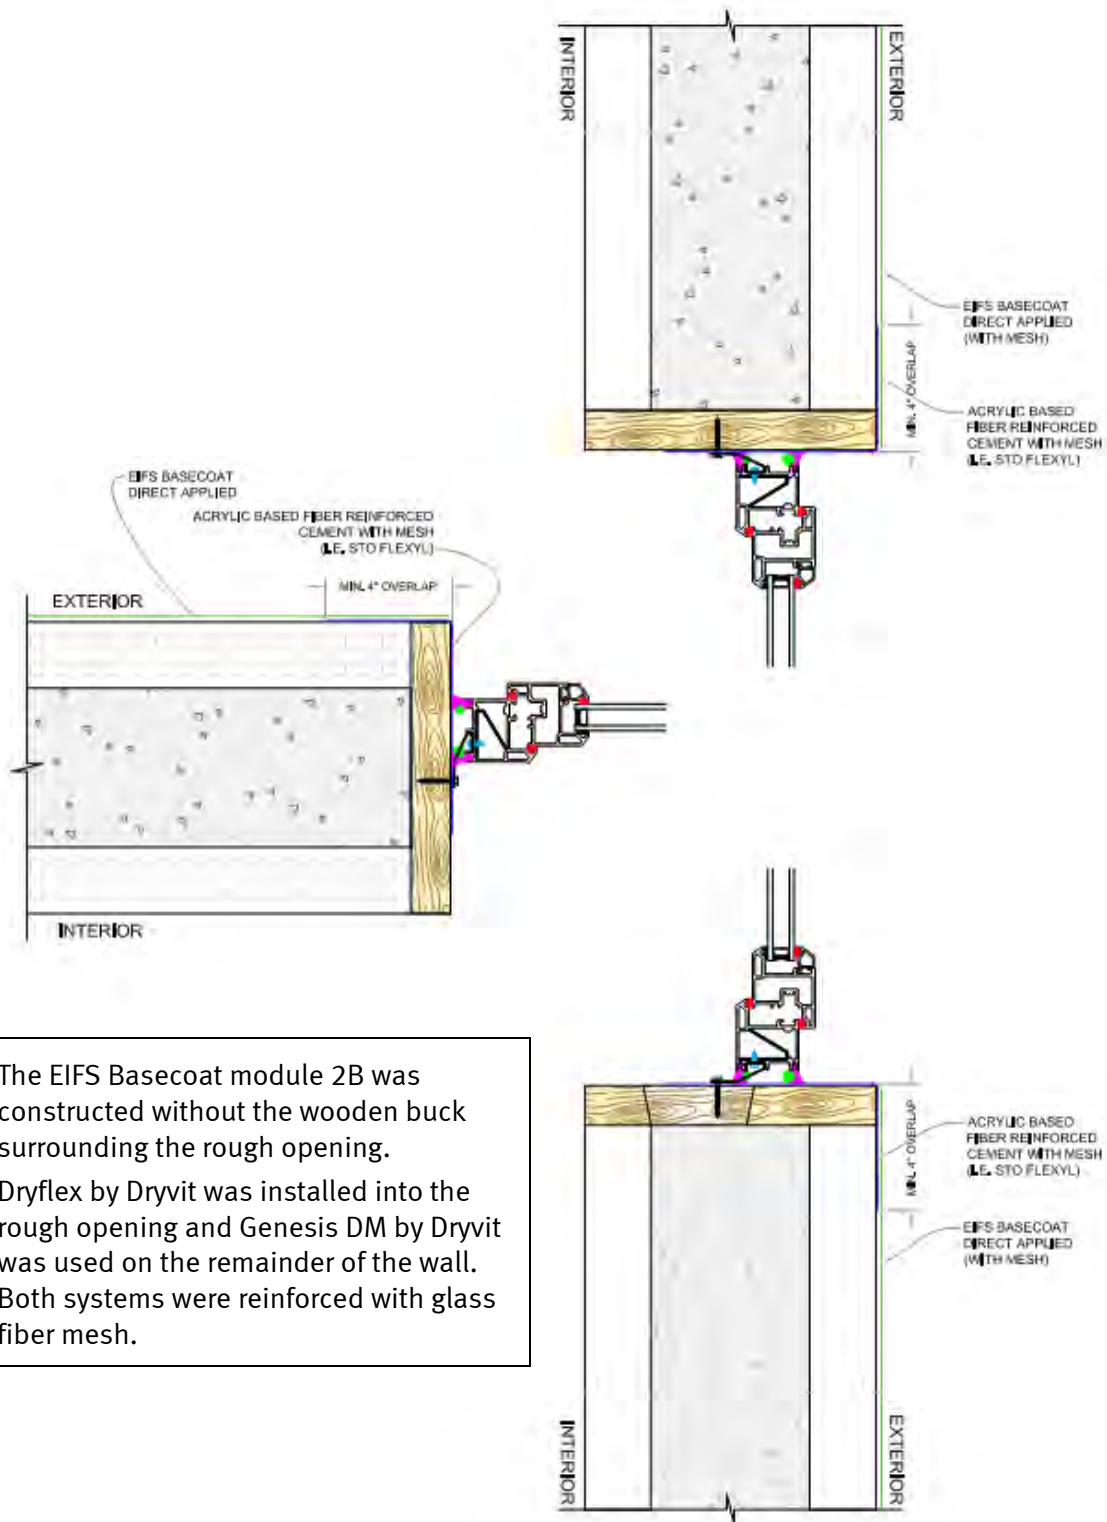
TEST MODULE 2B EIFS BASECOAT

- 1) The EIFS Basecoat module 2B was constructed without the wooden buck surrounding the rough opening.
- 2) Dryflex by Dryvit was installed into the rough opening and Genesis DM by Dryvit was used on the remainder of the wall. Both systems were reinforced with glass fiber mesh.

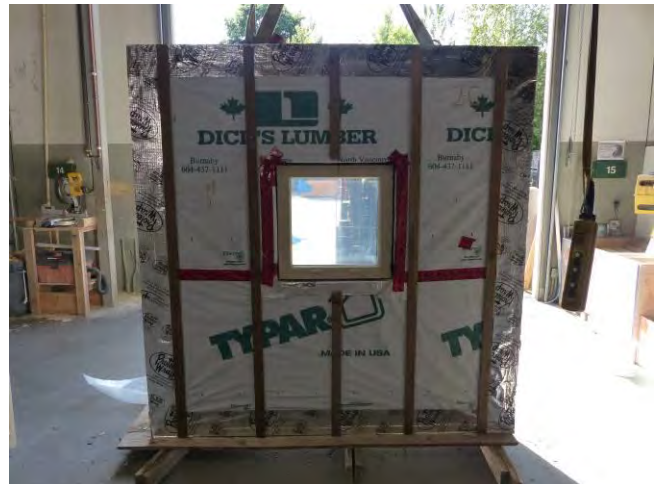
Module #2C	
Wall -Type	Module #2C – Benchmark – Sheathing Paper
- ICF Manufacturer	Plasti-Fab EPS Product and Solutions – Advantage ICF Systems
Window - Manufacturer	Cascadia Windows Ltd.
- Series	300A
Age	0
Overall Dimensions (Width x Height)	Window: 584 x 584 mm (23 x 23 in.) Wall: 1994 x 2032 mm (78 1/2 x 80 in.)
Frame Material	Fibreglass
Thermally Broken	Fibreglass integral to frame
Details Included	Fixed Lite, Perimeter interface, and ICF wall
Material List	The wall was constructed using light-weight EPS by Plasti-Fab Advantage ICF as formwork for the steel reinforced 6” thick concrete. A 23” x 23” fixed window was installed within the wall assembly.

Fig. 1.2.2 Overall exterior view of Module 2C

An elevation drawing and section details can be found in Appendix B. Figure 1.2.1 illustrates the full view of module 2C as viewed from the exterior.

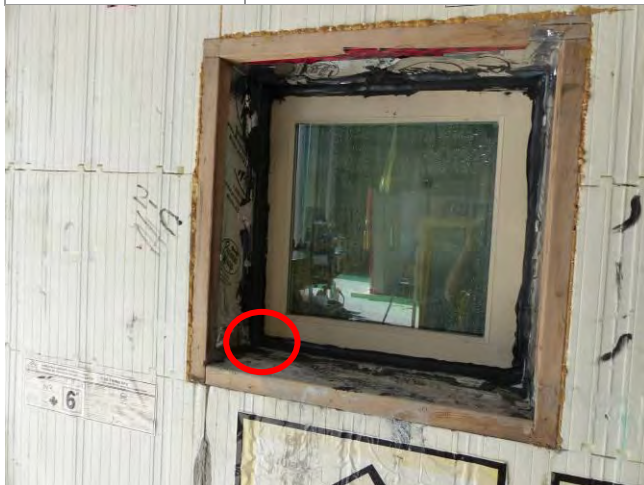
Penetration Point	
Water Penetration Point	P1
Penetration is a Failure Mode	Yes
Location	Lower left corner of the window.
Time	4 min
Volume of Water	Small pooling

Fig. 4.1.1 Water penetration point P1 for Module 2C at 150 Pa

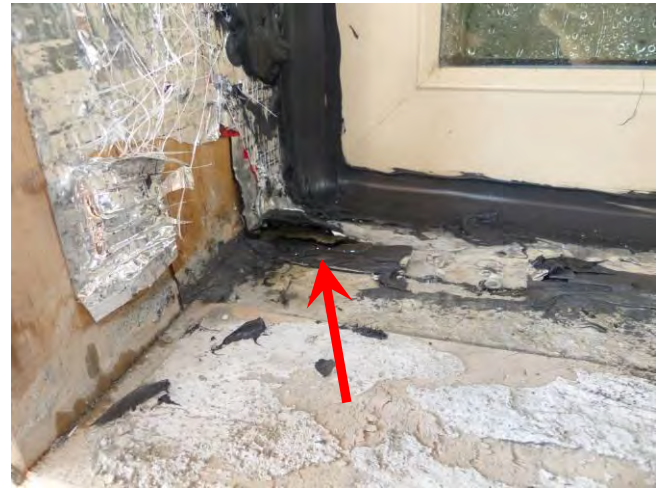
Fig. 4.1.2 Water ingress at lower left-hand corner of window penetrated through the fasteners

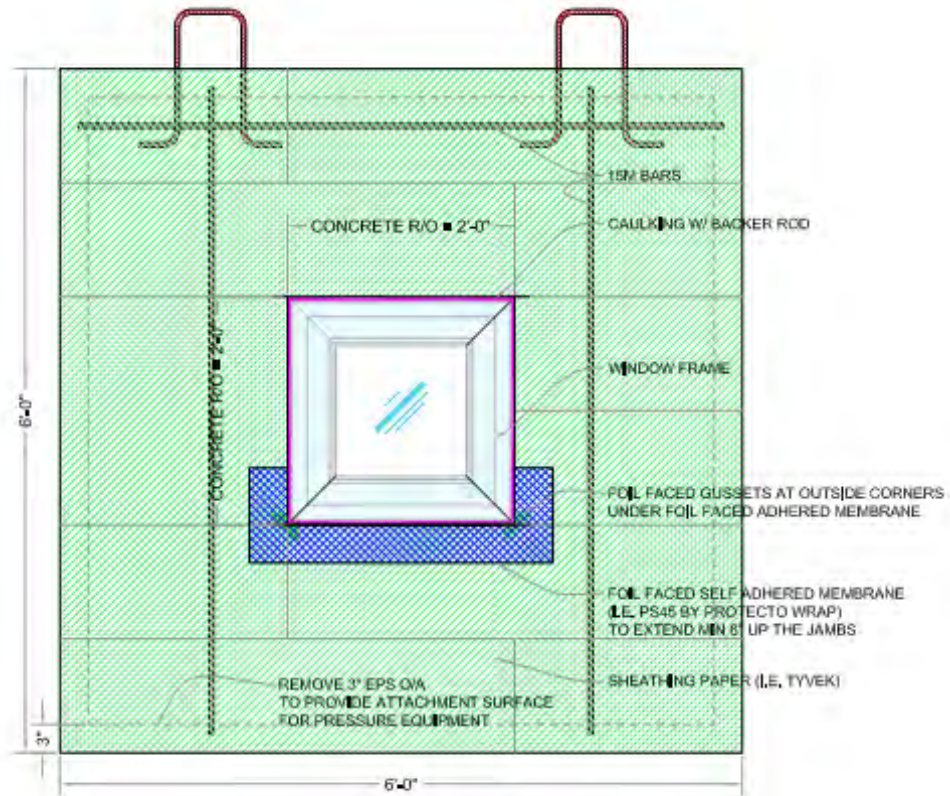
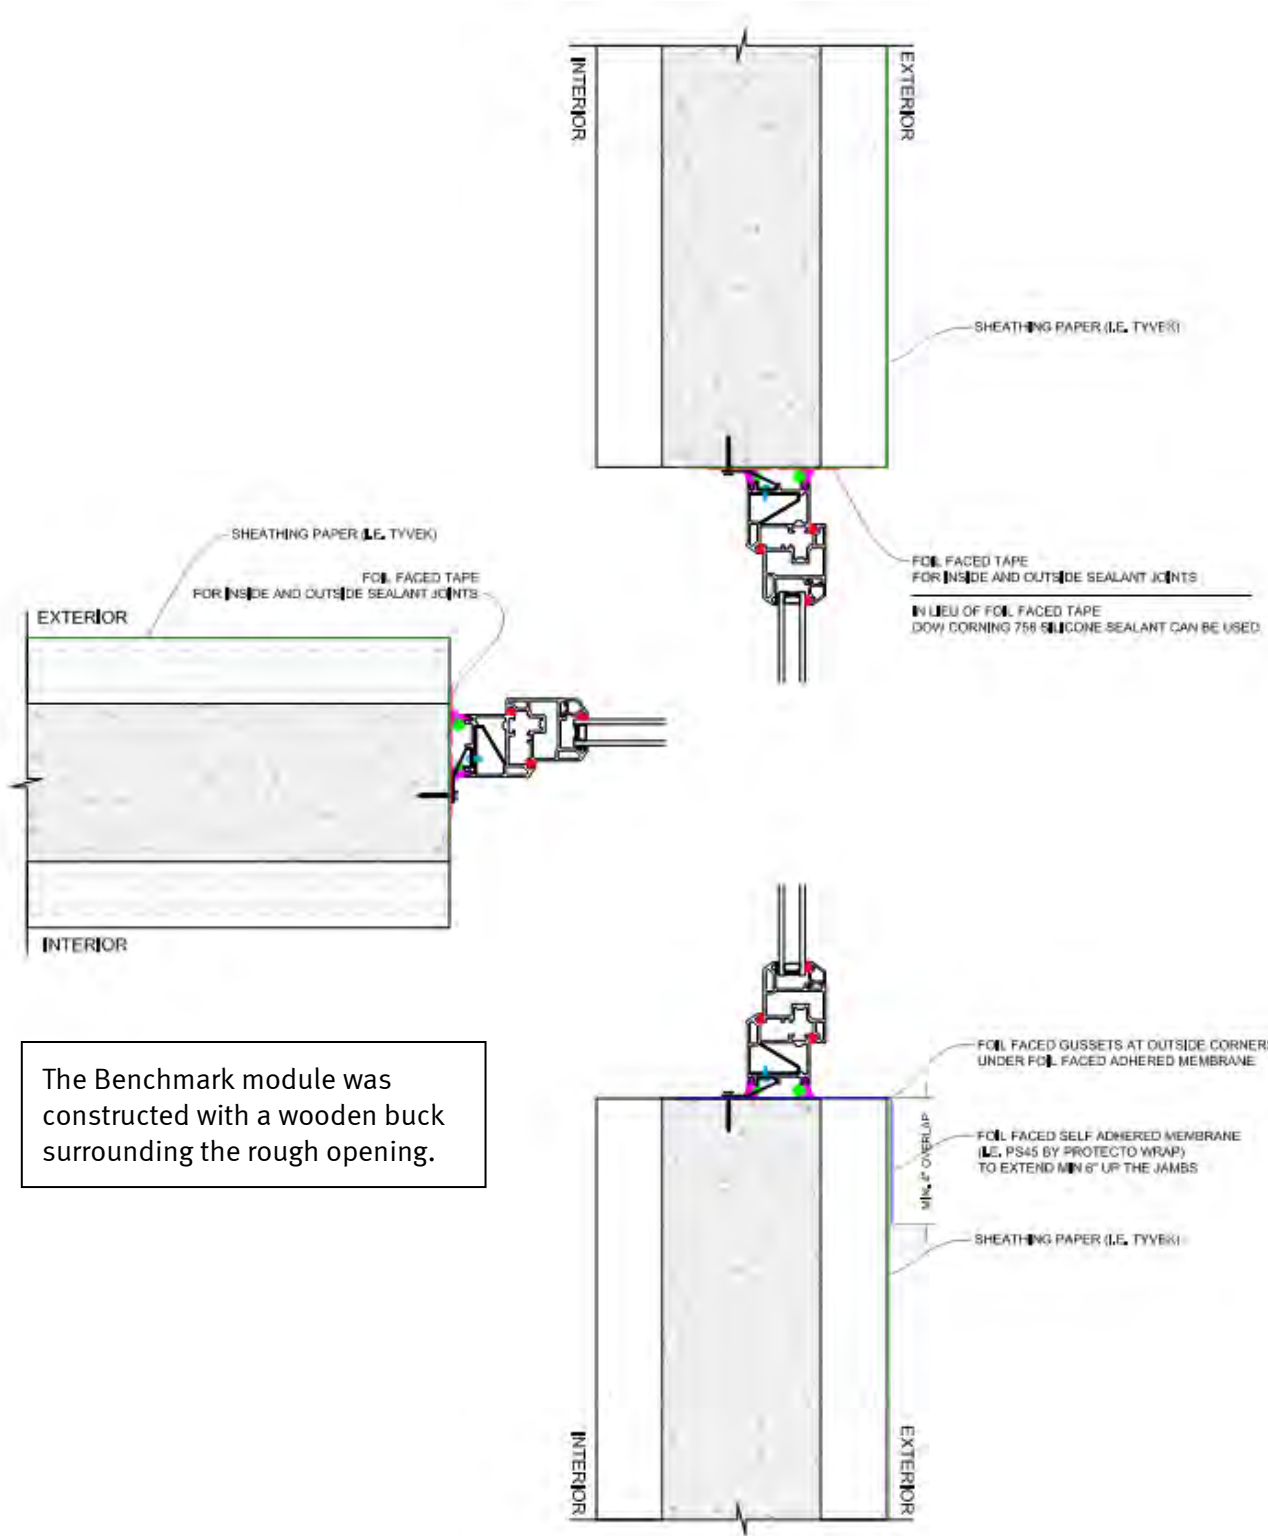
BENCHMARK SHEATHING PAPER

The Benchmark module was constructed with a wooden buck surrounding the rough opening.

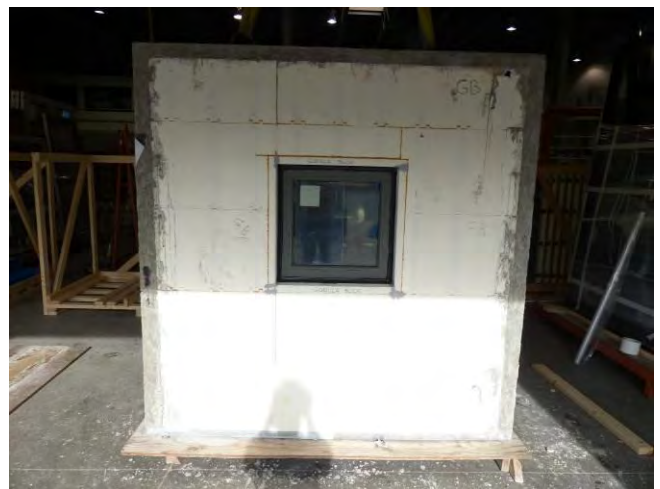
Gorilla Buck Module	
Wall -Type	Gorilla Buck Module
- ICF Manufacturer	Plasti-Fab EPS Product and Solutions – Advantage ICF Systems
Window - Manufacturer	Cascadia Windows Ltd.
- Series	300A
Age	0
Overall Dimensions (Width x Height)	Window: 584 x 584 mm (23 x 23 in.) Wall: 1994 x 2032 mm (78 1/2 x 80 in.)
Frame Material	Fibreglass
Thermally Broken	Fibreglass integral to frame
Details Included	Fixed Lite, Perimeter interface, and ICF wall
Material List	The wall was constructed using light-weight EPS by Plasti-Fab Advantage ICF as formwork for the steel reinforced 6” thick concrete. A 23” x 23” fixed window was installed within the wall assembly.

Fig. 1.2.2 Overall exterior view of Gorilla Buck Module

An elevation drawing, section details, and the buck flash details can be found in Appendix B. Figure 1.2.1 illustrates the full view of the specimen as viewed from the exterior.

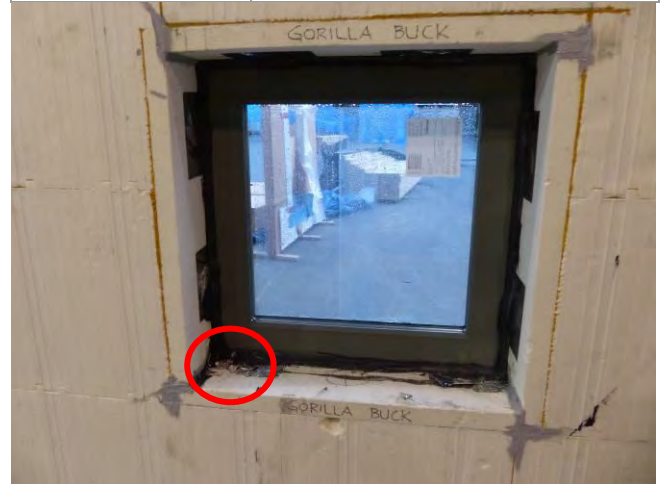
Penetration Point	
Water Penetration Point	P1
Penetration is a Failure Mode	Yes
Location	Lower left-hand corner inside the buck at sealant joint
Time	3 min
Volume of Water	Small pooling

Fig. 4.2.2 Water penetration point P1 for Gorilla Buck Module at 300 Pa

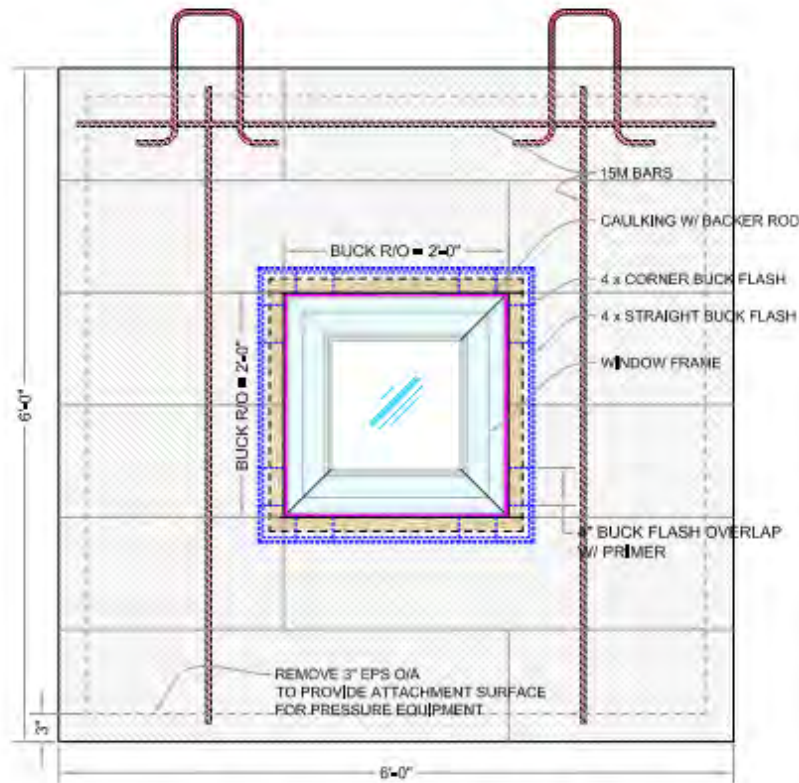
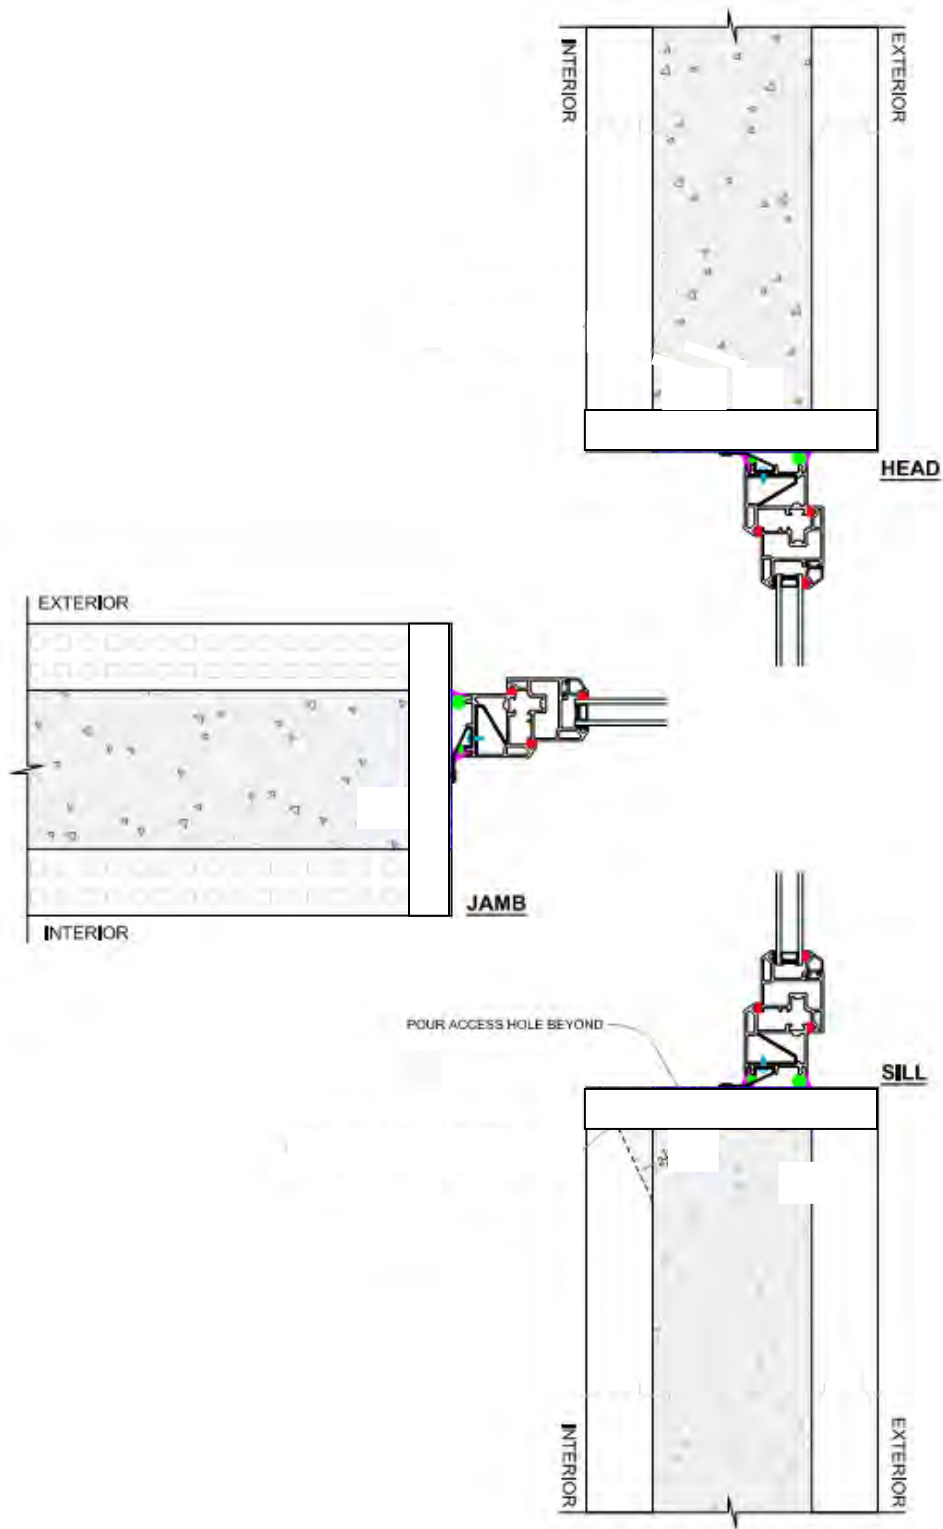
TEST MODULE 1B
EXTERNAL WITH BUCK FLASH

The Gorilla Buck ICF wall was constructed in a similar manner as Module 1B; the only change is that the wooden buck is replaced with a Gorilla Buck around the window.

The Gorilla Buck is a proprietary system constructed from expanded polystyrene (EPS) for window and doors openings in ICF construction.
