Low Energy Monitoring Research Report

North Park Passive House, Victoria, B.C.

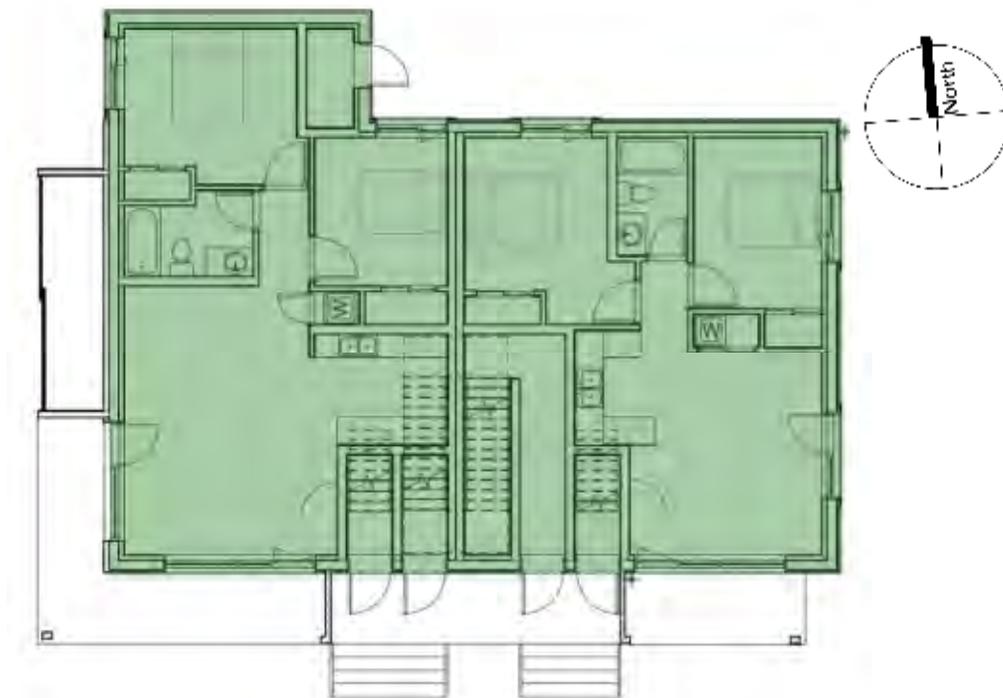
Figure 2-1: Typical floor layout

Total (conditioned) floor area is 424 m² (4,560 ft²). Gross Floor Area (GFA) including exterior walls is 469 m² (5,050 ft²).⁴ The floor plate is a simple rectangular shape, with one cut-out in the rear, as shown in *Figure 2-1* below.

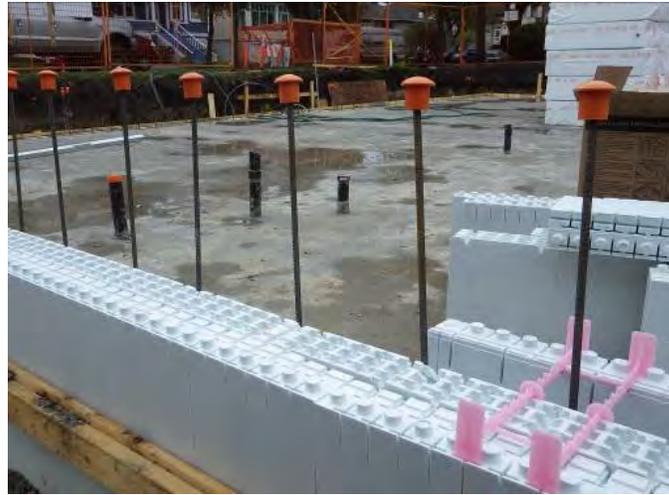
Exterior Above-Grade Wall: 38 x 184 mm (2x8) wood stud wall 600 mm (24") OC, filled with 64 kg/m^3 (4 lb/ft^3) dense pack blown-in cellulose + 38 x 89 mm (2x4) service cavity filled with mineral wool batts.

Effective Assembly U-value: $U=0.154 \text{ W/(m}^2\text{K)}$ (RSI-6.5) (R-37)

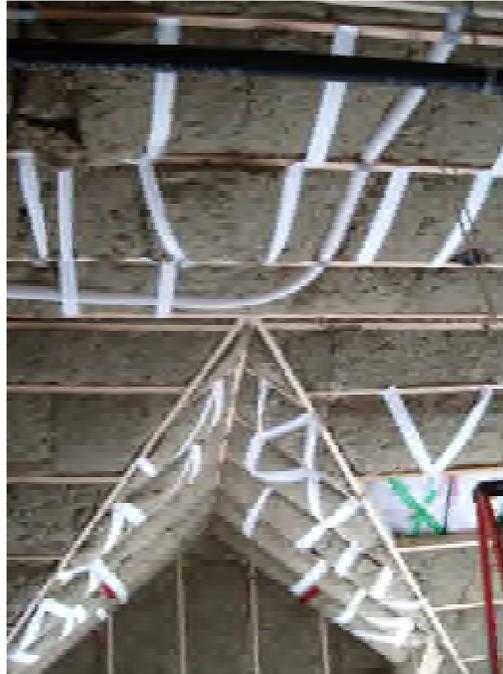
Roof: Insulated, vented cathedral roof with 280 mm (11") rock wool between roof trusses + 38 x 89 mm (2x4) service cavity filled with mineral wool batts.

Effective Assembly U-value: USI-0.102 W/(m²K) (RSI-9.8) (R-56)

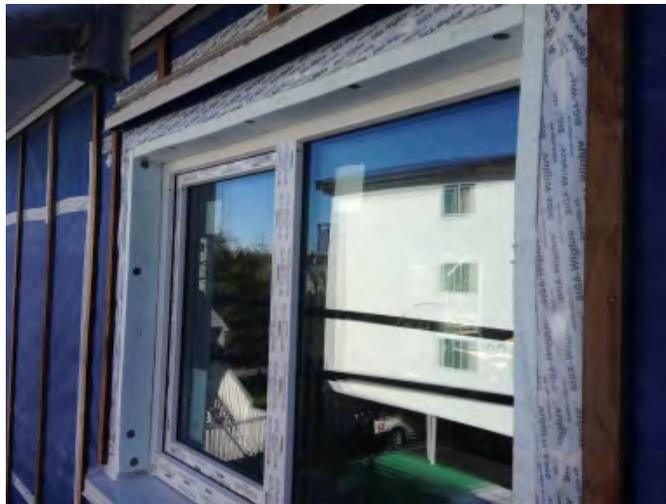
Windows: Passive House certified triple glazed, argon filled vinyl windows and patio doors

Installed average U-value: USI-0.87 W/(m²K) (RSI-1.1) (R-6.5), varies by dimension

Solar Heat Gain Coefficient (SHGC): 0.39

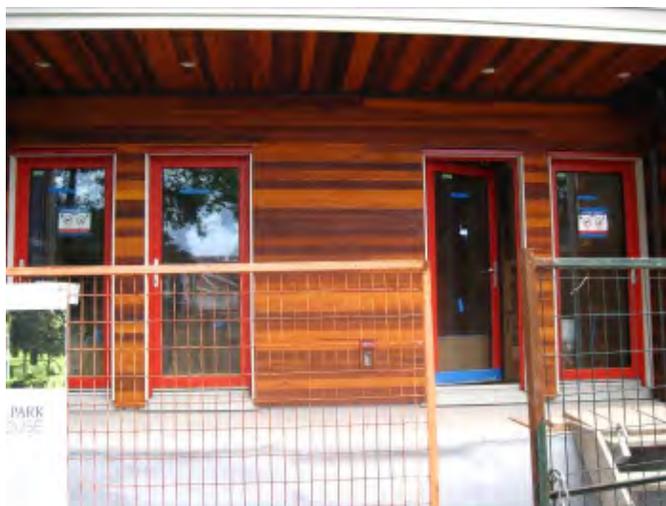
Entry Doors: Passive House certified wood exterior glazed doors

Installed U-value: USI-0.93 W/m²K (RSI-1.1) (R-6)

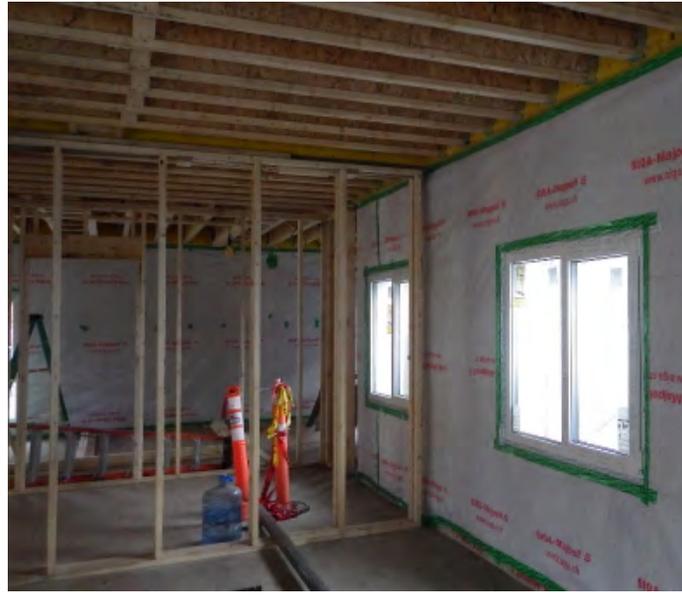
Air & Vapour Barrier: SIGA Majpell on interior of deep stud wall and on interior truss framing in roof. All transitions taped with SIGA Rissan.

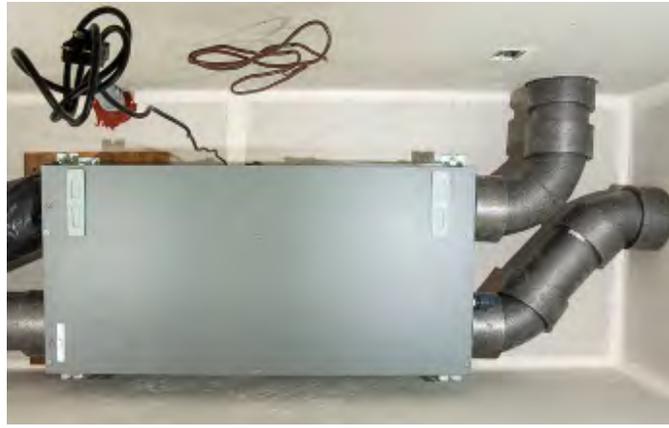
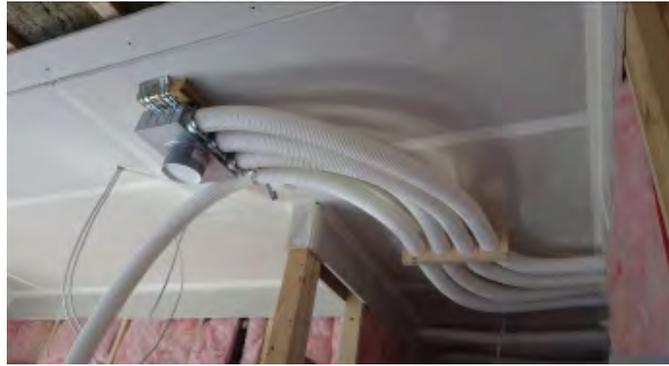
Passive House certified HRV; one Zehnder ComfoAir 200 unit per suite:

Nominal efficiency: 92%

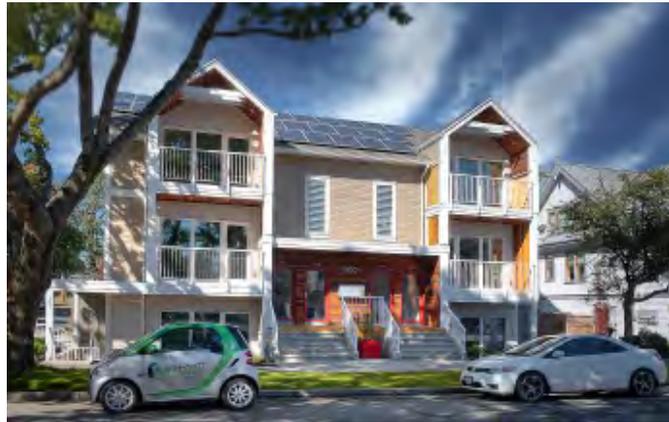
7 kW rooftop photovoltaic solar array on the south facing roof, with net metering to BC Hydro

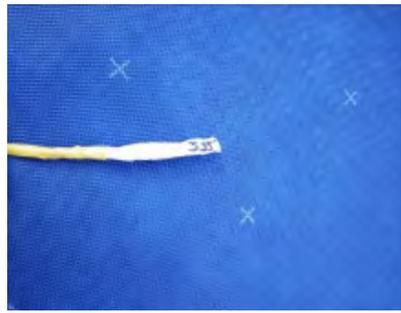
Thermoset polymer capacitive sensor with onboard signal conditioning	±3.5%, from 10%-90% RH

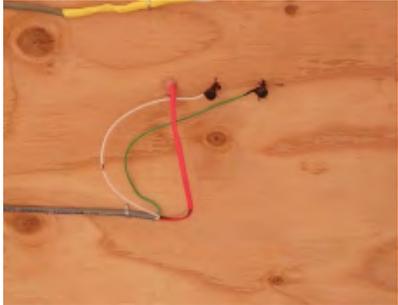
In-situ electrical-based resistance measurements between corrosion-resistance and electrically insulated pins, including 10k NTC thermistor	$\pm 3\%$, with temperature and wood species correction.

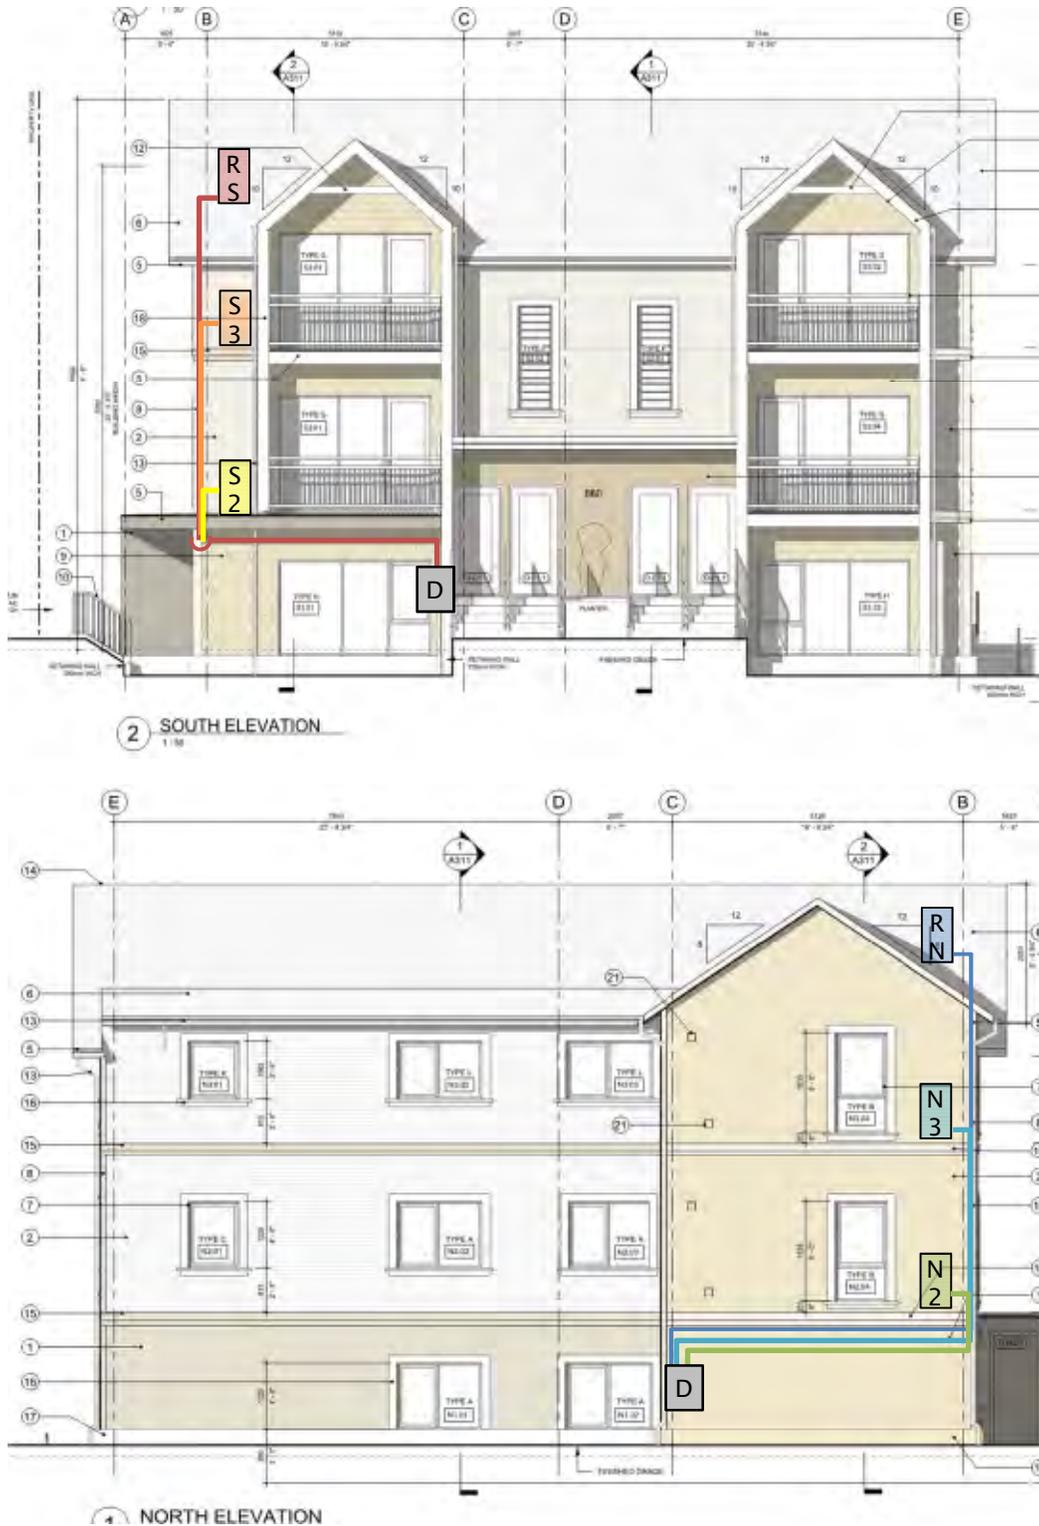
Figure 3-4- North and South elevations showing approximate locations for the instrumented enclosure sections.⁶

⁶ The nomenclature for the assemblies follows the orientations (N or S) for the walls, followed by the floor level (2 or 3). The roofs are identified by an R and the orientation (N or S). The data acquisition system is positioned in the ground floor and is lettered by a D.

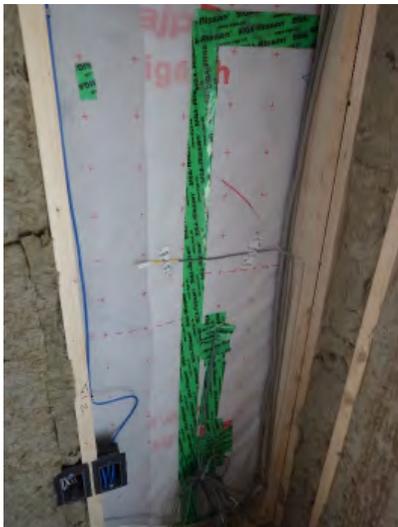
A photograph of the phased sensor installation is provided in Figure 3-6.

Figure 3-6 – S2 interior relative humidity and thermistor in partial installation (awaiting insulation).

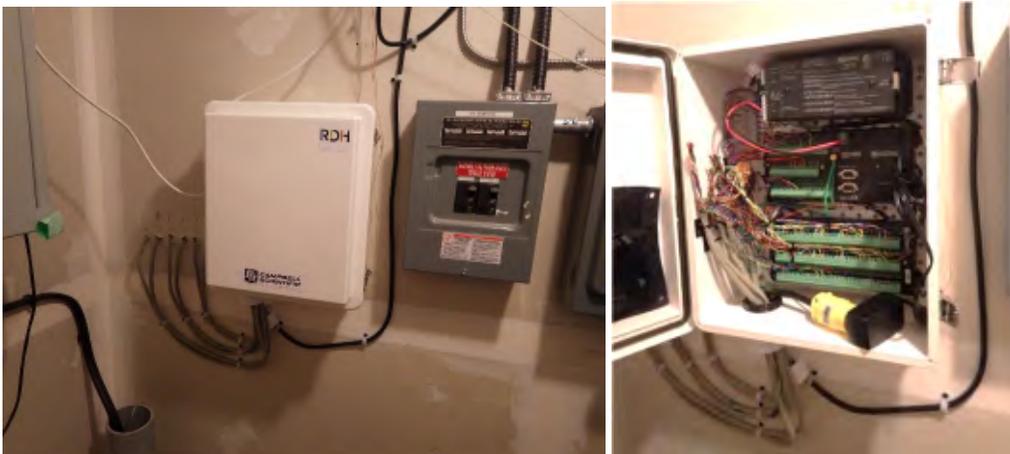
Figure 3-8 – Campbell Scientific CR1000 Data Logger and Multiplexer

The data logger was installed in the common electrical room. The data logging system consisted of the data logger (CR1000) with a multiplexer (MUX), which permitted collection of 76 single-ended channels of data (shown in Figure 3-8). The data were recorded on a 5-minute basis and averaged over an hour. The internal program included the conversion from raw data unit into functional units, including any required corrections.

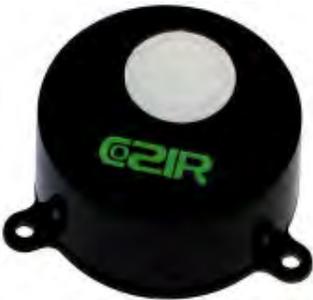
<p>(from co2meter.com)</p>	Carbon dioxide sensor (COZIR 2K)	±50ppm or ±3%

The temperature, RH, and CO₂ sensors were installed in a hollowed out smoke detector on the underside of the ceiling in the two critical locations for the suites: the living room and the master bedroom. The locations are shown in Figure 4-1.
