**TESTING R22+WOOD-FRAME WALLS FOR  
HYGROTHERMAL PERFORMANCE IN THE  
VANCOUVER CLIMATE: FIELD WALL  
PERFORMANCE**

Project Number: 301013124 R22 Wall Testing

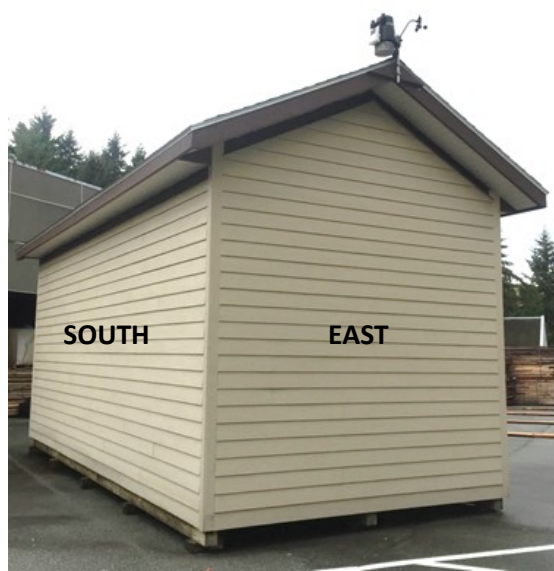
**Figure 1.** Exterior of the finished test hut

The test hut is positioned away from surrounding buildings so that it is well exposed to the elements (Figure 1) and is oriented so that each of the four walls face one of the cardinal directions. With a column spacing at 1200 mm (4 ft.), the frame of its walls is built to allow installing 10 wall panels, each measuring 1200 mm (4 ft.) wide and 2400 mm (8 ft.) tall in the north and the south orientations. It also has a double-size bay (2400 mm (8 ft.) by 2400 mm (8 ft.)) in its east-facing wall to accommodate two wall panels. A total of 12 test wall panels were built in the laboratory and installed on the test hut from June to August 2018. One replicate of the wall assemblies, labelled from No. 1 to No. 5, is installed north-facing (i.e., N1, N2, N3, N4, and N5), while a second replicate is installed south-facing (i.e., S1, S2, S3, S4, and S5). Wall assemblies No. 3 and No. 6 are installed to face east (E1, E2), with wall assembly No. 3 serving as a reference wall for these three orientations (i.e., N3, S3, E1, Figure 2).

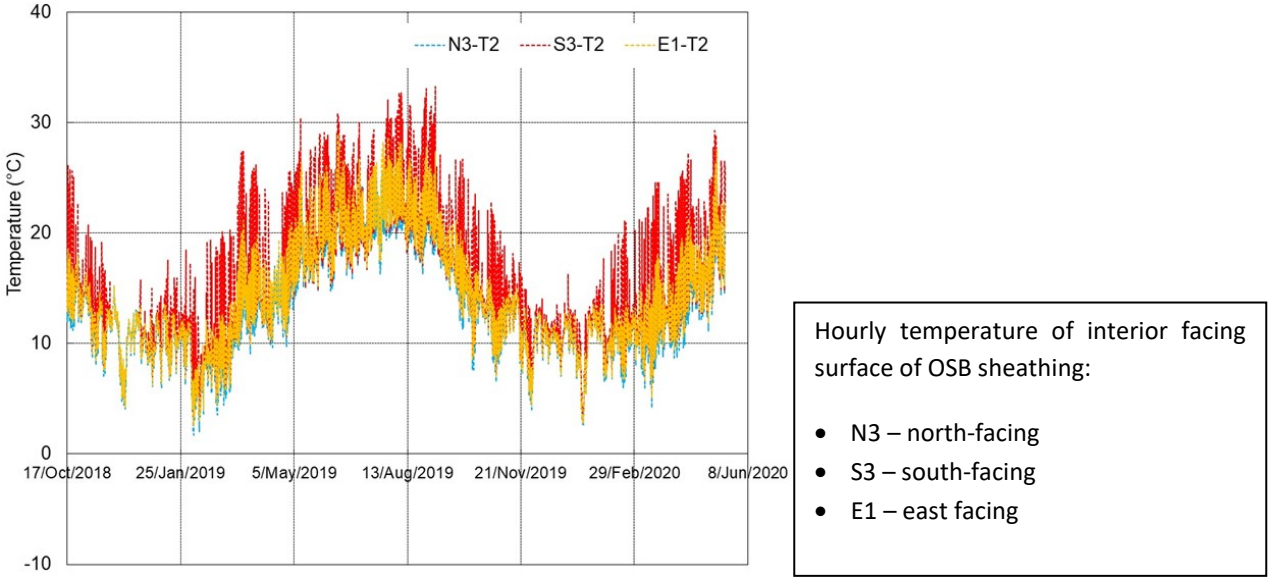
**Figure 10. Comparison of interior surface temperature of OSB in three orientations of wall No. 3**

As expected, the OSB sheathing remains the warmest in the south-facing wall panel S3 and the coldest in the north-facing wall panel N3 (Figure 10). The north-facing wall panels, being the most likely to suffer from poor drying due to the smallest solar effects, are the focus for examining the moisture-related performances below.

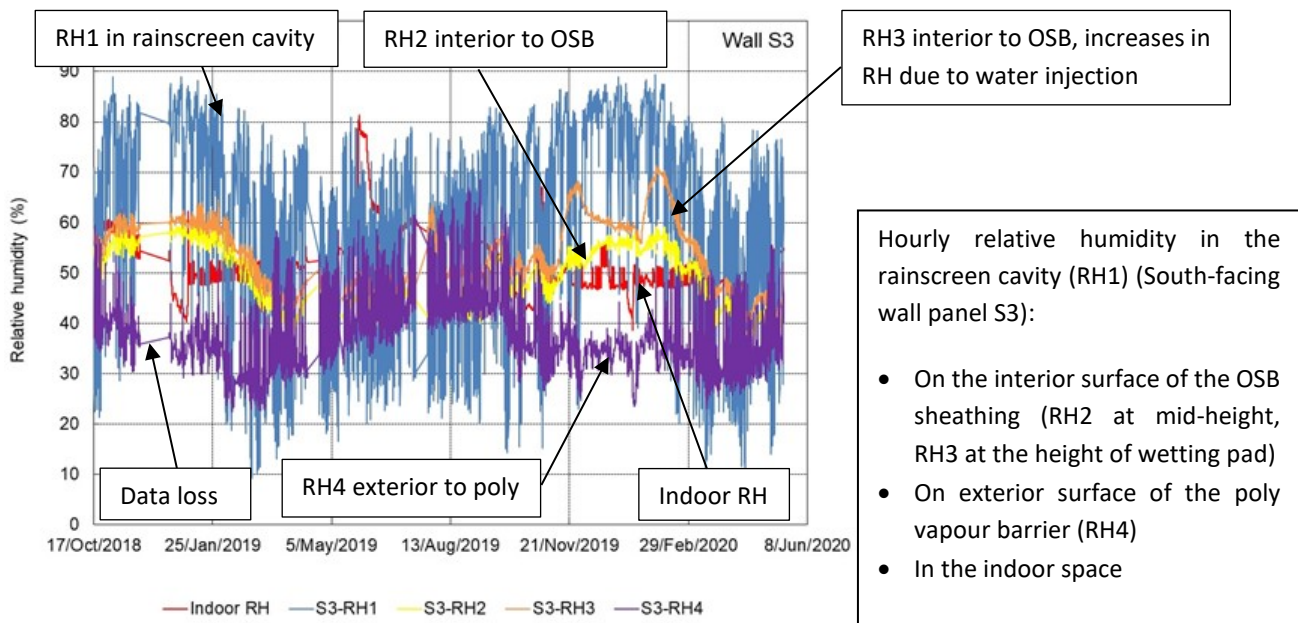
Figure 12. Hourly relative humidity in the rainscreen cavity (RH1) for wall panel S3

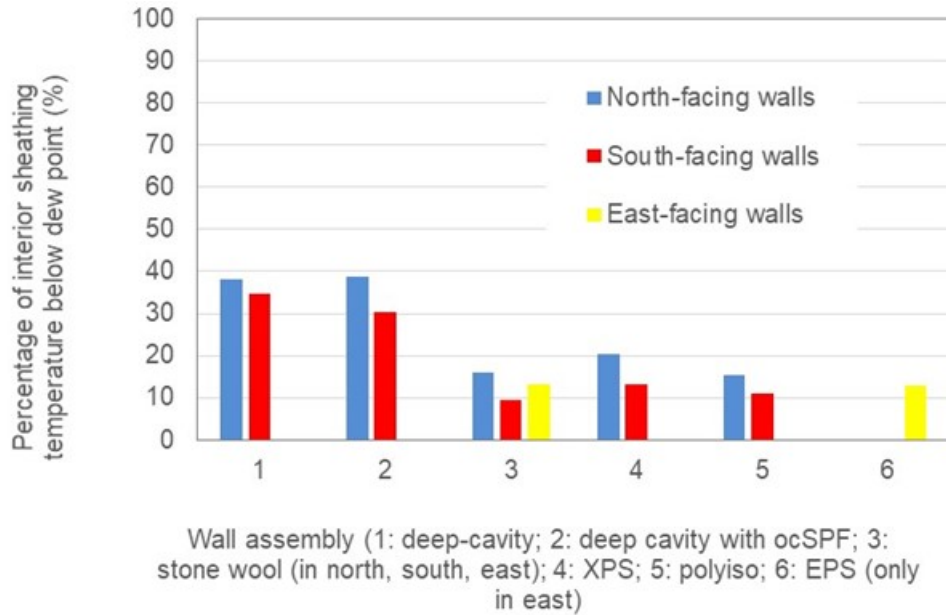
**Figure 19. Percentages of the interior surface temperature of the OSB sheathing falling below the dew point for six wall assemblies in three orientations over the year of 2019**

highest in the winter when the sheathing is colder. Facing south reduces the risk. By comparison, the split-insulated walls No. 3-No. 6, all having exterior insulation to keep the OSB sheathing warmer, have greatly reduced vapour condensation potential (10-20% on a yearly basis). Wall No. 4 has slightly higher potential due to the lower R-value of the XPS (R5) insulation, compared to walls No. 3, No. 5, and No. 6, all with R6 exterior insulation.

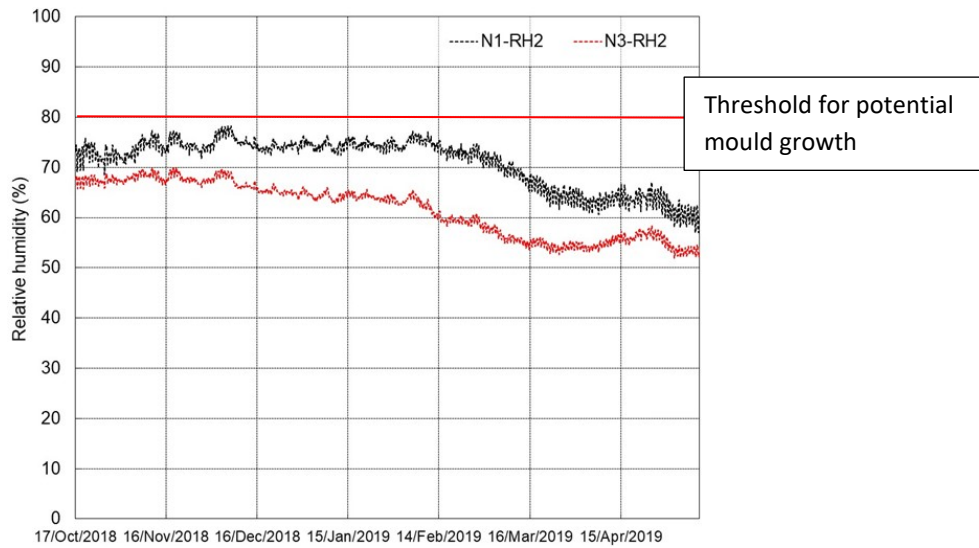
**Figure 20. Relative humidity (RH2) on the interior surface of the OSB sheathing of north-facing test wall panels N1 and N3 (stone wool) over the first winter**

The warmer temperature achieved by applying exterior insulation makes the OSB’s ambient environment drier, which is subsequently expected to improve durability. Examining the test wall panels N1 and N3, the RH2 measurements from N3’s OSB sheathing are lower than those of wall panel N1, by up to 15% in the winter (Figure 20). The major difference between wall panels N1 and N3 is N1 is a deep-cavity wall without exterior insulation, while N3 is exterior-insulated with vapour-permeable stone wool rigid insulation. Both walls have an interior poly vapour barrier to minimize outward vapour diffusion from the interior environment.

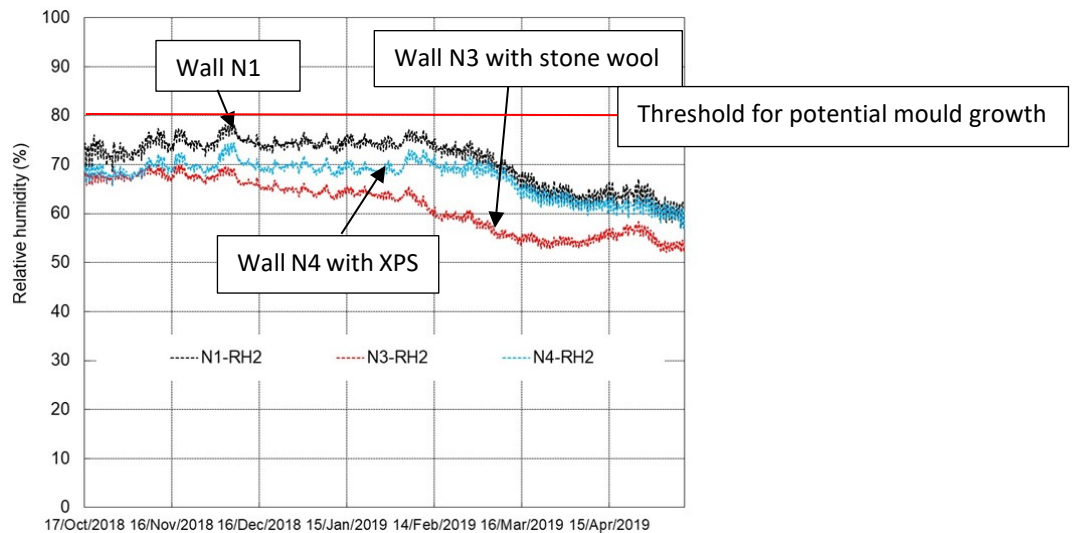
**Figure 21. Relative humidity (RH2) on the interior surface of the OSB sheathing of north-facing test wall panels N1, N3 (stone wool) and N4 (XPS) over the first winter**

Comparing test wall panel N4 (with XPS exterior insulation) to N3 (with stone wool) (Figure 21), it appears that the reductions in the RH2 measurements in N4 are considerably smaller than those in N3, both relative to wall panel N1 (without exterior insulation) over the winter season. Because all these three walls have the same interior poly vapour barrier, the difference is due to the presence and the permeability of the exterior insulation used. This result indicates that the stone wool exterior insulation in wall panel N3, allowing vapour to diffuse towards the exterior environment (i.e., the rainscreen cavity), provides a drier service environment for the OSB sheathing, compared to the less vapour permeable XPS in panel N4.

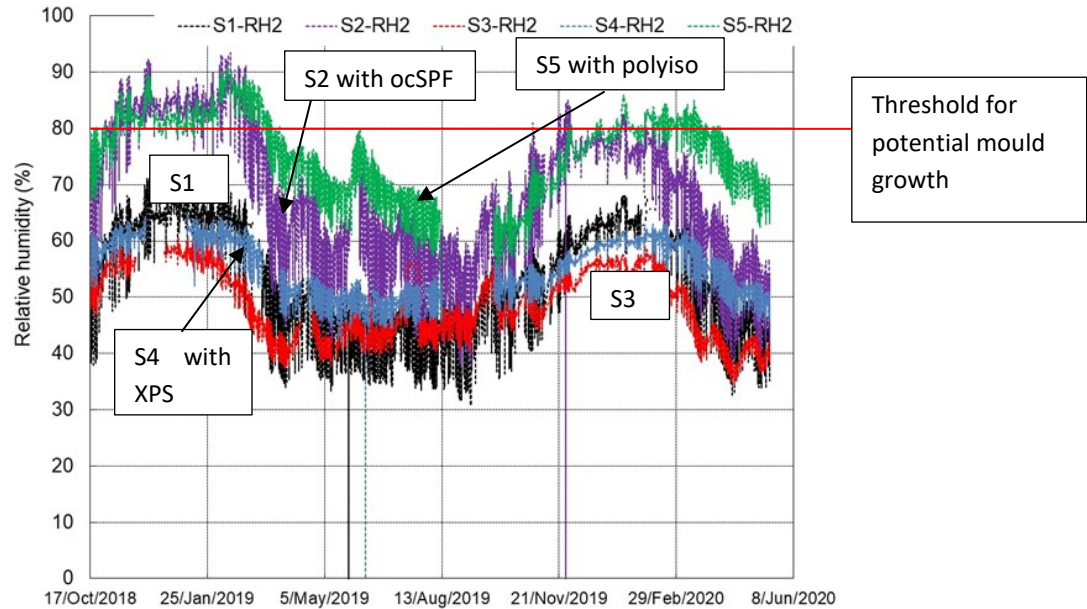
**Figure 25. Comparison of the relative humidity on the interior surface of OSB sheathing of five five-facing wall panels S1, S2 (ocSPF), S3 (stone wool), S4 (XPS), and S5 (polyiso) over the entire test period**

The RH2 measurements from the five south-facing wall panels overall follow similar trends observed from the counterpart north-facing wall panels (Figure 25). But the measurements have much larger fluctuations, as expected, particularly in wall panels S1 and S2, where the OSB sheathings are not covered by exterior insulation and thus more exposed to the exterior environment. Overall, the south-facing wall panels are drier than the corresponding north-facing wall panels. The two east-facing wall panels E1 (wall assembly No. 3) and E2 (wall assembly No. 6) are very close in terms of the RH2 measurements at the interior surface of the OSB sheathing (Figure 26). The EPS exterior insulation in wall panel E2 has much lower vapour permeance than the stone wool exterior insulation used in wall panel E1 but is more permeable than XPS. Among the four exterior insulation products covered in this study, the Canadian building code only considers foil-faced polyiso to be a vapour barrier material. Foil-faced polyiso has a dry cup vapour permeance close to zero (see material properties in Appendix I, Table 4, ASTM 2010).

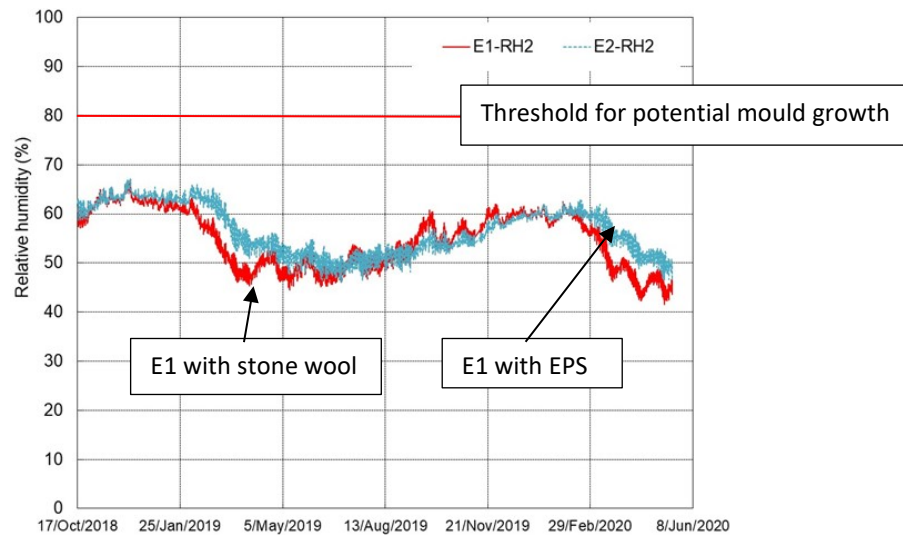
**Figure 26. Comparison of the relative humidity on the interior surface of OSB sheathing of two east-facing wall panels E1 (stone wool) and E2 (EPS) over the entire test period**

Figure 24, Figure 25, and Figure 26 provide a complete picture of the service environment of the OSB sheathing of all these 12 test wall panels. Among the five north-facing test wall panels (Figure 24), wall panel N2 overall shows the highest humidity levels on the interior surface of the OSB sheathing, followed by wall panel N5. The RH2 levels from these two walls consistently remain above 80% in the two winter seasons, indicating a high risk of mould growth on the sheathing. It also implies the interior vapour-retarding paint(s) used are not able to effectively prevent outward vapour diffusion from the humid indoor space. By comparison, wall panels N1, N3, and N4 show better performance, with their RH2 measurements consistently staying below 80% over the entire test period. Among these three wall panels, N3 overall shows the lowest humidity close to the OSB sheathing, wall panel N1 has the highest RH levels, and wall panel N4 is between N3 and N1.

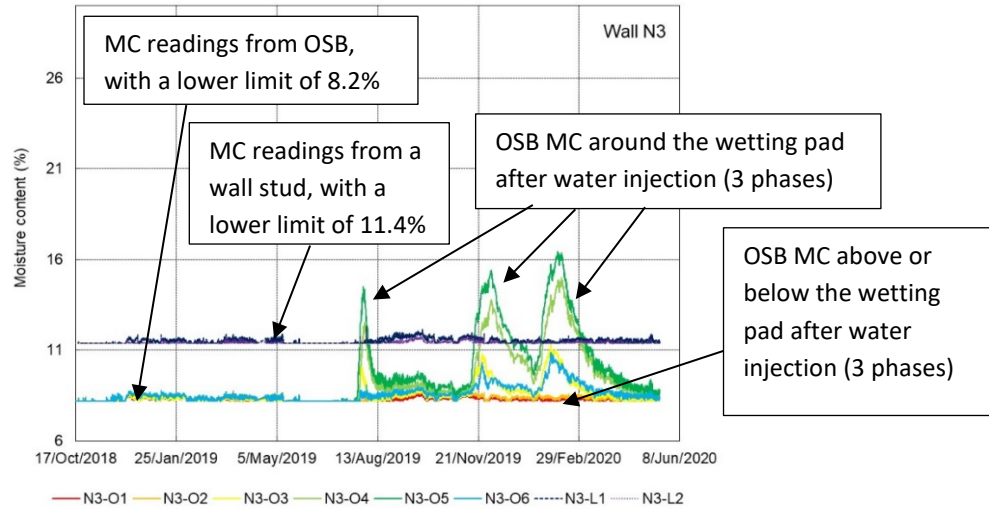
**Figure 27.** Moisture content measured from the OSB sheathing (O1-O6) and a wall stud (L1, L2) of north-facing wall No. 3 (wall panel N3) with stone wool exterior insulation

dry, showing little seasonal effect. The wall design provides the OSB sheathing with a good drying capacity; its MC drops quickly and mostly remains below 16% after each phase of water injection.

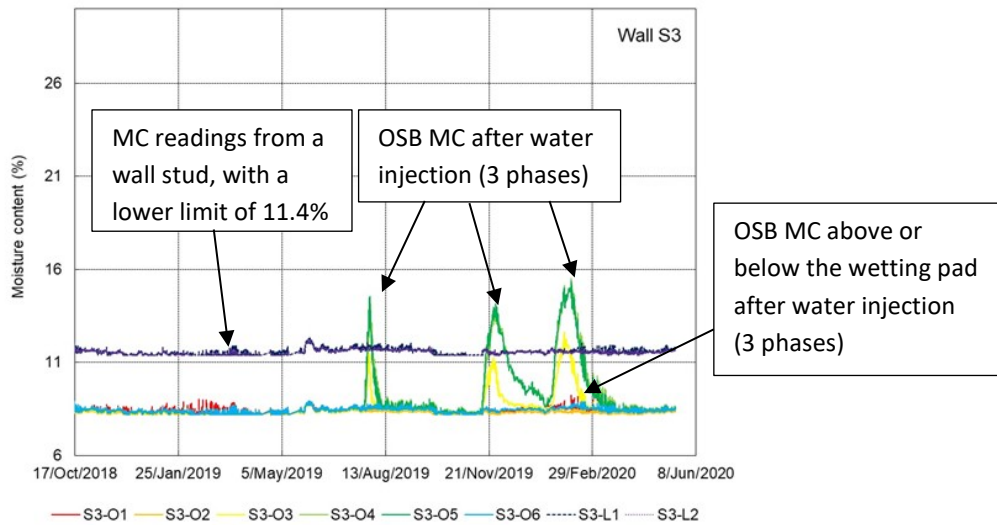
**Figure 28.** Moisture content measured from the OSB sheathing (O1-O6) and a wall stud (L1, L2) of south-facing wall No. 3 (wall panel S3) with stone wool exterior insulation

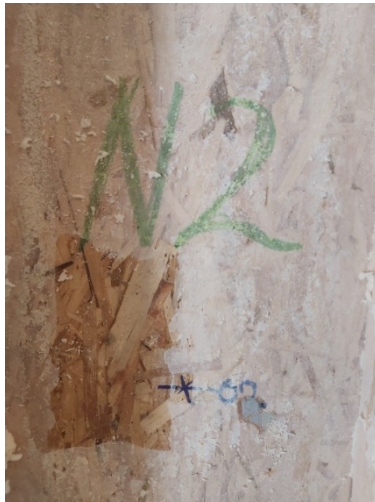
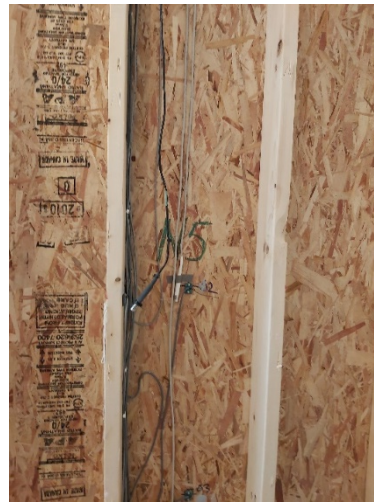
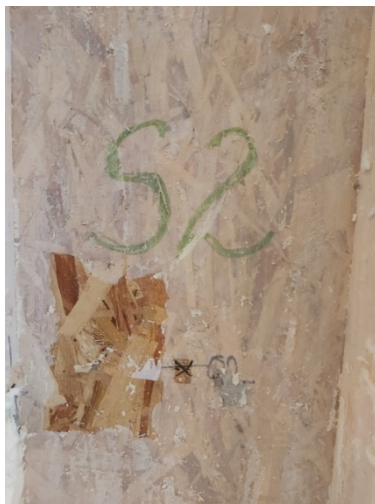
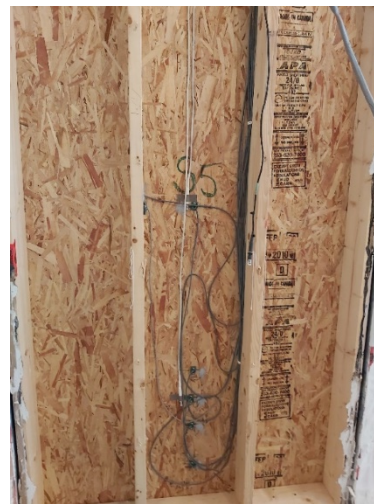
**Figure 51. Photos of interior appearance of OSB sheathing of wall panel N2, N5, S2 and S5, following completion of testing in July 2020**

The wood components, particularly the OSB sheathing were carefully checked when the test wall panels were deconstructed in July-August 2020. The field inspection was focused on the OSB’s interior surface for comparison with the MI calculations above, given the fact that the temperature and RH used for calculating MI were measured from the interior surface. It was found that all of the OSB sheathings, including that of the test wall panels N2 and N5 were clean, without any visible mould growth (Figure 51). In terms of wall assembly No. 2, the spray foam appeared to seal the entire OSB sheathing on its interior surface and may have prevented mould growth by reducing the oxygen supply, as suggested by other researchers (Smegal et al. 2017).

sources. Second, mould growth can be highly variable, given the large variations in both wood and fungi growth. Lowering the sensitivity class of the OSB sheathing to “Sensitive” considerably reduces the calculated MI and appears to better match the field observations.

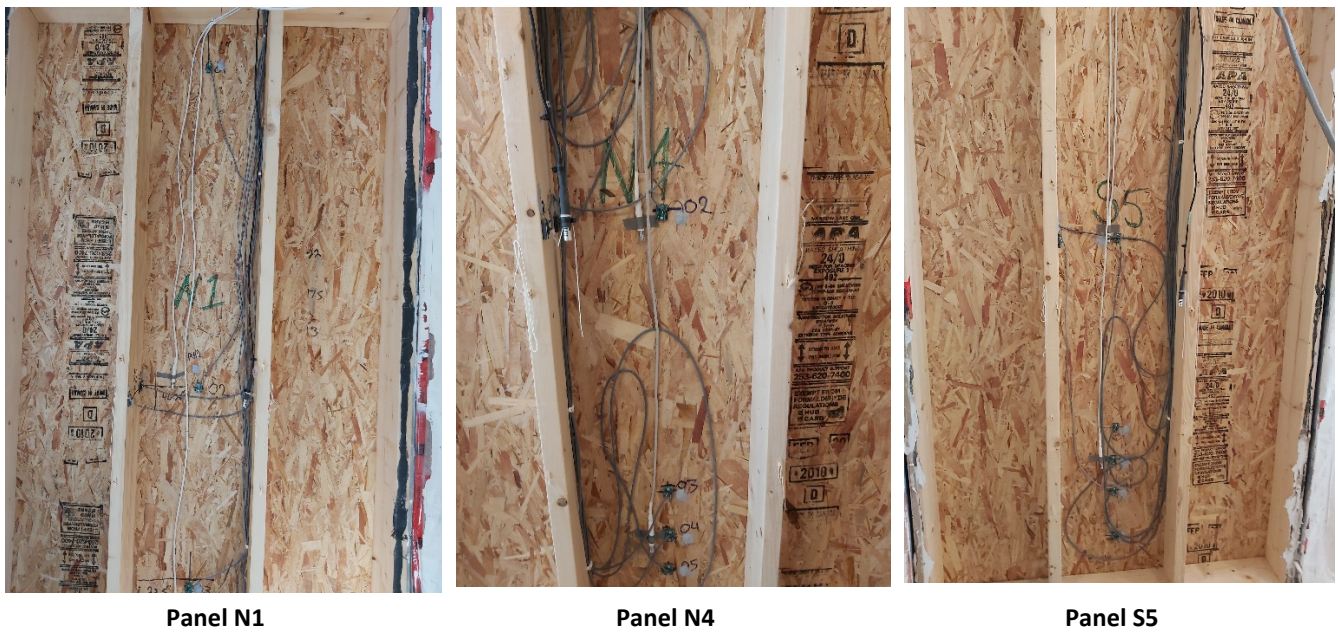
**Figure 117. Visual condition of OSB sheathing of selected wall panels at the completion of testing in July 2020**

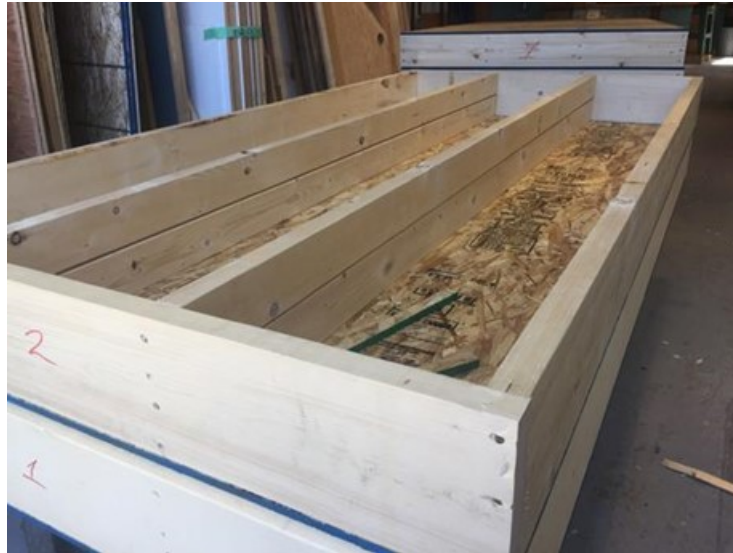
Figure 119. A double-stud wall with a 6 mm gap between the two rows of studs

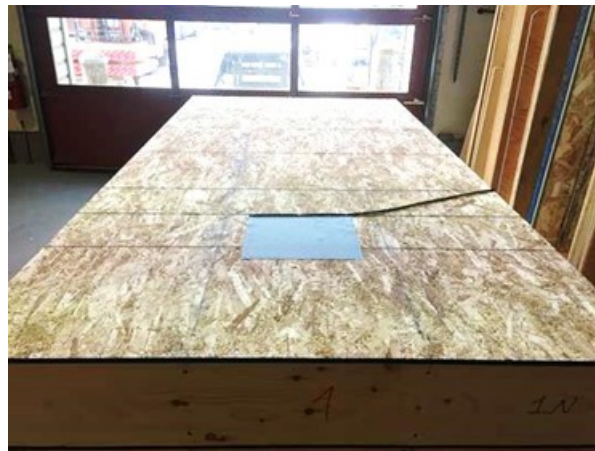
Figure 120. A paper towel together with a plastic tube installed on the exterior surface of the OSB sheathing for injecting water in the future

To simulate water leaks from, for example wind driven rain, and to further stress the test walls for assessing their drying performance, water was injected into the wetting pad located on the exterior surface of each OSB sheathing (see the wetting pad installed on OSB in a picture Figure 120) in three phases in different seasons. The injection was provided once or twice daily over five consecutive days in late July 2019, nine days separated by a weekend in November 2019, and 10 days separated by a weekend in January 2020. A total of around 200 mL of water was injected into each wall in each phase (see Appendix II,

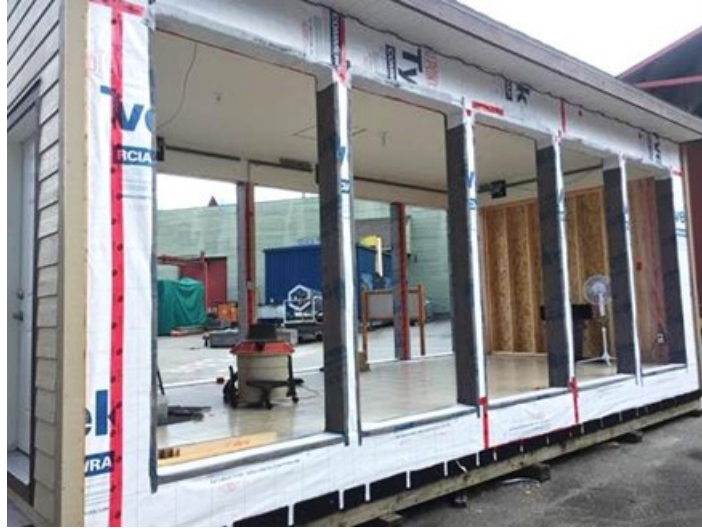
Figure 121. The perimeter of each wall opening pre-sealed with membranes, with gasket installed at the bottom

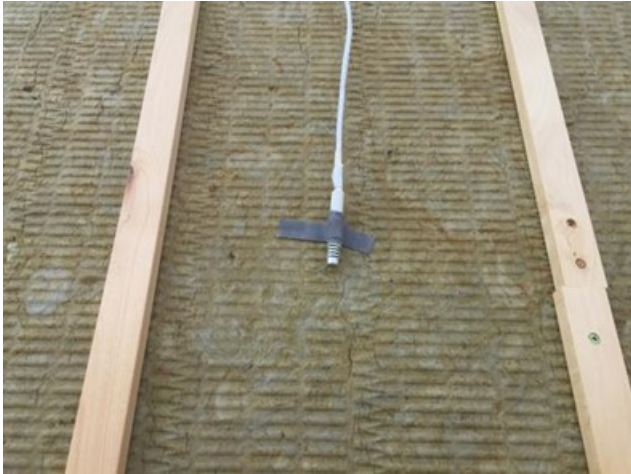
Figure 122. An RH/T sensor installed in the rainscreen cavity, being exterior to the exterior stone wool insulation
