Study of High-Rise Envelope Performance in the Coastal Climate of British Columbia

October 2, 2001

STUDY OF HIGH-RISE ENVELOPE PERFORMANCE IN THE COASTAL CLIMATE OF BRITISH COLUMBIA

RDH Building Engineering Limited

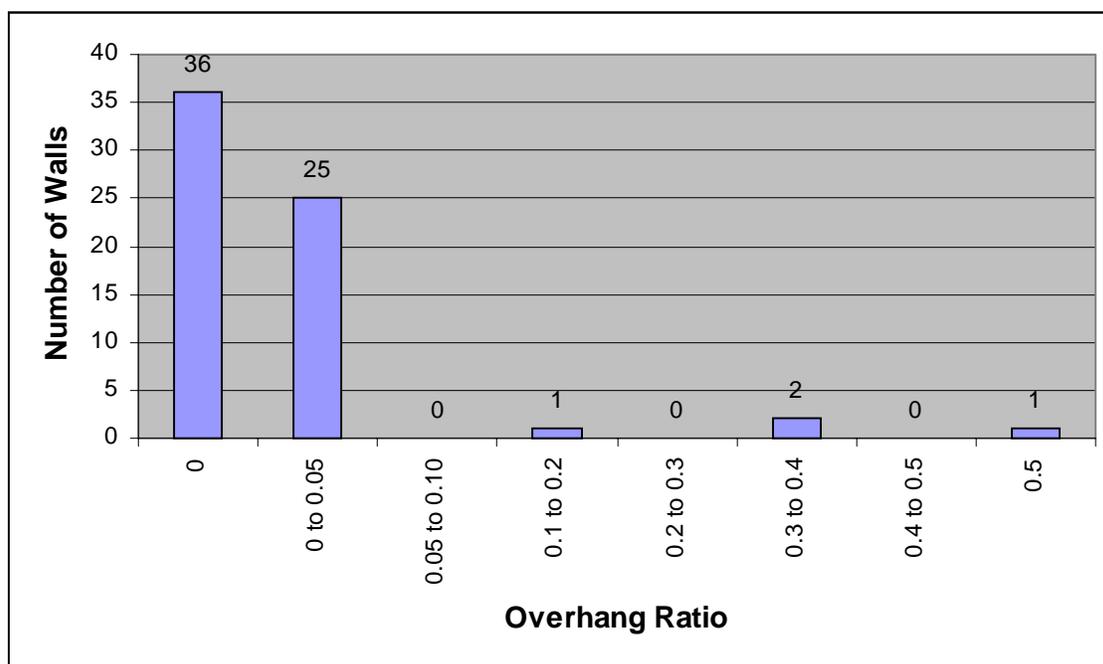
**FIGURE 3.6
DISTRIBUTION OF WALL OVERHANG RATIOS**

Figure 3.6 shows the distribution of overhang ratio for walls in the database. About 2/3 of the walls defined have no overhang at all. Only 4 walls have an overhang ratio greater than 0.1 (equivalent to 250mm (10”) per storey of height); all of these walls are one storey or less in height, and none were damaged.

No relationship was found between the overhang ratio and the percentage of walls that were damaged by moisture exposure. Five of the 35 main wall assemblies (making up most or all of the height of the building) were not damaged; 3 of these walls had no overhang and the other two had very small overhang ratios, equivalent to an accent reveal band at the top of the wall.

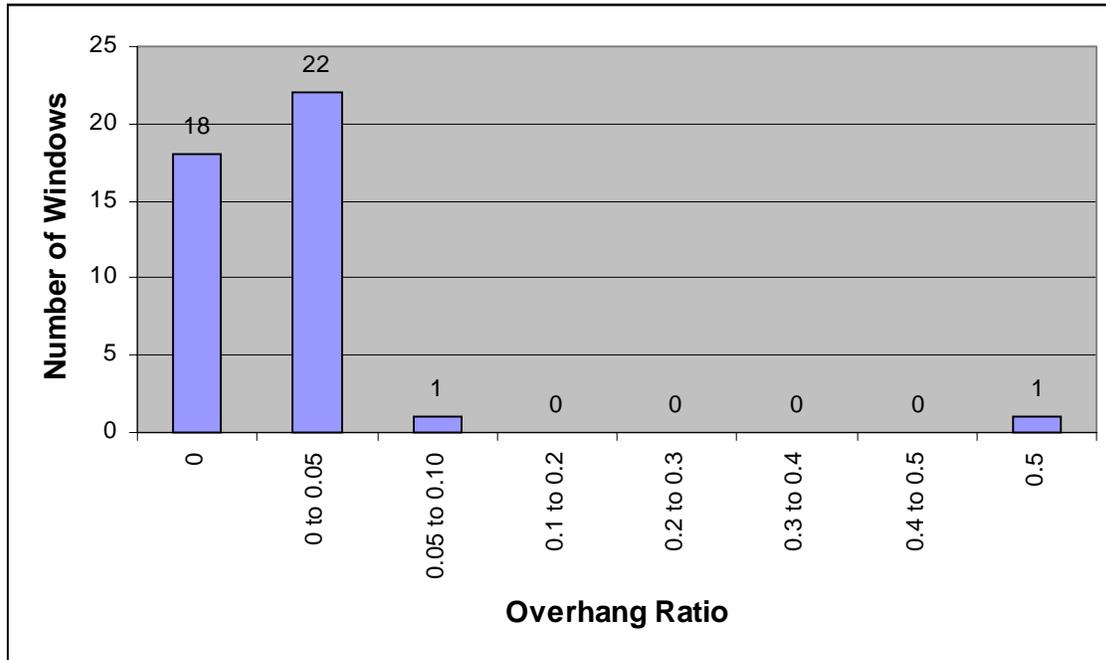
**FIGURE 3.7
DISTRIBUTION OF WINDOW OVERHANG RATIOS**

Figure 3.7 shows the distribution of window overhang ratio for the 42 window assemblies in the database. Typically, only one or two different types of window assembly are used on these buildings. 25 of the 42 window assemblies are essentially flush with the exterior wall face and have no overhang. The remaining 17 assemblies have small overhangs, some of which represent windows rebated within the surrounding wall assemblies, and some of which are protected by the overhangs within the wall above. No relationship was found between the overhang ratio and the percentage of windows that were damaged by moisture exposure.

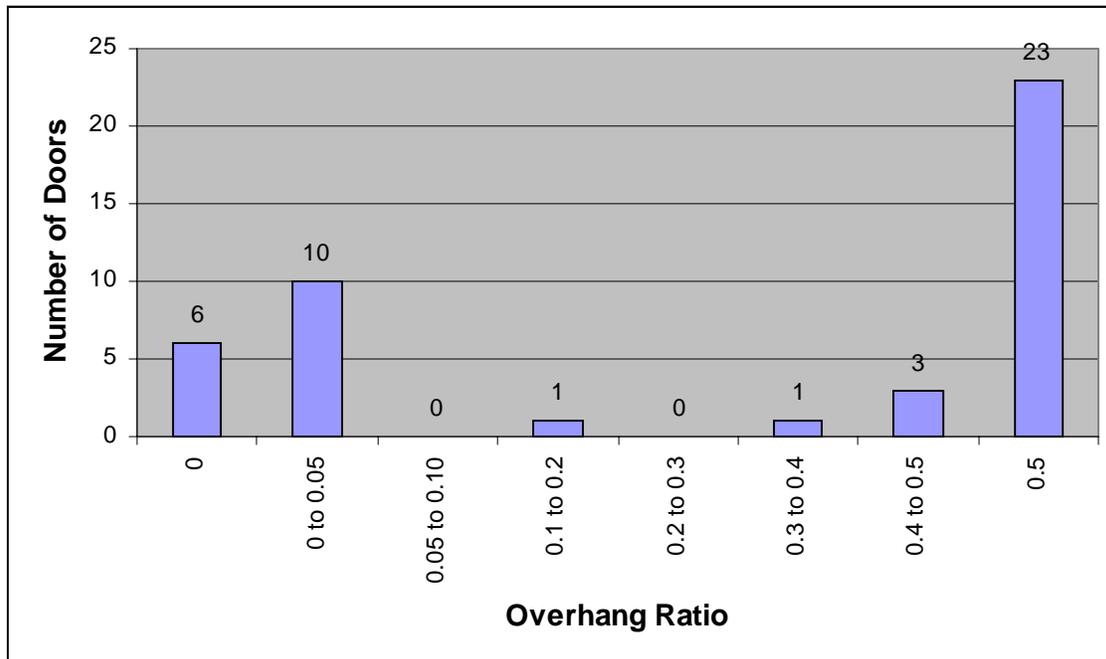
**FIGURE 3.8
DISTRIBUTION OF DOOR OVERHANG RATIOS**

Figure 3.8 shows the distribution of door overhang ratio for the 44 door assemblies in the database. The overhangs on doors are typically large as a result of balconies being located in vertical stacks so that the balcony above shelters the door to the balcony below. More than half of the buildings provide this protection even to doors located on the top floor, which don't have a balcony above.

Only one door assembly problem was reported in the database. This problem was more related to poor drainage of the adjacent deck, rather than to water ingress through the door assembly itself. Typically there are a relatively small number of unprotected doors at upper levels of each building that may fail but their repair is not costly enough to qualify as a problem. The lack of problems found to be associated with door assemblies should not be misinterpreted; the lack of problem occurrence emphasizes the substantial value of large overhangs since by their nature doors are susceptible to moisture ingress if exposed to direct rainfall.

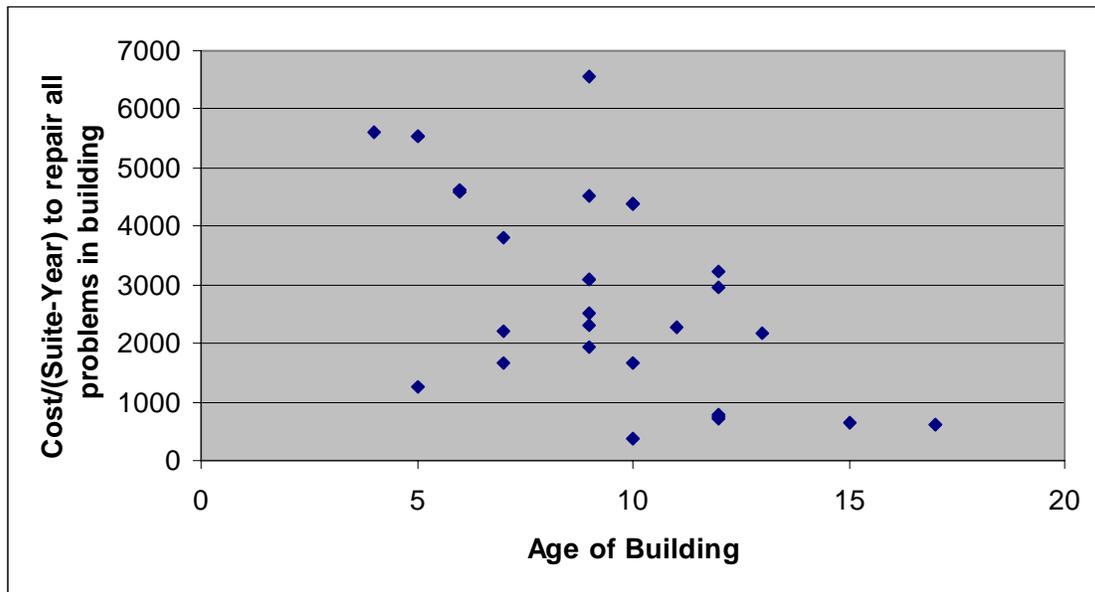
**FIGURE 3.9
COST/(SUITE x YEAR) VS. AGE OF BUILDING**

Regression analysis was carried out in order to determine the importance of variables such as building size and age on the cost of repairs as a result of envelope failures on the high-rise buildings in the study group. Figure 3.9 shows the relationship of Repair Cost/(Suite x Years) to the age of the building. The cost statistic represents the amount of money that each suite owner would have had to put aside each year since the suite was new, in order to pay for the repairs that were required to deal with all envelope problems in the building. The logarithmic correlation of this statistic to the age of the building was over 60%, representing a moderate level of explanation (60% of the variation in cost is explained by the variation in age of the buildings). Since the cost statistic is already normalized for the age of the building, it appears that factors such as different cladding systems and different building heights used on newer buildings also play a role in making the cost greater for newer buildings.

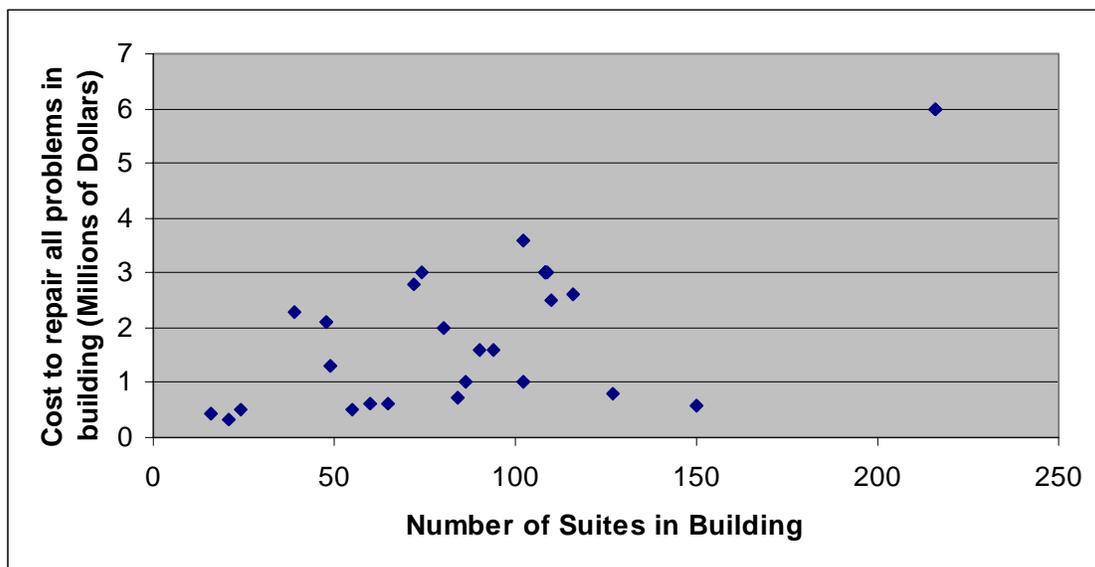
**FIGURE 3.10
COST VS. NUMBER OF SUITES**

Figure 3.10 is a scatter chart showing the relationship between cost of repairs and size of building. As expected, a moderately good correlation coefficient over 0.70 was found for the linear relationship of these variables. The total cost of repairs is closely related to the size of the building.

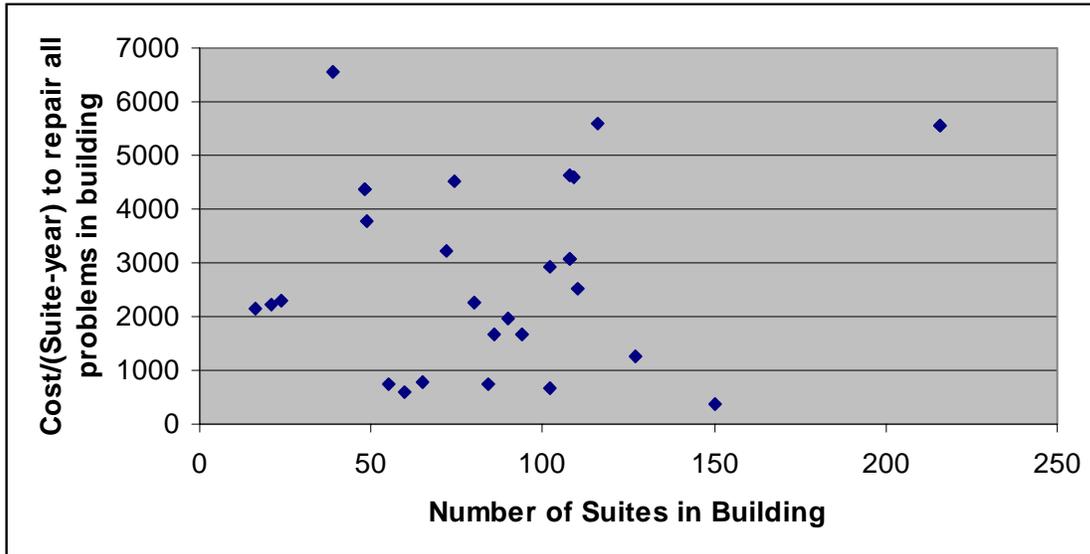
**FIGURE 3.11
COST/(SUITE X YEAR) VS. NUMBER OF SUITES**

The relationship between cost/(suite x year) and the number of suites in the building shown in Figure 3.11 is quite poor, with a correlation coefficient of 0.23 for a linear relationship. Thus, the cost/(suite x year) has little relationship to the size of the building – a suite in a small building costs about as much to repair as one in a large building.

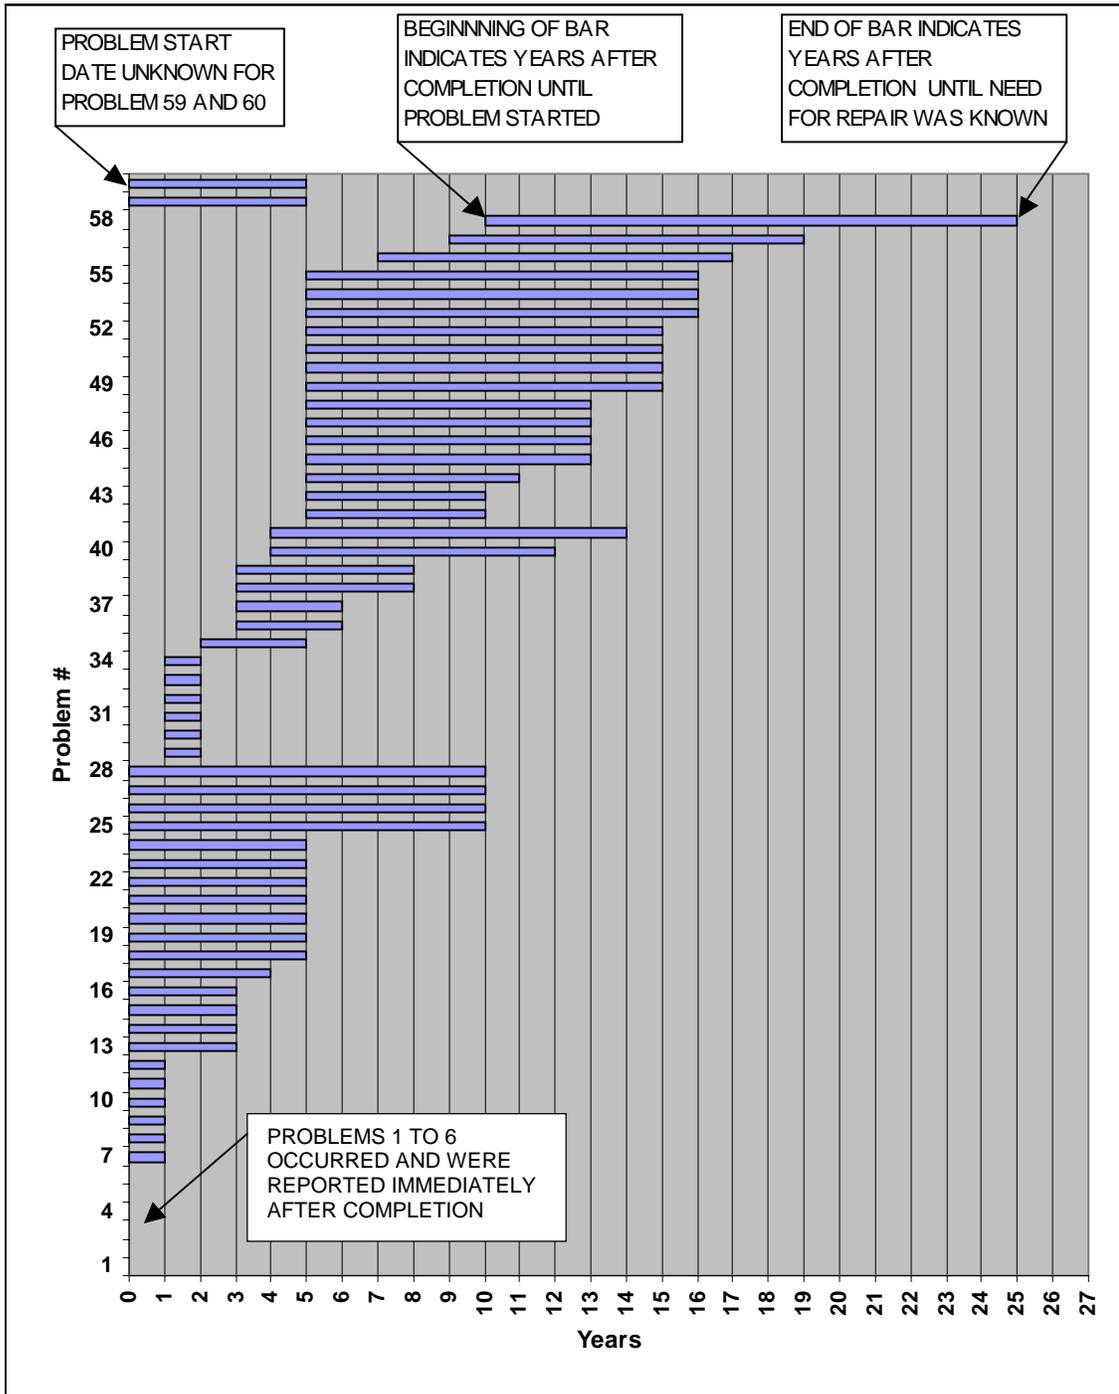
FIGURE 3.12
TIME TO PROBLEM OCCURRENCE AND REPORTING

Figure 3.12 shows the distribution of “Time to Start” and “Time to Report” for the 60 problem reports in the database. Time to Start indicates when the damage resulting in the need to repair started, whereas Time to Report indicates when the owners generally became aware that repairs would be required (not when the first symptoms of damage were reported). Note that nearly half of the problems were considered to be inherent design or construction defects that were allowing water ingress since the time of the original construction of the building. In the majority of cases, there is a time lag of a few years before a problem relating to water ingress through the envelope assemblies is reported. This indicates that assessments of envelope performance issues during the years immediately after construction are failing to identify the problems. This may be due to:

- Time lag for symptoms to become readily noticeable
- Inadequate assessments
- A reliance on the original project team to correct ‘defects’ in the original design and construction such that they are not initially perceived to be problems by the owners.
