Structural Considerations for Frame Supported Gypsum Area Separation Firewalls

BC Advisory Group on Advanced Wood Design Solutions

Edited by: Conroy Lum

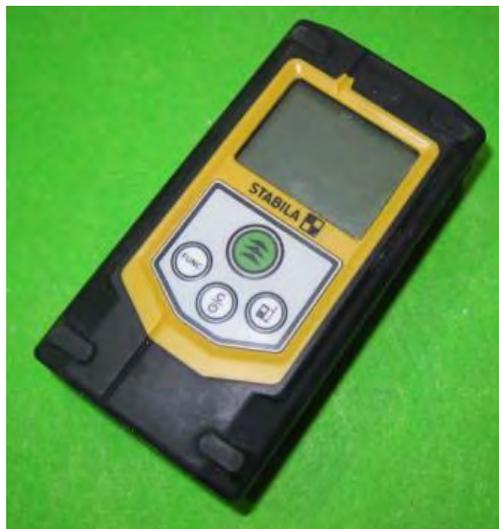
Figure 8 Stabila Laser Measure

After each impact, the bag was removed and the amount of panel deflection along with any damage/failure was recorded. Deflection was measured using a Stabila LD-320 Laser Measure (Figure 8) from the floor to the bottom surface of the center panel. Each drop was repeated 3 times, unless a failure occurred first.

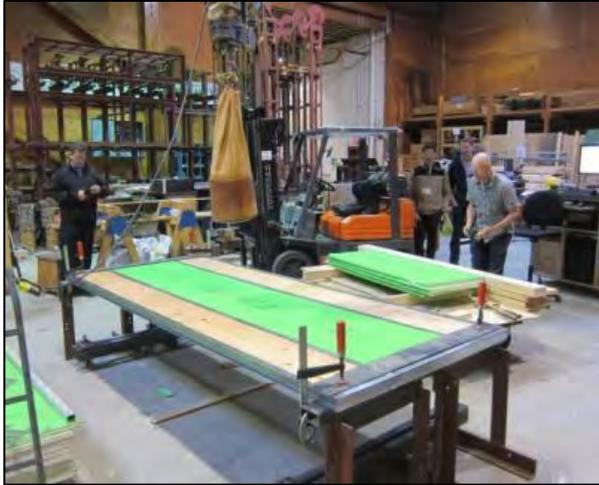
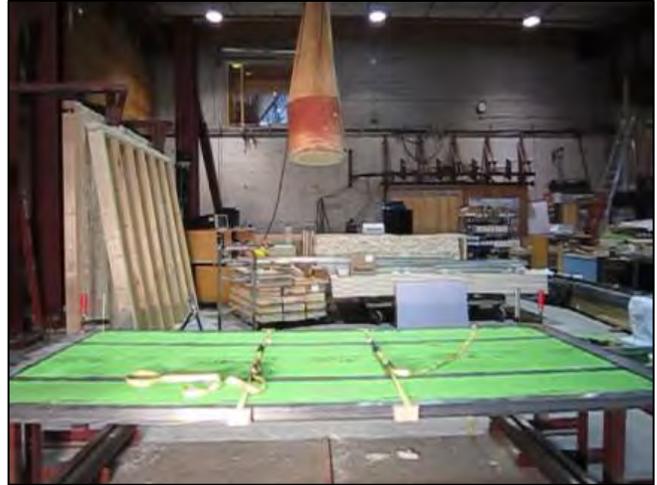
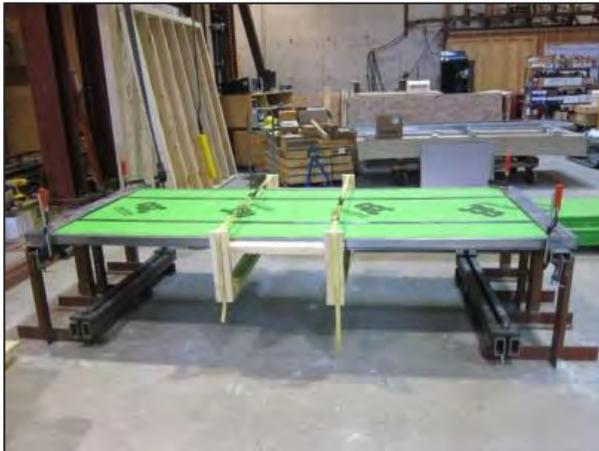
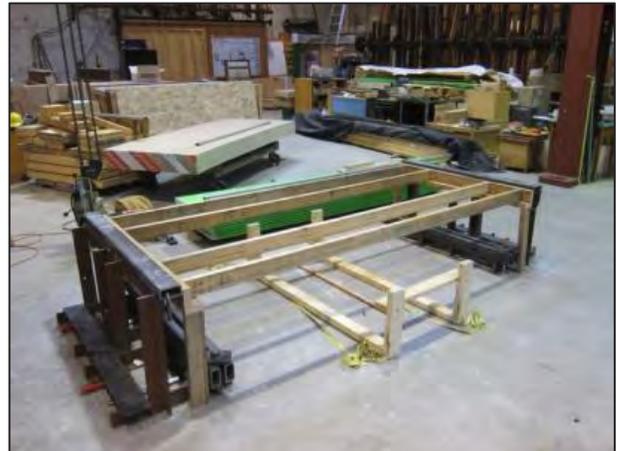
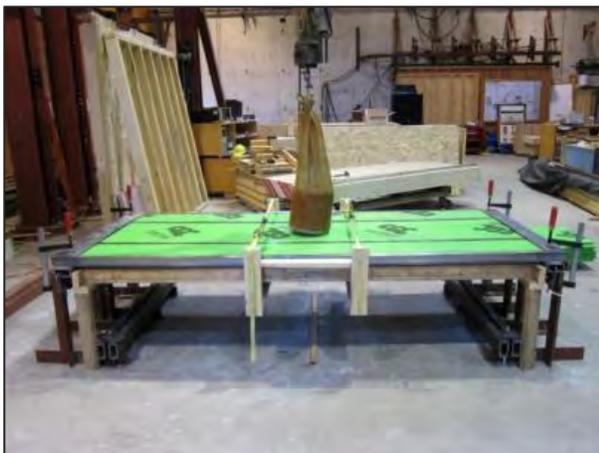
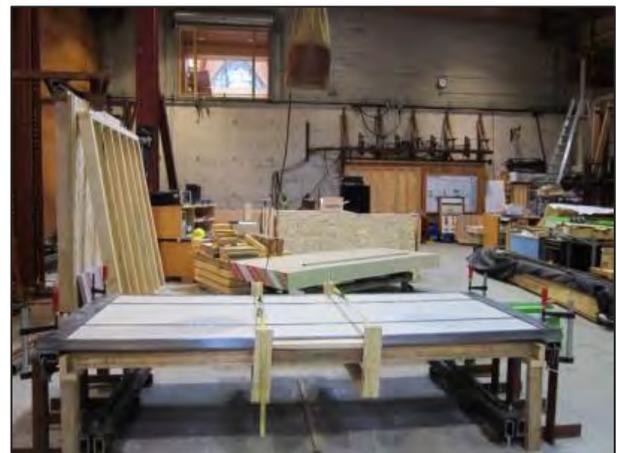
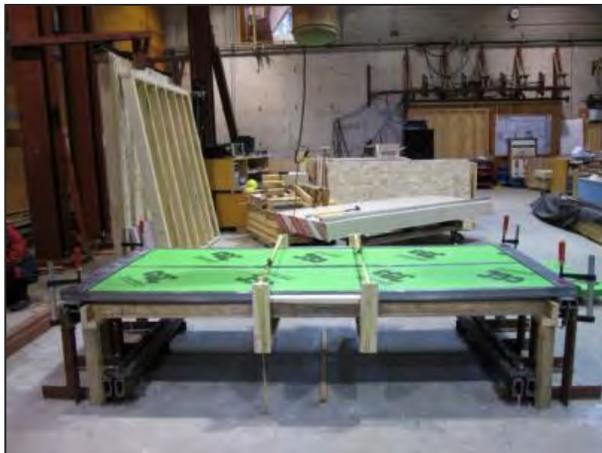
a) 1/2" plywood on each side

b) small wood blocks and straps tied at outer edges of H-studs

c) wooded frame and straps tied at outer edges of H-studs

d) stud frame

e) stud frame below firewall

f) 1/2" Type C gypsum wallboard and stud frame

g) Two 24” wide panels and stud frame

Figure 12 Configurations of impact tests

Figure 12 shows the specimen configurations and test setup.

Specimen	Impact height* (m)	Impact #	Panel deflection (m)	Observation
2 layers of 1” thick fibre-glass GWB on center section, 4 layers of 1/2” plywood on each side (Figure 12a)	0.5	1	0.024	Center H-studs rotated and center portion of panel came loose. Plywood sides may be too stiff.
		2	0.00	No damage.
		3	0.00	No damage.
2 layers of 1” thick fibre-glass GWB on center section and each side, wood blocks and straps tied at outer edges of H-studs (Figure 12b)	1.0	1	0.015	‘Wavy’ deformation on all H-studs.
		2	0.043	Further deformation with center H-studs buckling/rotating slightly and panel coming loose. However, the straps held the panel in place, which prevented further deflection/damage.
		3	0.063	Further deformation with center H-studs buckling/rotating more and bottom center panel coming free. However, the straps held the panel in place, which prevented further deflection/damage.

Specimen	Impact height* (m)	Impact #	Panel deflection (m)	Observation
2 layers of 1" thick fibre-glass GWB on center section and each side, wood blocks and straps tied at outer edges of H-studs (Figure 12b)	1.5	1	0.053	Center H-studs buckled/rotated and center panel came loose.
		2	Panel broke	Panel broke in half.
2 layers of 1" thick fibre-glass GWB on center section and each side, wood frame and straps tied at outer edges of H-studs (Figure 12c)	1.5	1	0.066	Center H-studs buckled/rotated and center panel came loose.
		2	Panel broke	Panel broke in half.
4 layers of 1/2" thick Type C GWB on center section and each side, wood frame and straps tied at outer edges of H-studs (Figure 12f)	1.5	1	0.009	Very slight deformation on H-studs. No apparent damage to panel. Panel bounces off stud frame.
		2	0.012	Further 'wavy' deformation to the H-stud. No apparent damage to the panel. Panel bounces off stud frame.

Specimen	Impact height* (m)	Impact #	Panel deflection (m)	Observation
2 layers of 1" thick fibre-glass GWB on center section and each side, stud frame 1" below gypsum firewall, wood frame and straps tied at outer edges of H-studs (Figure 12e)	2.0	1	0.022	Center H-studs buckled/rotated and center panel came loose. Panel bounces off stud frame.
		2	0.032	Center H-studs buckled/rotated further as well as the side wood frame. Bottom center panel resting on stud frame.
		3	0.037	Center H-studs buckled/rotated further as well as the side wood frame. Bottom center panel resting on stud frame. Panel torn on bottom. When taking apart panels, the bottom layer of the top panel was also torn.

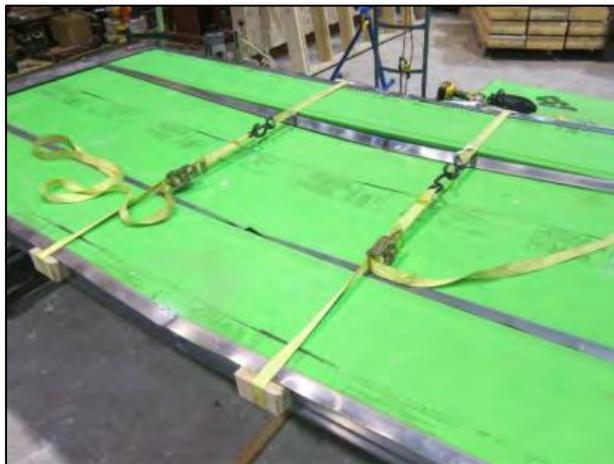
Figure 13 Center H-studs buckling/rotating

Figure 13 to Figure 17 show the typical failure modes that occurred during testing.

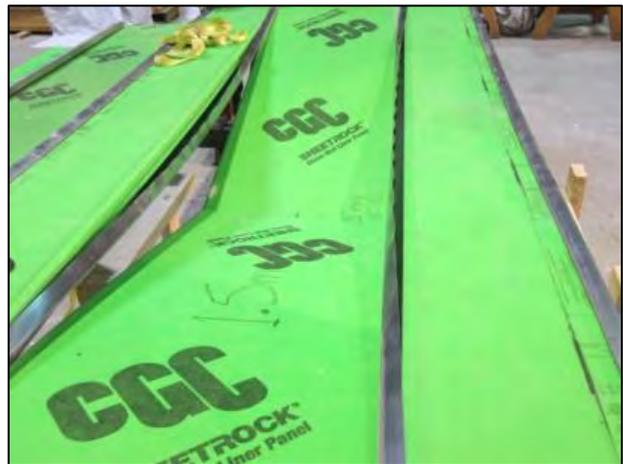
Figure 14 Panel failure

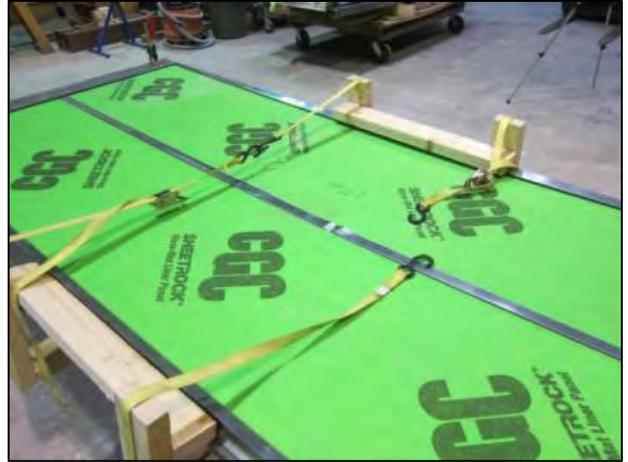
Figure 16 Center H-stud damage for 2 panels

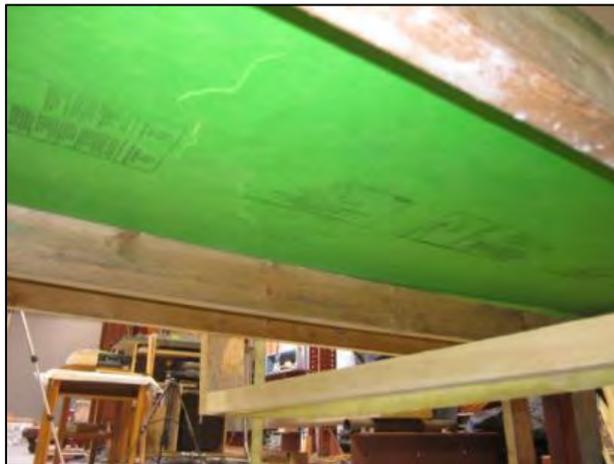
Figure 17 Bottom panel face damage

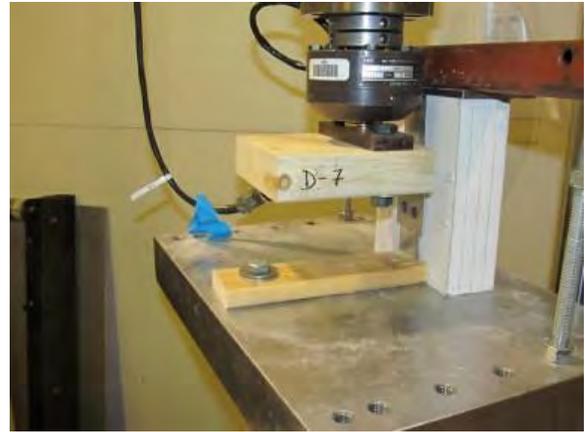
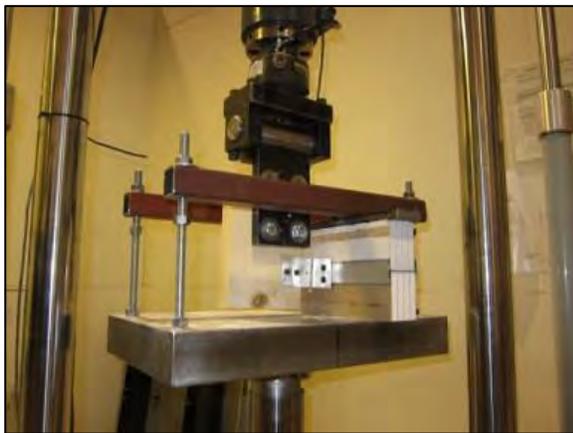
The setups of clip joint tests are shown in Figure 21. The load was applied through a steel plate attached to the specimen. The wood member was prevented from rotation by the steel plate which holds the member in place. The firewall section was held down onto the actuator table by clamping a long narrow metal tube onto the edge of the gypsum. The actuator table moves downward during testing. Loading rate was 0.25 in/min for load condition A and 1.0 in/min for load conditions B and C.

a) Load condition A

b) Load condition B

c) Load condition C

Figure 21 Clip joint test setups

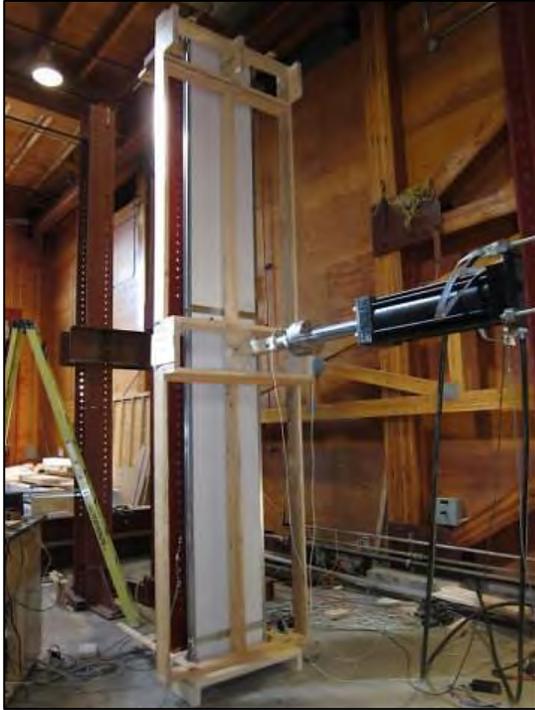
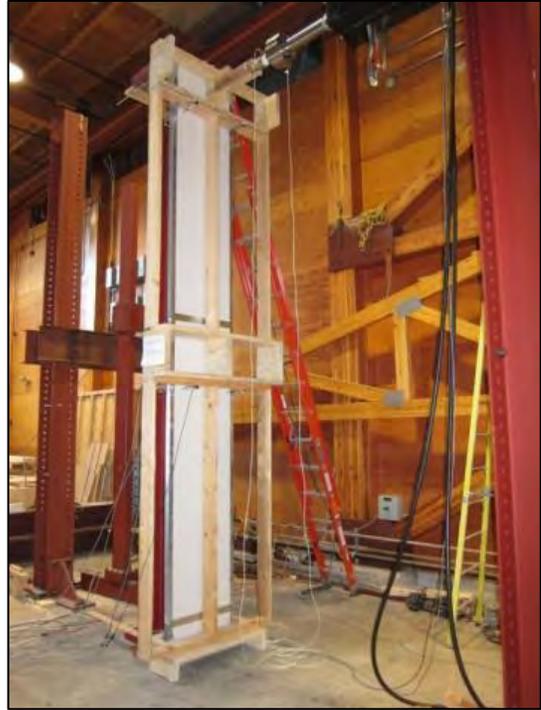
The fire wall test setups are shown in Figure 22. The actuator is connected to the framing members through 2 short pieces of 2x4 lumber bolted at each end. The load was applied at the center of the floor joist at the first or second storey. Loading rate for each wall test condition was 0.50 in/min.

There are 8 transducers used to measure movement of the gypsum firewall; 4 at mid-level and 4 at the top level with 2 on the front face (firewall surface facing actuator) and 2 on the back face (firewall surface facing steel column) at each level. The transducers were located next to each aluminum angle clip.

a) Load condition A

b) Load condition B

Figure 22 Firewall test setups

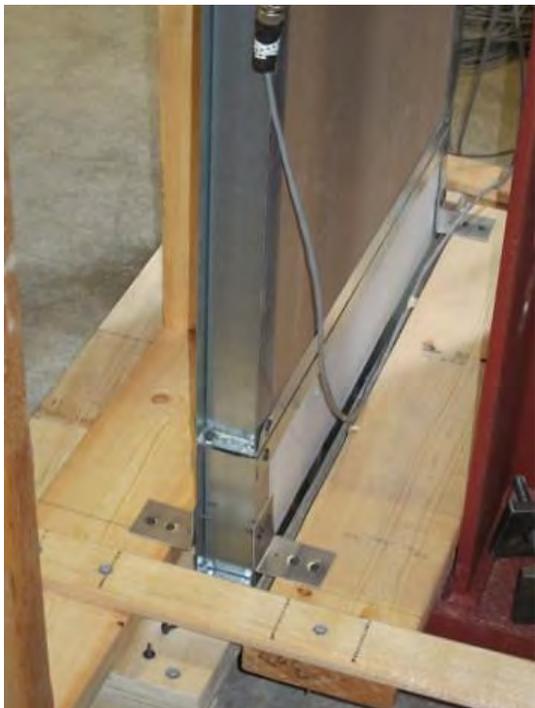
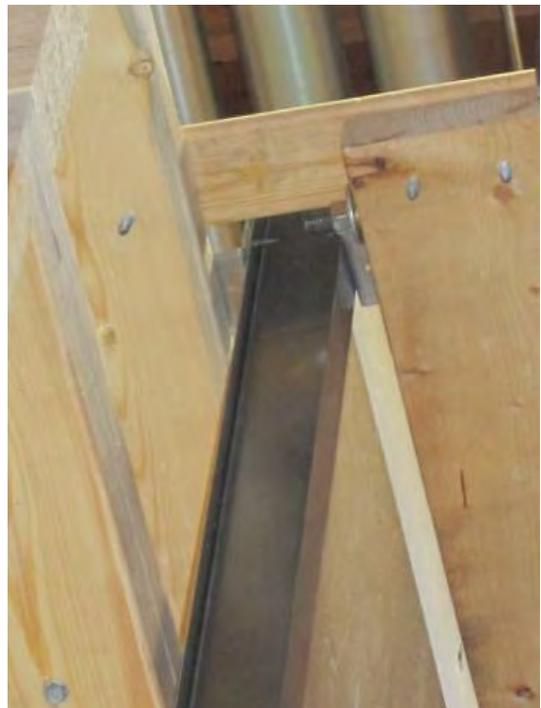
For the wall assemblies, the plate of wood frame on the foundation was tied to the wood plate at the same location on the back of the firewall through wood straps. For wall assembly 1, the plate of wood frame at the top of the wall assembly was also tied to the wood plate at the same location on the back of the firewall through wood straps. The connectin details are shown in Figure 23.

a) Connection at bottom of wall assembly

b) Connection at top of wall assembly

Figure 23 Firewall test setups

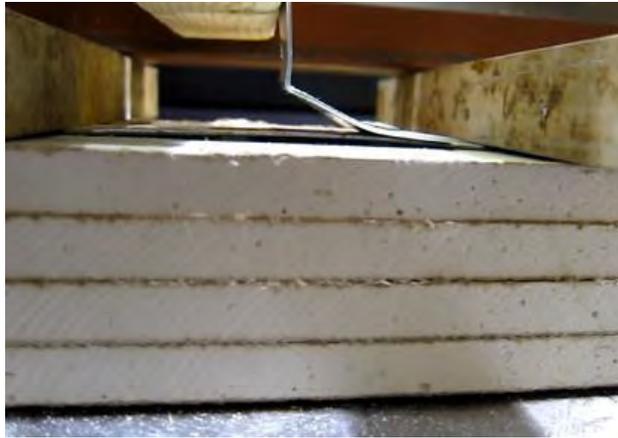
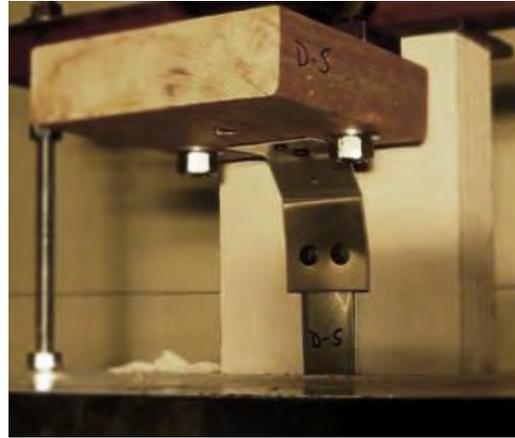
a) Load condition A

b) Load condition B

Figure 25 Aluminum clips straighten out

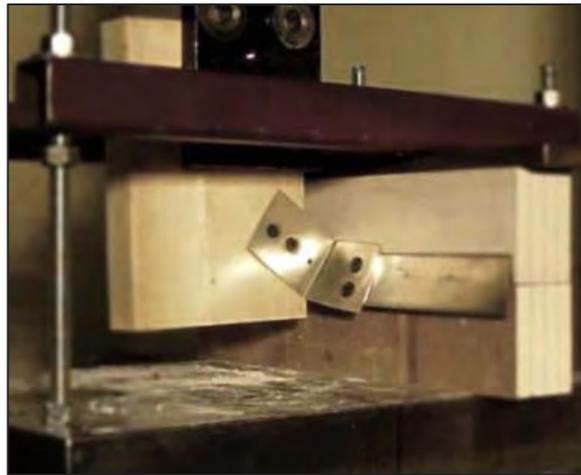
Figure 26 Twist of aluminum clips under load condition C

Figure 24 shows the load-displacement curves of the clip joint tests. As can be noticed from Figure 24b, there is a drop of load at approximately 0.8 inches under load condition B. This is probably due to the fracture of aluminum clip around the screw which is connected to wood member. Figure 27b shows the fracture of the aluminum clip. For joints under load conditions A and B, aluminum clip was straightened out first before the screws started to pick up the force. From the load-displacement curves, it seems to indicate that the aluminum clip was straightened out at approximately 0.7 inches under load condition A and at around 0.5 inches under load condition B. Figure 25 shows the straightened out clips during the tests. For joints under load condition C, the load-displacement curves indicate that the screws started to pick up the force right from the beginning of the tests. This is because that the clip angle cannot be easily twisted, as shown in Figure 26.

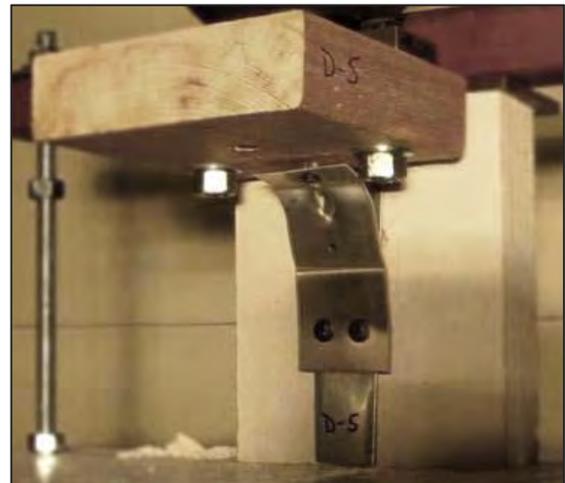
b) Failure of clips under load condition B

Figure 27 Failure modes of clip joints

Under load condition B, failures occurred at two different stages, which correspond to the peak load observed in Figure 24b. At the first peak load, either the wood screw connected to wood member was pulled out of the wood member or the aluminum clip was torn open at the screw, as shown in Figure 27b. At the second peak load, the wood screw, which is connected to wood member and away from the metal H-stud, was pulled out of the wood member. The failure modes were similar for joints

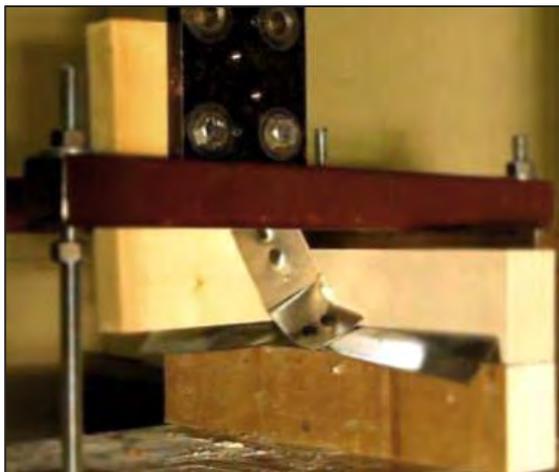
c) Failure of clips under load condition C

Under load condition C, different failure modes were observed for joints with standard metal H-stud: a) the screw connected to wood member was pulled through the aluminum clip; b) metal H-stud was opened up and screws connected to H-stud were pulled out, as shown in Figure 27c; and c) the head of wood screw connected to wood member broke off. For the proprietary H-stud, the joint failed after the head of wood screw, which is connected to wood member, broke off. No proprietary metal H-studs were opened up during the test, as shown in Figure 27d.

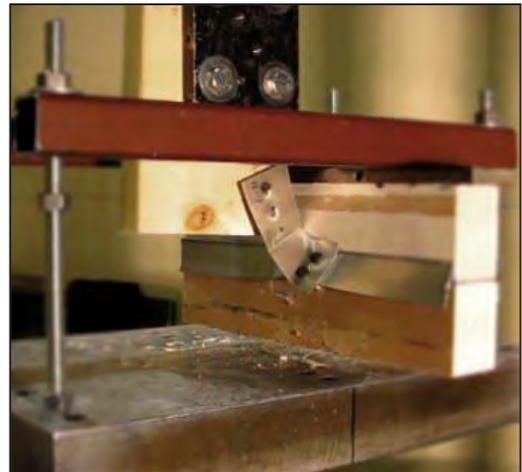
d) Failure of clips under load condition C

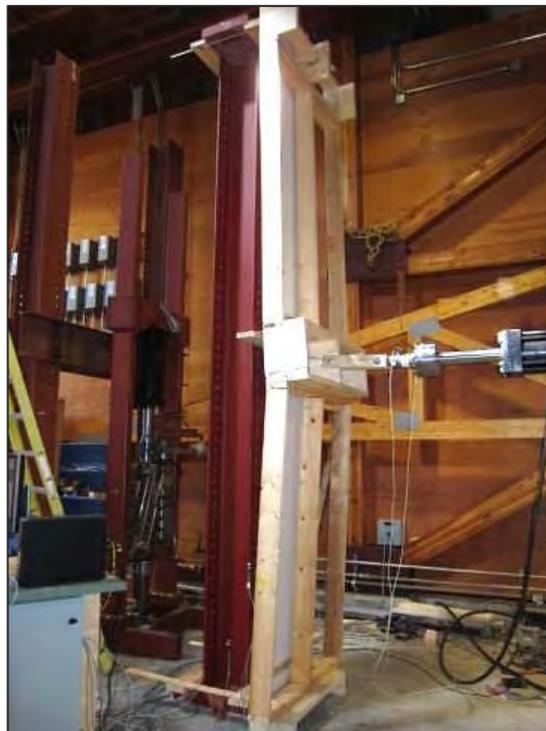
Figure 28 Rotation of floor joist under horizontal load

Table 5 summarises the test results of wall assembly specimens. It is noticed that the displacements at the back of the firewall (deformation of clips attached to plate connected to steel column) are always larger than the displacements at the front of the firewall (deformation of clips attached to plate of wood frame). This is because the floor joists were tilted under the applied load. As the transducers are fixed to the wall plate, the rotation of the plate causes the transducer to move further closer to the firewall. Figure 28 shows the movement of the floor joists.

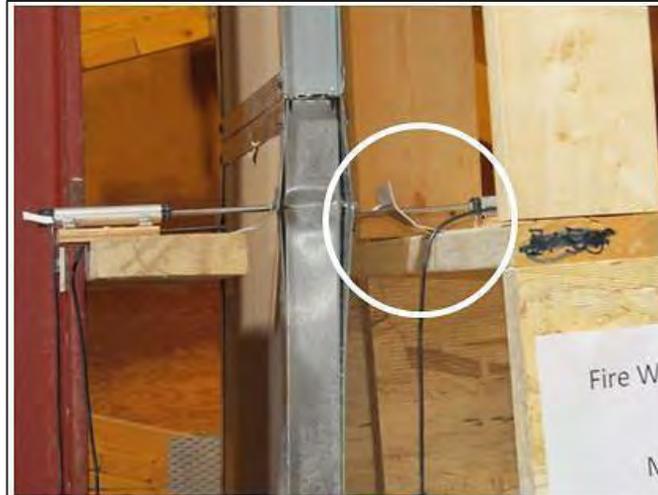
Figure 30 shows the failure mode observed in Wall 1. The screw on the clip was pulled out of the H-stud next to transducer #2 (front left at first floor). As shown in the photo, local deformation of H-stud was observed at location where clips are attached. This seems to indicate that concentrated force was applied on the H-stud through the screws symmetrically placed at both sides of the walls. It is not clear whether or not the localised deformation of H-stud has any negative impact on the fire performance of the gypsum firewall. Further study is needed.

Figure 30 Failure mode of Wall 1

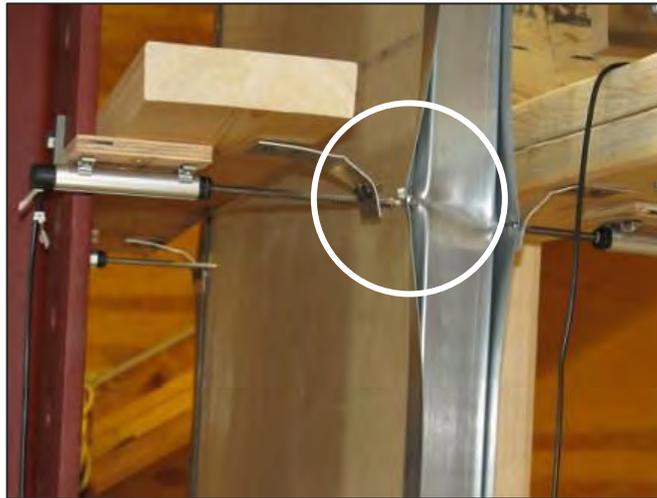
Figure 32 shows the failure mode observed in Wall 2. The screws on the clip was pulled out of the H-stud next to transducer #5 (back right at the second floor). This indicates that clips could break on either side of the firewall. This is not surprising as the clips on both sides of the firewall receive the

same amount of force. As shown in the photo, local deformation of H-stud was observed at location where clips are attached.

Figure 32 Failure mode of Wall 2

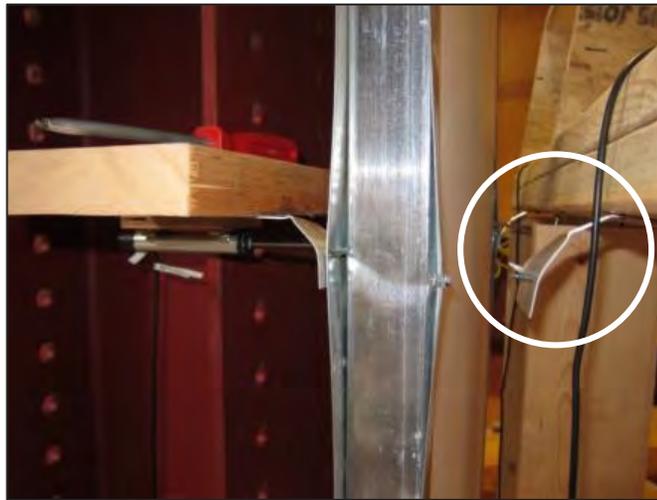
Figure 34 shows the failure mode observed in Wall 3. The screws on the clip was pulled out of the H-stud next to transducer #6 (front left at the second floor). For standard H-stud, local deformation of H-stud was also observed at location where clips are attached.

Figure 34 Failure mode of Wall 3

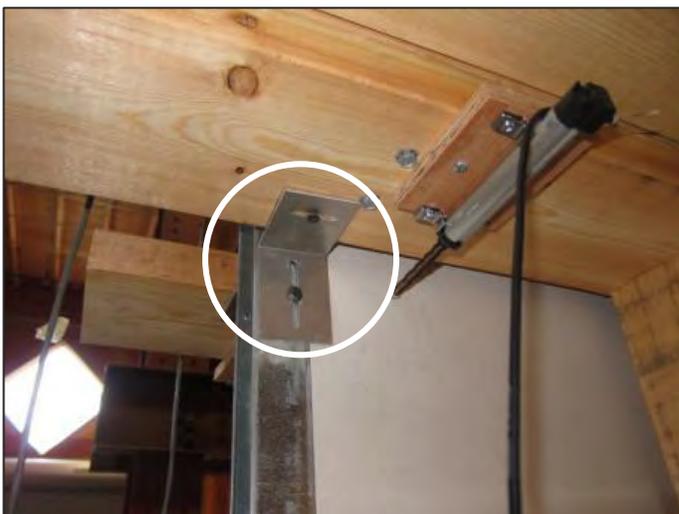
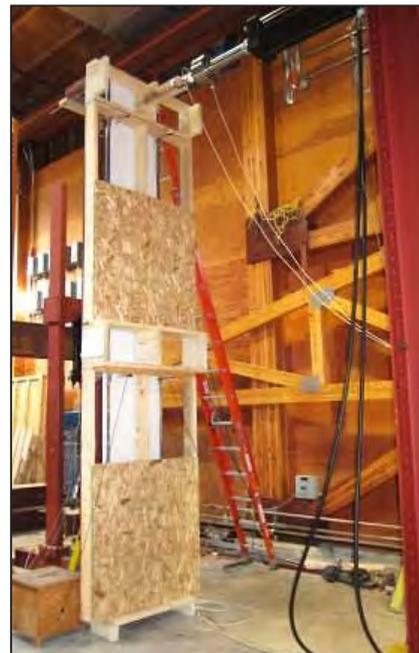
Except modified clips which was used in this test, the load condition and materials used for Wall 4 are the same as those used in Wall 2. The screws were installed at the middle of the vertical slot (attached to H-stud) and horizontal slot (attached to wood member). Because of the slots in the clips, the wood frame become unstable in the plane of the framing. To solve this issue, OSB panels were attached to the framing with two screws on each stud (at the top and bottom of the panels). Figure 35 shows the positions of the screws in the clip slot and placement of the panels.

Figure 35 Construction details of Wall 4

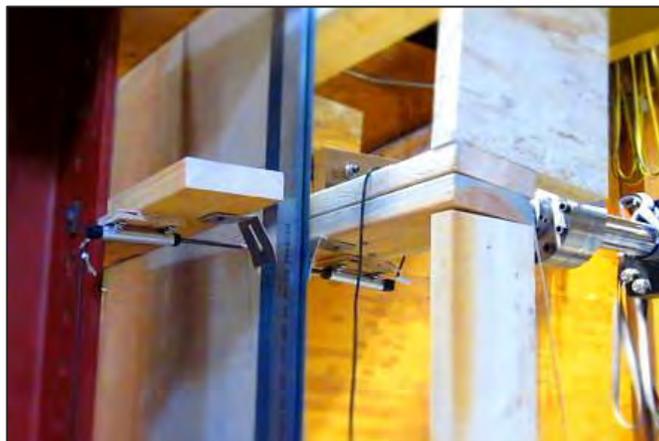
Figure 37 Movement of clips in Wall 4

The load-displacement curve of Wall 4 is shown in Figure 36. Compared to Wall 3, the modified clips underwent almost twice the deformation of standard clips. This is due to the slot which allows screws to slide under the load, as shown in Figure 37. With modified clips, the displacement (deformation of clips) at first floor is still very small, almost negligible.

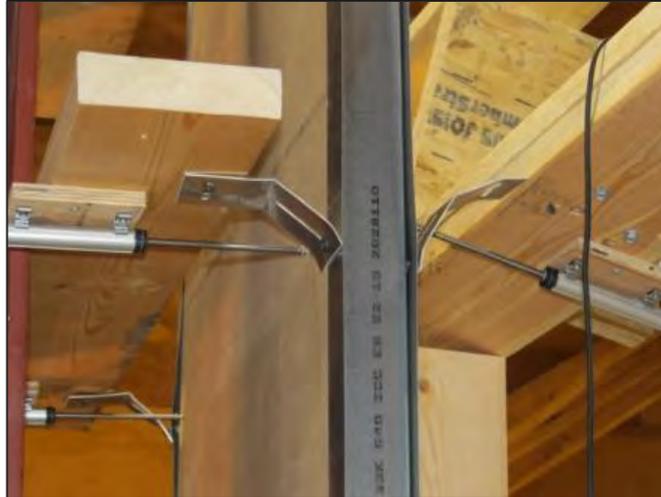
Figure 38 shows the failure mode observed in Wall 4. The horizontal slot of the clip popped off of wood screw next to transducer #2 (front left at the second floor). The screw head was broken when it was removed from the plate. Compared to standard clips, this failure mode seems to be more desirable as the metal H-stud had much smaller local deformation around screws.

Figure 38 Failure mode of Wall 4

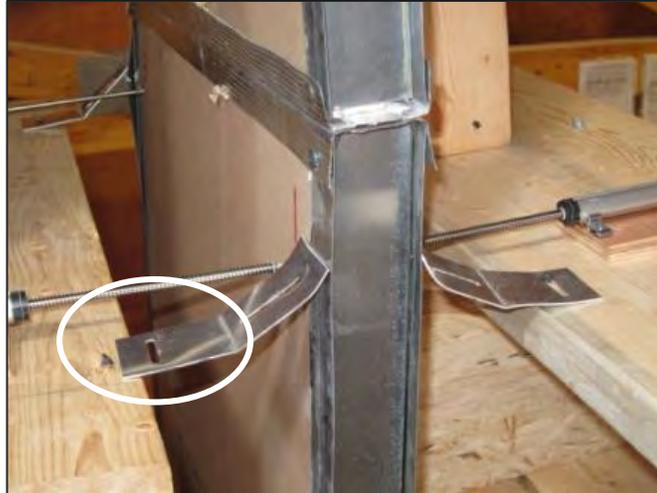
Figure 40 shows the failure mode observed in Wall 5. The horizontal slot of the clip popped off from wood screw next to transducer #1 (back right at the first floor). Similar to Wall 4, metal H-stud had little local deformation around screws.

Figure 40 Failure mode of Wall 5

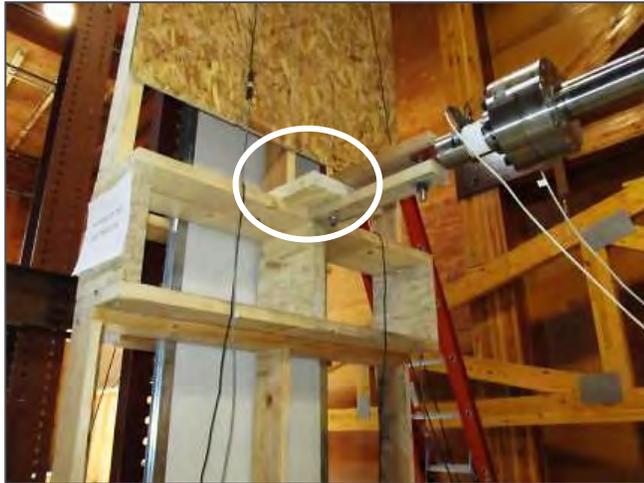
a) Position of actuator

Figure 41 Test setup of Wall 7

Except standard H-stud which was used in this test, the materials used for Wall 7 are the same as those used in Wall 1. Based on the tests of Wall 1 and 5, it was observed that the floor joist was tilted up during the test. This does not represent what would happen in a real fire condition in which floor joist will likely to fall due to the collapse of adjacent structural members. As a result, the load was applied at the top of the floor joist, instead of at the center of the floor joist. Figure 41 shows the position of the actuator and the deformation of the wall framing under load. As noticed from Figure 41b, the floor joist in the first floor did not rotate in this test.

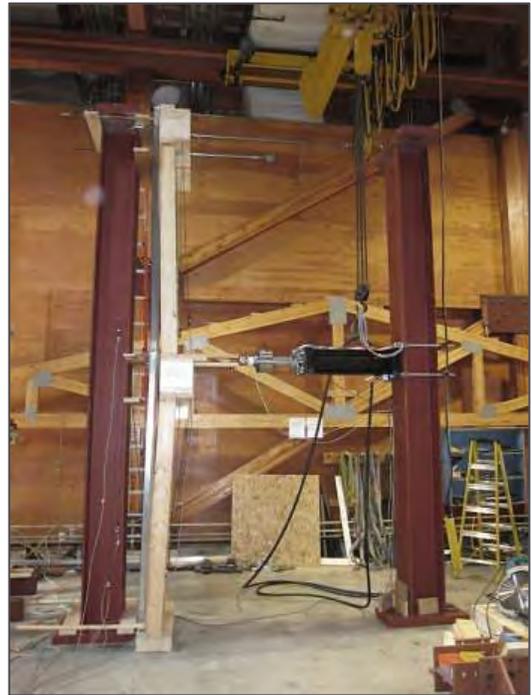
b) deformation of wall framing under load
