Residential Solar Power Systems

for Affordable Housing in B.C.

Introduction

Project Overview

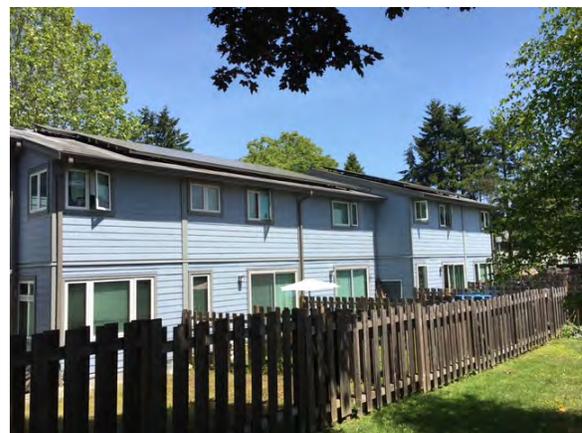
The modules are mounted 10 cm (4 in.) above the roofs, using a UniRac mounting system. The project's structural engineer evaluated the attachment details between the UniRac systems and the roofs.

Figure 1: PV system installed at Greenbrook.

The solar PV system consists of almost 700 Sanyo HIP 195-watt PV modules for a total generating capacity of approximately 139 kW. The system was projected to generate roughly 130 MWh per year.

The PV installation is spread throughout 11 buildings in the complex. The site was a viable candidate for PV because many of the buildings had south-facing roofs.

In total, nine PV installations face south, one south-west, and one west. The PV modules are connected in different sub-arrays, which are then connected to three varied sizes of inverters (5 kW, 6 kW, and 7 kW).

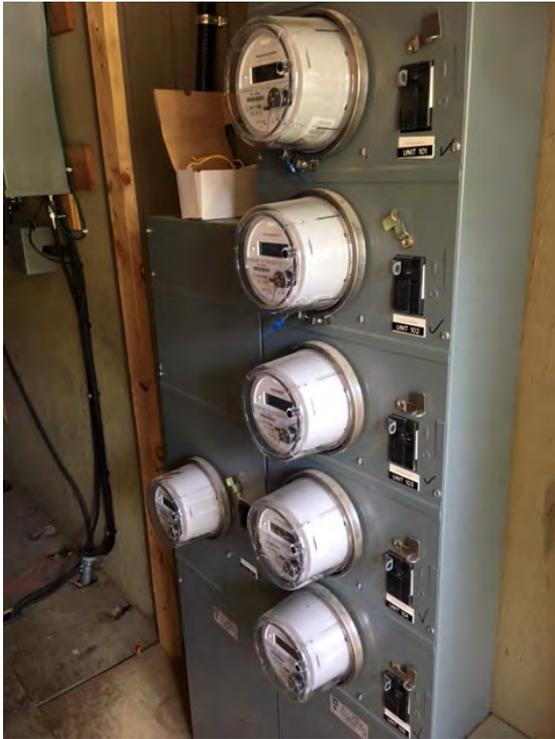
The system was installed under a net-metering agreement with BC Hydro. The PV-generated electricity is fed into each building (approximately five suites per building.) When electricity is being generated, it first meets all the electrical loads of that building. If there is more electricity generated than the building consumes, the excess is fed back into the grid via the building's electricity meter, which generates a credit for future consumption.

Figure 2: Electrical meters at Greenbrook.

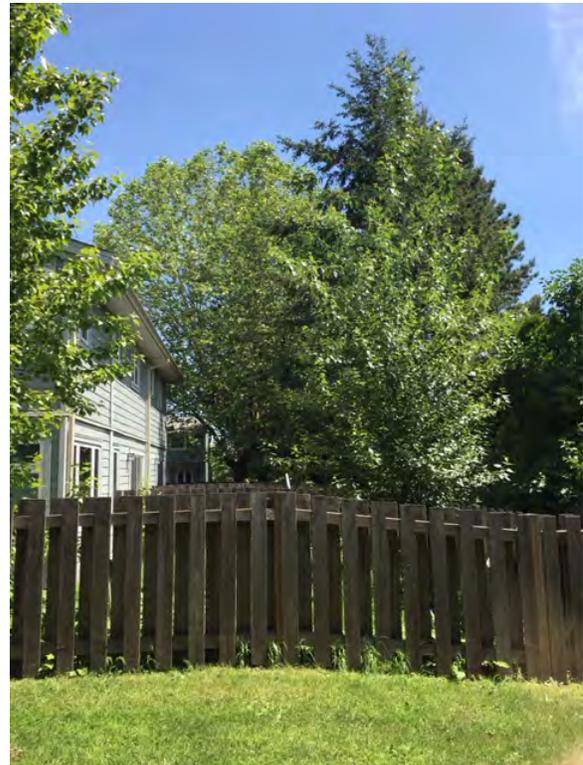
The large trees at Greenbrook were a factor in choosing where to locate the PV installations, as shading may impact the performance of the whole array. Fortunately, there are south-facing roofs with unshaded roof surfaces. One system was mounted on an unshaded south-west roof and another on a west-facing roof.

Figure 3: Large trees at Greenbrook.
