# PERFORMANCE MONITORING OF AN ENERGY EFFICIENT SIX- STOREY WOOD-FRAME BUILDING

Hygrothermal Performance,  
Thermal Comfort, and Space  
Heating Energy

**PERFORMANCE MONITORING OF AN  
ENERGY EFFICIENT SIX-STOREY WOOD-  
FRAME BUILDING**

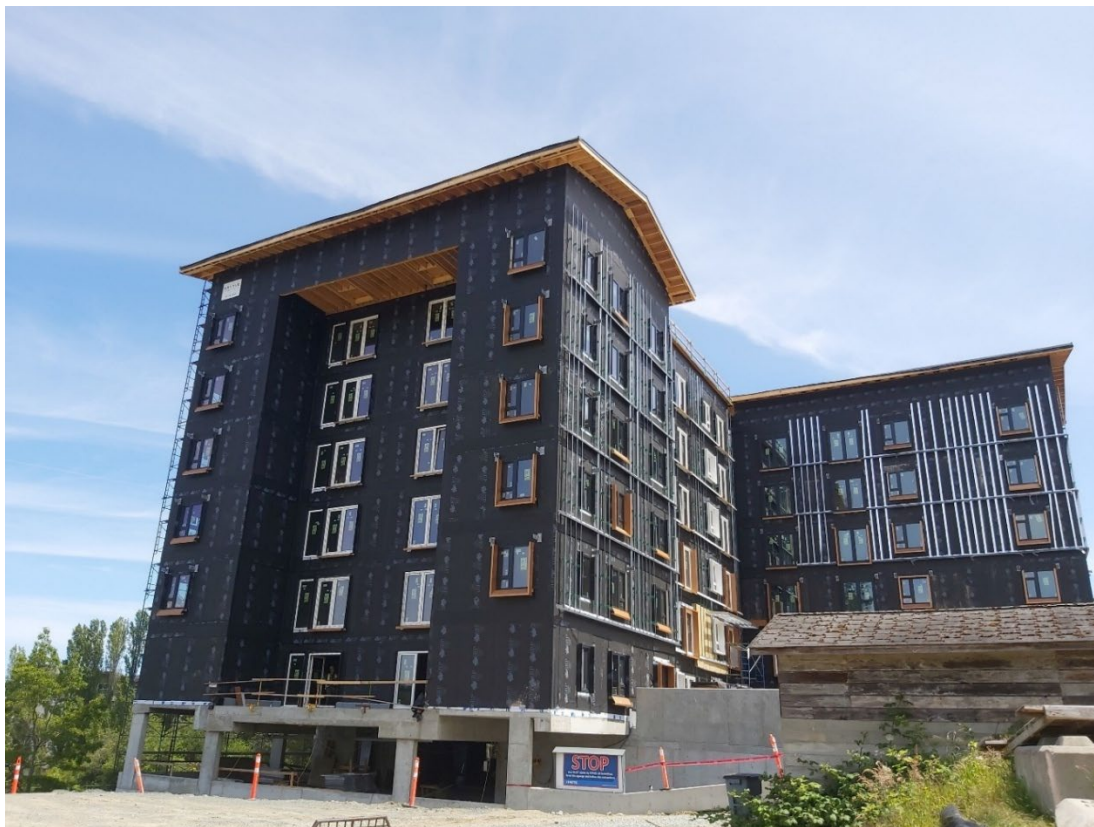
Figure 1. Building under construction.

The building has an “L” shape with suites facing different orientations, designed to provide optimal solar gains as well as natural light for the entire building (Figure 1). Its building envelope includes highly insulated light-wood-frame wall and roof assemblies and high-performance windows to minimize space heating needs in cold weather. For example, with wall panels prefabricated in a factory located in Metro Vancouver, the wood-frame exterior walls achieved about effective R37 with split-insulated assemblies. They were built with 2 by 4 (actual 38 mm by 90 mm) dimension lumber wall studs, with R14 batt insulation installed in the stud cavities and R24 rigid stone wool insulation boards [6 in. (152 mm) in thickness] installed outboard of the 1/2 in. (actual 13 mm) thick plywood exterior sheathing. A vapour-permeable sheathing membrane was pre-installed in the factory also to provide protection during the installation on site. The low-slope roof was built with “I” joist [11 7/8 in. (actual 302 mm) deep] with batt insulation installed inside the joist cavities and rigid exterior insulation of R40 installed above the plywood roof sheathing, approximately achieving effective R70. The prefabricated panels were installed from October 2019 to February 2020. Exterior sunshades were installed at major windows facing south, west, and east to block unwanted solar gains to keep the indoor temperature comfortable in the summer. The building has electrical baseboard heaters in each living space (i.e., studio, bedroom, or living room) to provide space heating when needed by occupants. Mechanical cooling is not provided.

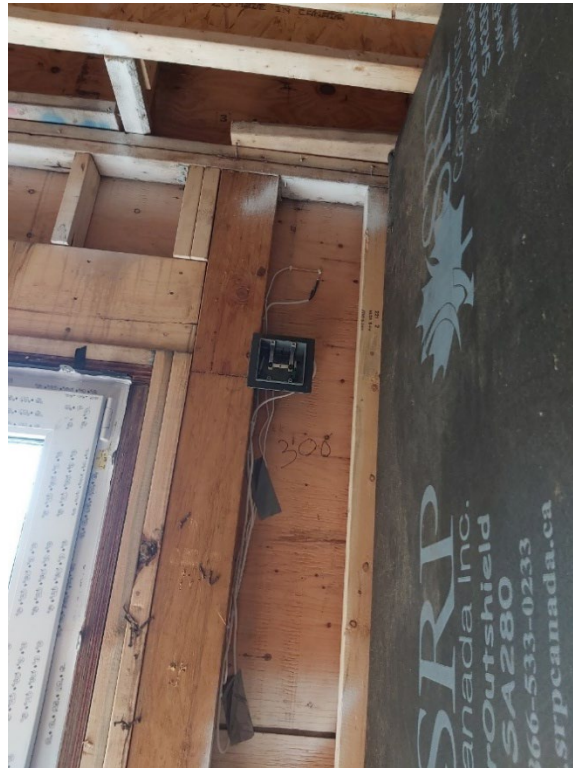
Figure 2. An RH/T/MC sensor with probes installed on interior surface of plywood wall sheathing.

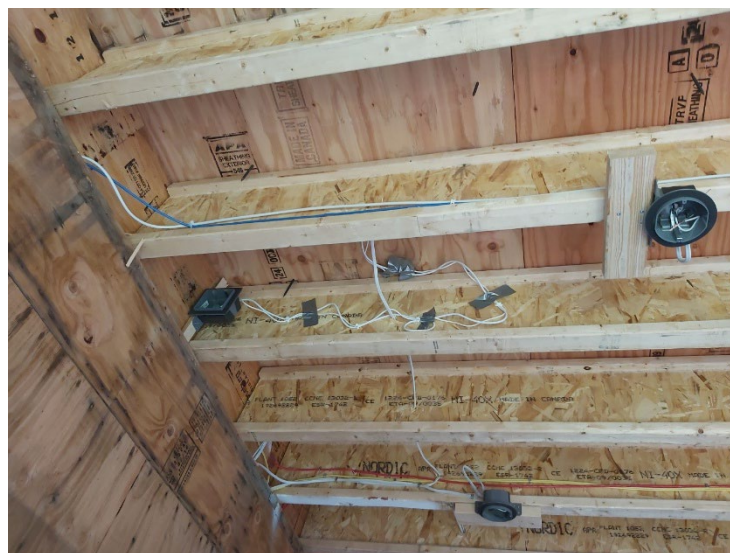
Figure 3. An RH/T/MC sensors with probes installed inside roof.

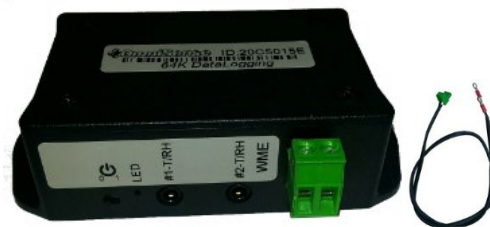
2. A sensor with three ports for measuring temperature, relative humidity, and wood moisture content (left), and probe (right)

Figure 17. Hardware used in this monitoring study.

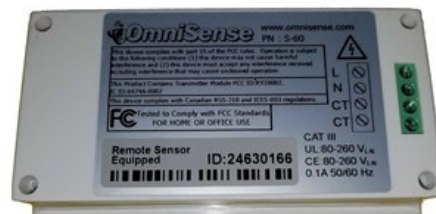
3. A submeter for measuring electricity consumption
