BUILDER INSIGHT

Rainscreen Walls: Field Monitoring and Performance in British Columbia

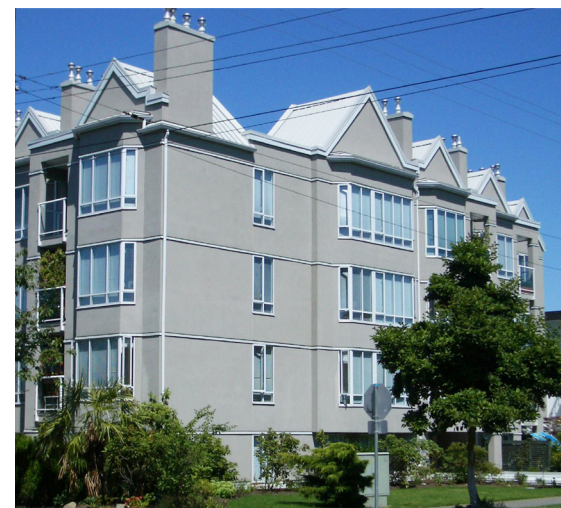
Typical four-storey, low-rise with rainscreen walls – **Building 2 of the Monitoring Study.** Flashing at each floor level directs water from the air cavity to the exterior and allows ventilation.

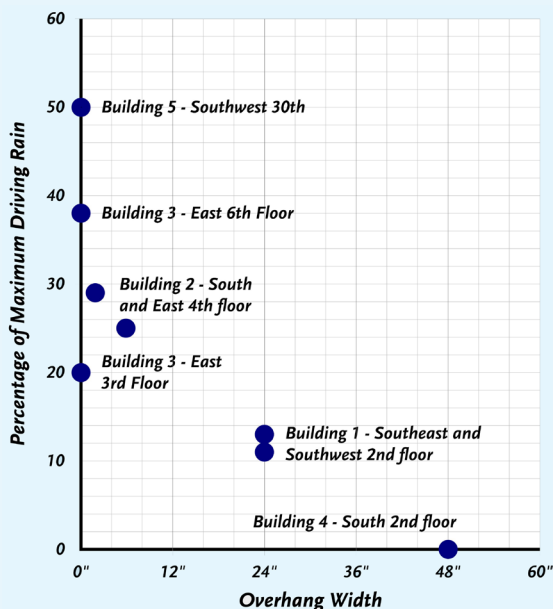
Roof overhang width versus measured percentage of driving rain potential.

While the annual rainfall amounts recorded were similar across all five buildings, wind speed differences, particularly at the four-storey buildings, account for the large differences in actual driving rainfall. Figure 2 compares the effect of roof overhang width versus driving rain accumulation at varying locations for all five monitored buildings. The measured driving rain is compared to the cumulative potential driving rain, based on horizontal rainfall, wind speed and wind direction measured at the roof. As shown, buildings with large overhangs (24-48") received significantly less driving rain than buildings with no overhang or overhangs less than 12". A 48" overhang on a relatively sheltered four-storey building can reduce driving rain on its façade to negligible levels. As anticipated, when overhangs are not present, upper floors received more driving rain than lower floors; however increased wetting from water cascading down over the lower wall areas is not shown by this figure. Taller buildings have greater wind-driven rain potential due to these wind spatial differences.
