Builder Insight

TECHNICAL BULLETIN

Alternatives to Domestic Water Re-Piping

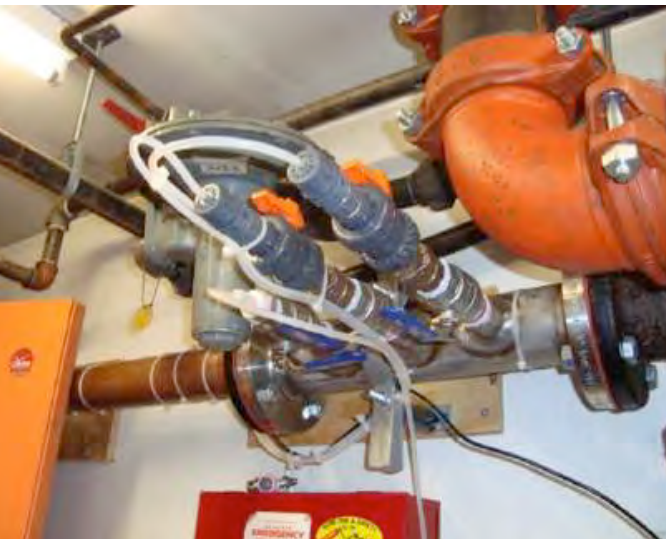
Image of the injection point of minerals into the domestic cold water supply.

A water management system is a water chemistry adjustment technique that injects minerals to the water supply as the domestic cold water enters the building. This technique adds naturally occurring hard water minerals to incoming, domestic cold water, creating a biofilm on the inside of the pipework, limiting further attack to the copper pipework. Additional pH correction of the water supply further assists this process.

Water systems utilise a water meter to measure domestic cold water consumption in the building, allowing two pumps to inject a predetermined amount of minerals into the drinking supply. The demand of water is automated and dosing pumps are locked to prevent tampering after installation. Government certified treatment minerals are safe to use, as per standard NSF-60. A number of safeguards are included to the monitoring and control system to prevent problems and ensure water quality. This includes a pulse splitter to protect dosing pumps, and sampling points connected to alarms.
