# BUILDER INSIGHT

**Builder Insight** is a series of bulletins and companion videos designed to provide practical information on new technologies, research results, good building practices and emerging technical issues in residential construction to Licensed Residential Builders and others in the industry. This bulletin was prepared by RDH Building Science with review by Evoke Buildings Engineering Inc.

## Retrofit and Renewal of Low-Slope Vented Wood-Frame Roofs

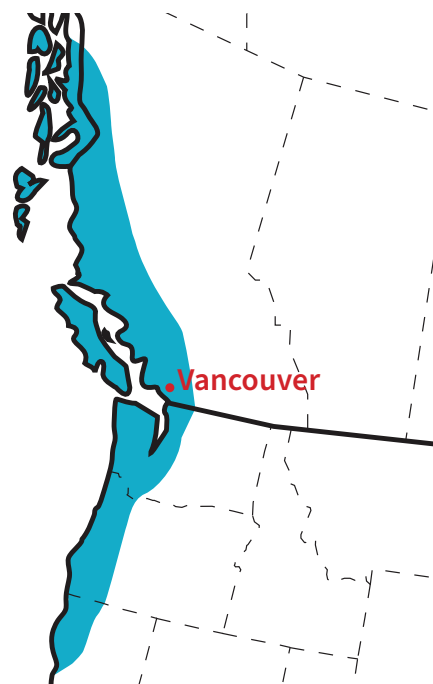
Figure 4: Map of Pacific Northwest with high mold risk area highlighted

Issues in low-slope vented roof assemblies are common in the Pacific Northwest (area of concern highlighted in Figure 4), largely due to a damp and cool marine climate, where there is significant opportunity for wetting, but limited opportunity for drying due to its moderate winter coinciding with overcast and rainy wetting season. Compared to sloped attic roofs, low-slope vented roofs are less reliably ventilated, and the vented space is inaccessible for periodic inspection.

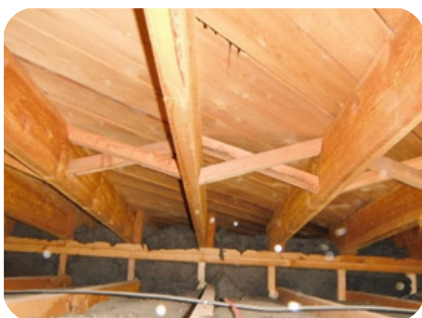
### Like New

*Roof deck in pristine condition  
(insulation above roof sheathing)*

Figure 5 shows the range of conditions that have been observed for low-slope vented wood-framed roofs in BC during recent roof renewals. Sources of moisture are often attributed to rainwater ingress; unintentional exfiltration of conditioned air from the interior spaces; or air leakage from ductwork that condenses on the underside of the roof sheathing. However, another source of moisture within the

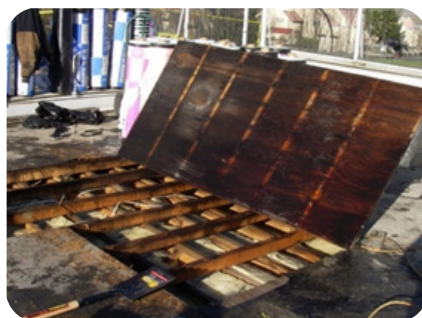
### Stained

*Significant staining of the sheathing and purlins*

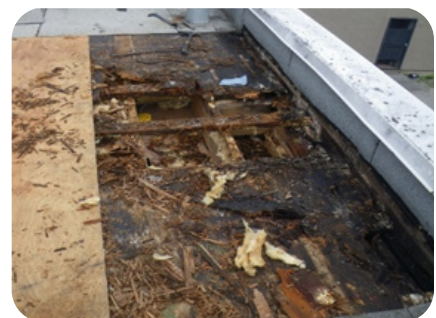
### Deteriorated

*Structural damage of the sheathing*

Figure 5: Range of observed low-slope vented wood-framed roof sheathing conditions in the Lower Mainland of BC at time of roof membrane renewal
