July 2023

# Guide to Mitigating Thermal Bridging at Roofs and Decks

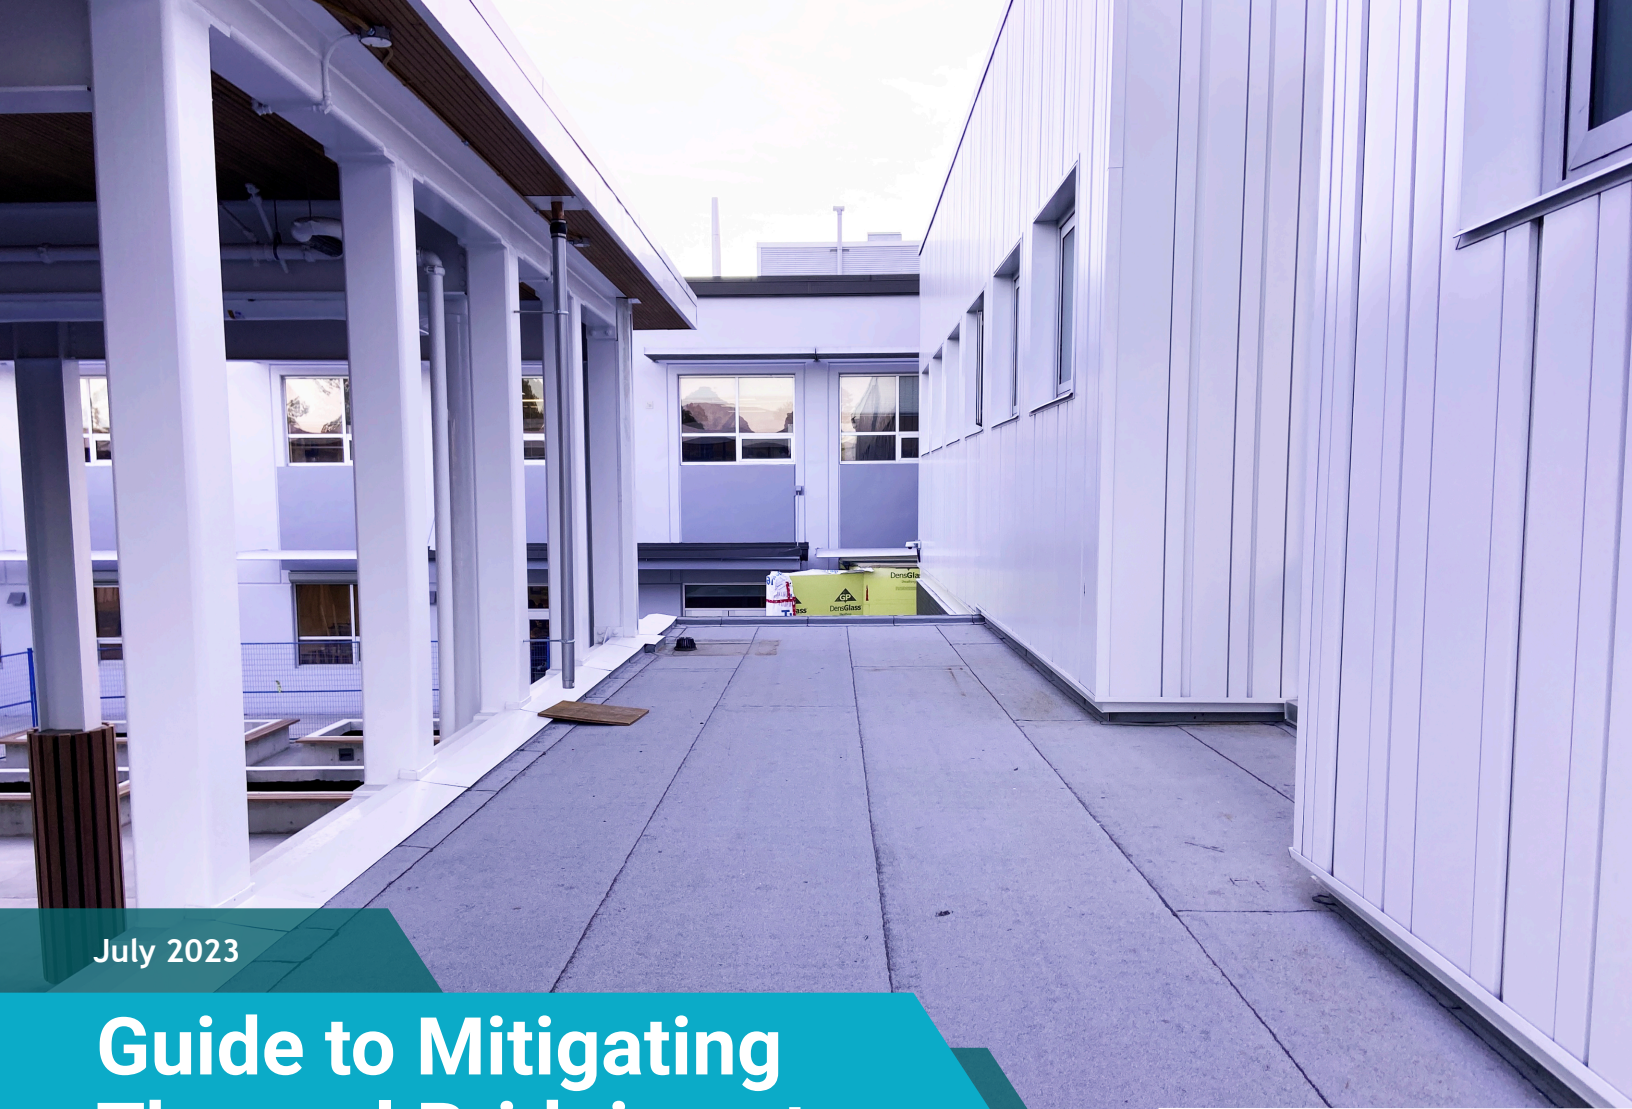
Figure 1. Roof Deck Plan

Roof plan showing parapet walls, planter with concrete curbs, and pedestals.

- Orange = Parapets (240 m)
- Blue = Planter Walls (150 m)
- Purple = Columns (10)

In this guide, a 900 m<sup>2</sup> (9680 ft<sup>2</sup>) roof deck, with features common to high-rise buildings, is provided as an example. These types of decks often include outdoor amenities as shown in Figure 1. This roof layout and data from the Building Envelope Thermal Bridging (BETB) database is used to highlight the impact of thermal bridging, the ways to achieve low overall thermal transmittances (high effective R-value), and offer solutions to mitigate thermal bridging

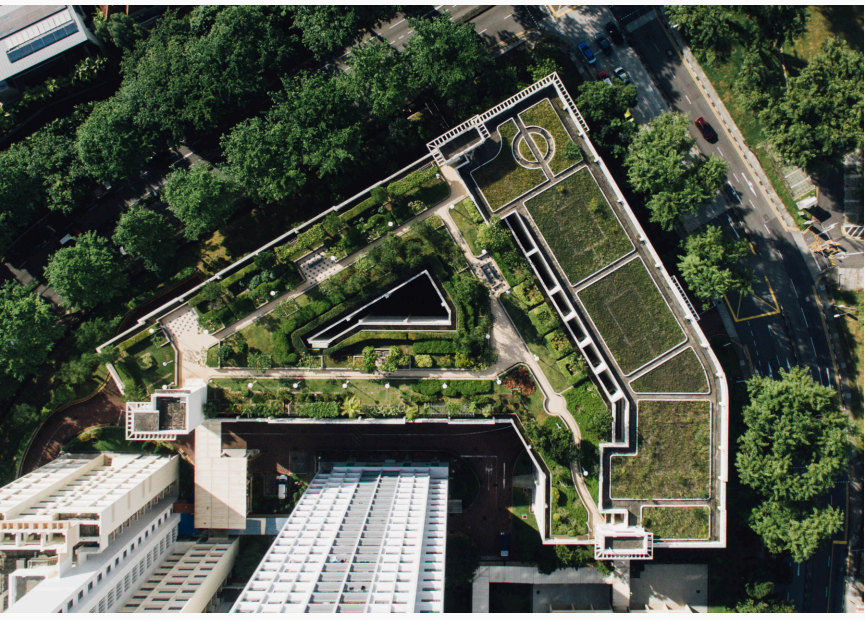
Figure 2. Accessible Green Roof Viewed from Above

Accessible roofs with a mix of planters and hardscapes often have more thermal bridging than compared to a roof that is only interrupted by service penetrations

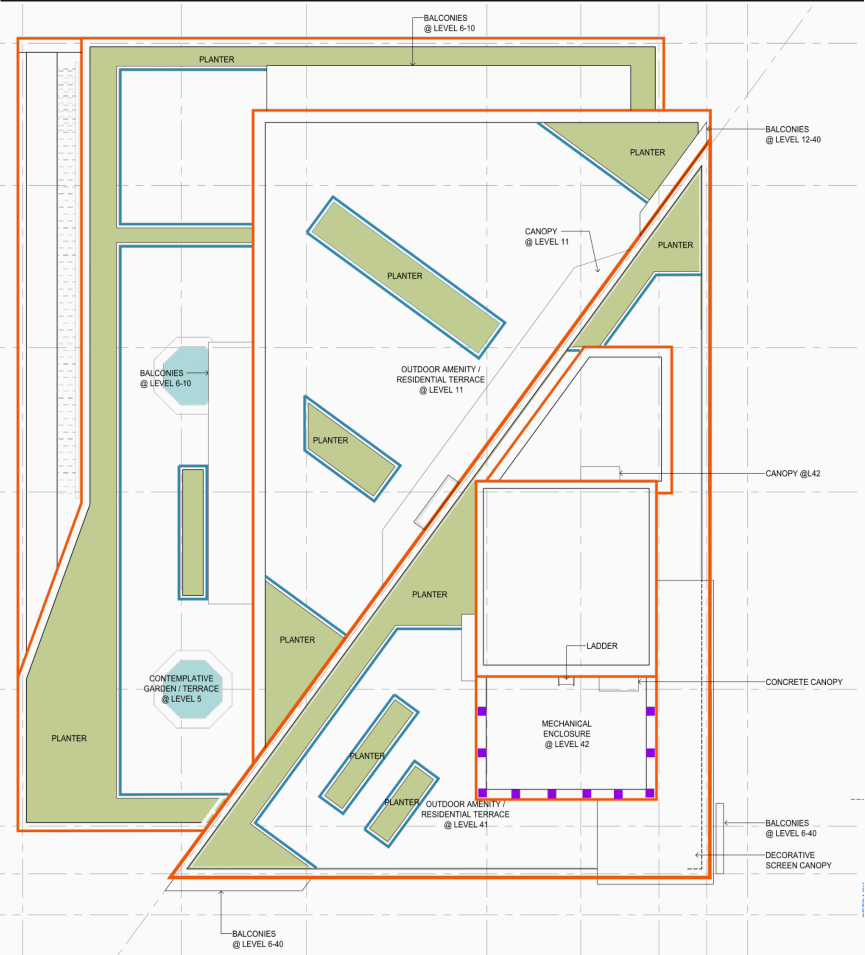
Scenario 1: Unmitigated Thermal Bridging for R-31 Clear Field Roof Assembly

| Roof Assembly | Parapet | Landscaping Wall With Curb | Base of Wall at Roof Deck | Door at Roof Deck | Steel Columns |
| Percent of Total Heat Flow Through Roof Area: | 31% | 26% | 3% | 9% | 1% |
| Clear Field:<br>R-31<br>(RSI-5.5)<br><br>Area: 9680 ft² (900 m²) | Linear Transmittance:<br>0.40 BTU/hr ft² °F<br>(0.70 W/m K)<br><br>Distance: 788 ft (240 m) | Linear Transmittance:<br>0.54 BTU/hr ft² °F<br>(0.93 W/m K)<br><br>Distance: 492 ft (150 m) | Linear Transmittance:<br>0.15 BTU/hr ft² °F<br>(0.26 W/m K)<br><br>Distance: 197 ft (60 m) | Linear Transmittance:<br>0.40 BTU/hr ft² °F<br>(0.68 W/m K)<br><br>Distance: 246 ft (75 m) | Linear Transmittance:<br>0.64 BTU/hr ft² °F<br>(0.34 W/m K)<br><br>10 Columns |
| <ul style="list-style-type: none"><li>Overburden</li><li>Rainwater Barrier</li><li>R-30 XPS Insulation</li><li>Solid Core Drainage Mat</li><li>Waterproofing Membrane</li><li>Concrete Structure</li><li>Interior</li></ul> | Parapet cast to roof slab and interrupts roof insulation. | Concrete curb penetrating through roof insulation. | Exterior and interior insulated steel framed wall on concrete curb with through-wall flashing. | Door on concrete curb. | Steel columns mounted directly onto the roof slab. |

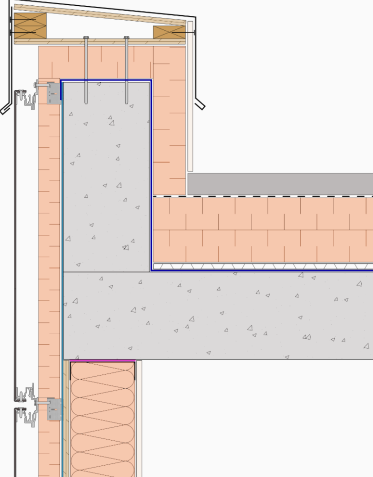
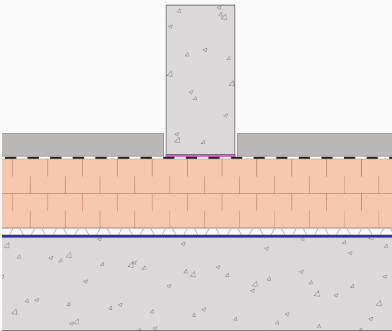
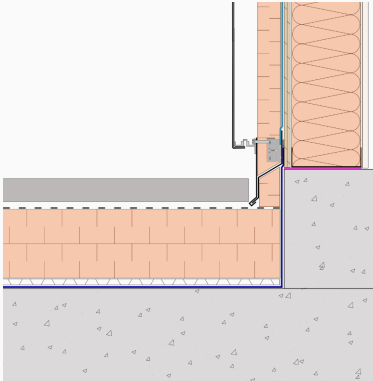
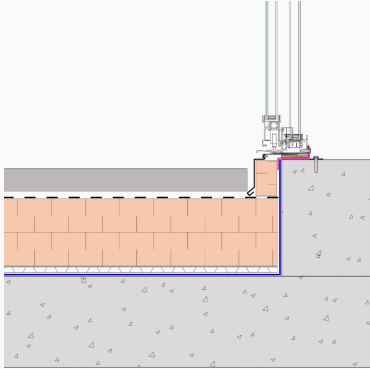
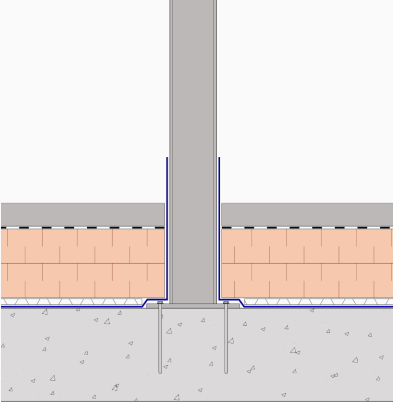
Scenario 2: Mitigated Thermal Bridging for R-31 Clear Field Roof Assembly

| Roof Assembly | Parapet | Landscaping Wall | Base of Wall at Roof Deck | Door at Roof Deck | Steel Columns |
| Percent of Total Heat Flow Through Roof Area: | 24% | 0% | 6% | 5% | 1% |
| Clear Field:<br>R-31<br>(RSI-5.5)<br><br>Area: 9680 ft² (900 m²) | Linear Transmittance:<br>0.14 BTU/hr ft² °F<br>(0.25 W/m K)<br><br>Distance: 788 ft (240 m) | Linear Transmittance:<br>0 BTU/hr ft² °F<br>(0 W/m K)<br><br>Distance: 492 ft (150 m) | Linear Transmittance:<br>0.15 BTU/hr ft² °F<br>(0.26 W/m K)<br><br>Distance: 197 ft (60 m) | Linear Transmittance:<br>0.10 BTU/hr ft² °F<br>(0.17 W/m K)<br><br>Distance: 246 ft (75 m) | Linear Transmittance:<br>0.64 BTU/hr ft² °F<br>(0.34 W/m K)<br><br>10 Columns |
| <ul style="list-style-type: none"><li>Overburden</li><li>Rainwater Barrier</li><li>R-30 XPS Insulation</li><li>Solid Core Drainage Mat</li><li>Waterproofing Membrane</li><li>Concrete Structure</li><li>Interior</li></ul> | Parapet wall is wrapped with insulation. | Concrete curb “floats” over the insulation. | Exterior and interior insulated steel framed wall on concrete curb with through-wall flashing. | Curb is exterior insulated. | Steel columns mounted directly to roof slab. |

Targeting higher effective R-values of roofs with optimal levels of insulation requires mitigation of the thermal bridging. For the concrete roof deck example, the most significant thermal bridges is at the parapets, landscaping curbs, and base of wall interface.

Targeting these three details can substantially improve the effective R-value, as seen in Scenario 2. Mitigation strategies include wrapping the parapet in insulation, floating the planter walls, and insulating outboard of the door threshold. These improvements reduce the impact of the interface details from 70% of the heat flow, down to 36% and bring the effective R-value up to R-20.

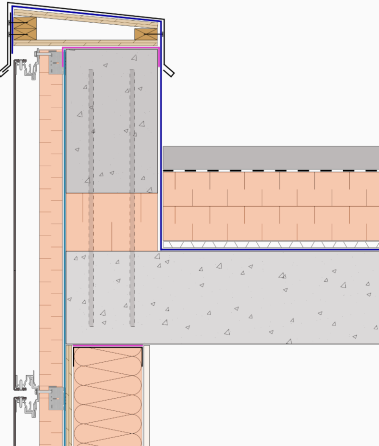
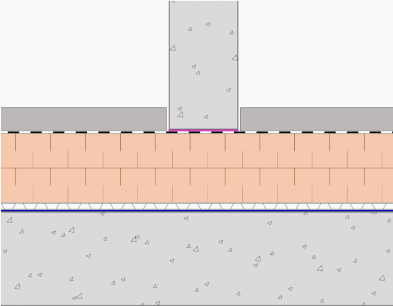
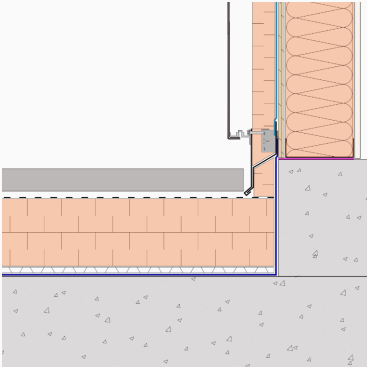
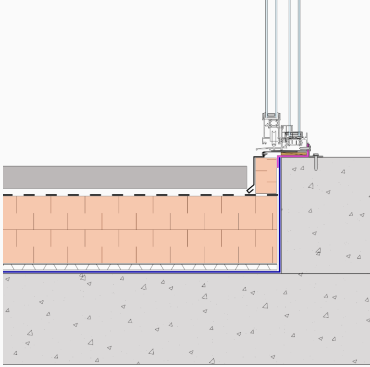
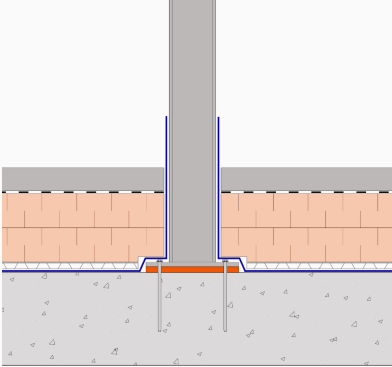
Scenario 3: Highly Mitigated Thermal Bridging for R-31 Clear Field Roof Assembly

| Roof Assembly | Parapet | Landscaping Wall | Base of Wall at Roof Deck | Door at Roof Deck | Steel Columns |
| Percent of Total Heat Flow Through Roof Area: | 18% | 0% | 7% | 5% | 0% |
| Clear Field:<br><b>R-31 (RSI-5.5)</b><br><br>Area: 9680 ft² (900 m²) | Linear Transmittance:<br><b>0.144 BTU/hr ft² °F (0.250 W/m K)</b><br><br>Distance: 788 ft (240 m) | Linear Transmittance:<br><b>0 BTU/hr ft² °F (0 W/m K)</b><br><br>Distance: 492 ft (150 m) | Linear Transmittance:<br><b>0.15 BTU/hr ft² °F (0.26 W/m K)</b><br><br>Distance: 197 ft (60 m) | Linear Transmittance:<br><b>0.10 BTU/hr ft² °F (0.17 W/m K)</b><br><br>Distance: 246 ft (75 m) | Linear Transmittance:<br><b>0.171 BTU/hr ft² °F (0.090 W/m K)</b><br><br>10 Columns |
| <ul style="list-style-type: none"><li>• Overburden</li><li>• Rainwater Barrier</li><li>• R-30 XPS Insulation</li><li>• Solid Core Drainage Mat</li><li>• Waterproofing Membrane</li><li>• Concrete Structure</li><li>• Interior</li></ul> | Parapet wall with manufactured thermal break. | Concrete curb “floats” over the insulation. | Exterior and interior insulated steel framed wall on concrete curb with through-wall flashing. | Curb is exterior insulated. | Steel columns mounted with thermal break. |

Maintaining exposed concrete parapets while improving thermal performance can be done via structural thermal breaks. These thermal breaks are similar to the technology used for cantilevered balconies, but are more cost-effective for this application. Scenario 3 on the next page shows the impact.

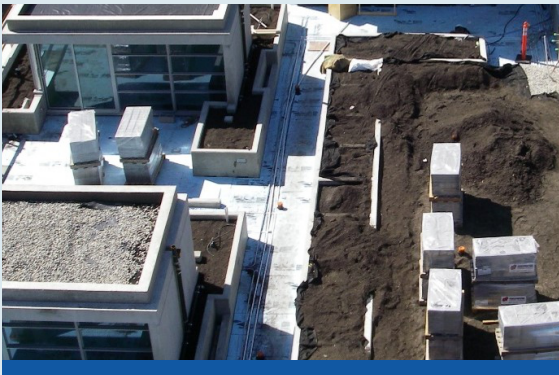
Figure 3. Accessible Rooftop  
Photo of exposed concrete parapets and concrete planter walls that bypass the thermal insulation.

Exposed concrete parapets and concrete planter walls that bypass the roof insulation are visually apparent significant thermal bridges (see Figure 3). However, there are less obvious thermal bridges that are not as commonly discussed or addressed. These include:

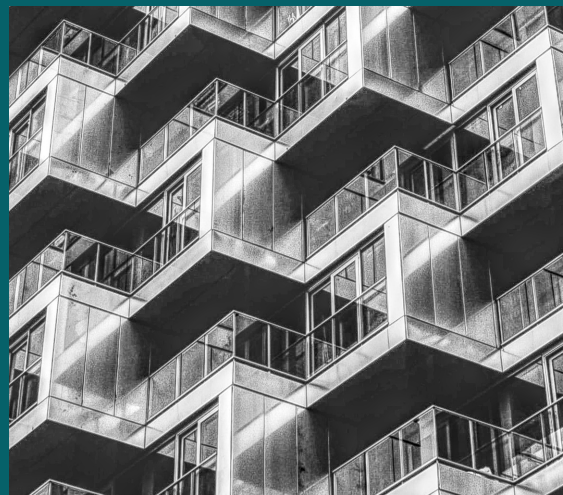
**Figure 4.** Roof decks can have significantly more thermal bridging compared to external balconies due to building articulation.

Pervasive building articulation and small roof decks, as seen in Figure 4, are examples where a significant amount of thermal bridging is introduced. In this example, it is difficult to mitigate and meet higher levels of energy performance.

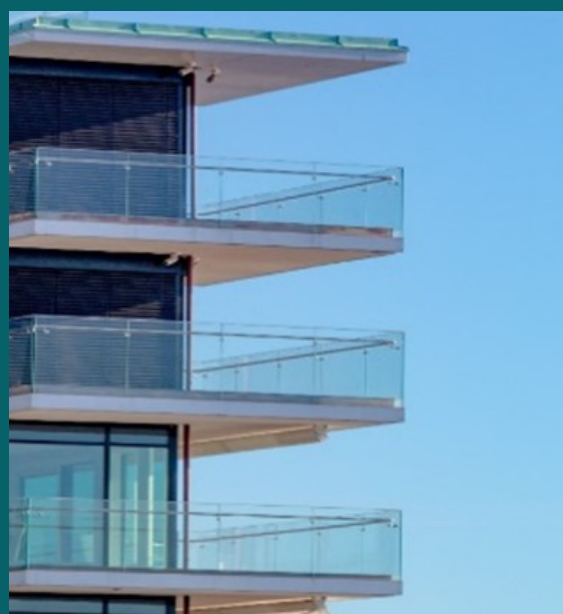
**Figure 5.** Cantilevered external balconies get a lot of attention as thermal bridges but less obvious thermal bridging at roof decks require equal consideration.

Cantilevered balconies like those shown in Figure 5, may have lower thermal quality details than can be provided at the perimeters of roof decks. However, the overall impact of the interface details for roof decks can be higher due to the quantity of thermal bridging for a deck of equal size as a balcony.

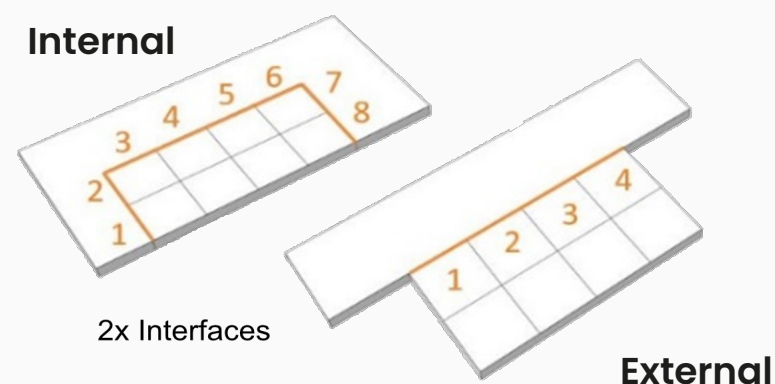
**Figure 6.** Illustration (to the right) showing the base of wall interface length of internal vs. external balconies.

Balconies do not always have less thermal bridging. For example, **internal balconies** that have an exterior wall on 2 or 3 sides as illustrated in Figure 6, have more interface length with the exterior wall making them about **50% worse performing than a comparable roof deck**.

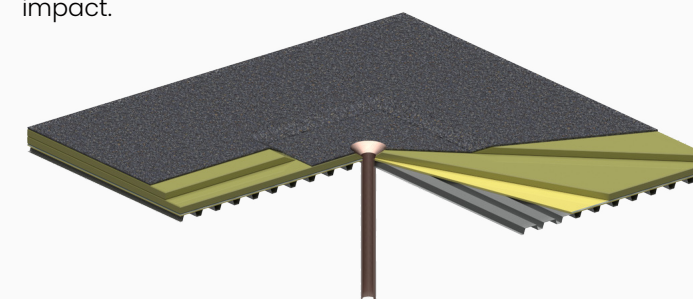
**Figure 8.** Sumped roof drain from the BETB Database.

Details in the BETB database include data for sumped roof drains and roof penetrations as seen in Figures 8 and 9. The roof penetration details are only for metal decks, but there are no issues using the data for other types of roof decks. The values are worst-case scenarios and there is often minimal penalties for taking a conservative approach.

Roof drains and pedestals contribute to the overall heat flow by approximately 0.6 W/K per location. To put it in perspective, these two details combined have a similar impact to one meter of exposed concrete parapet. Parapets have on an order of magnitude greater impact because of the quantity on roofs. As such, focusing on parapets and landscaping curbs will have the greatest impact.

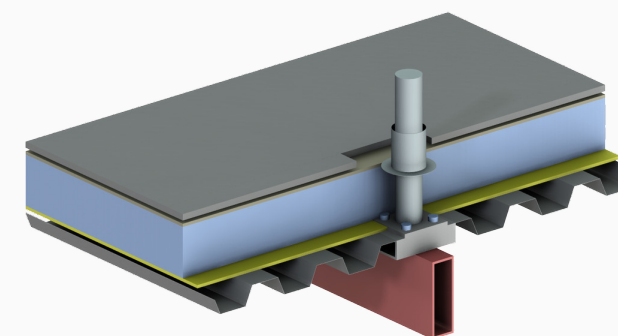
**Figure 9.** Roof anchor from the BETB Database.

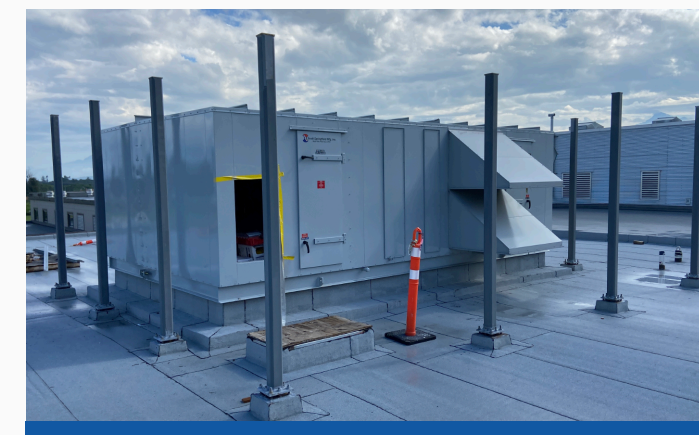
**Figure 7.** Figure showing anchor penetrations into the roof.

Minor building components are often overlooked from a thermal perspective. Examples include roof drains, fall arrest anchors, posts and pedestals for mechanical units or screens as seen in Figure 7. One reason for overlooking these details is that these components are not usually part of the drawings at early design stages.
